# Cooperative NRDA and Restoration at the Newport, DE Superfund Site.

**Ralph G. Stahl, Jr., DuPont; Maryann Nicholson, DuPont;  
Al Boettler, DuPont (retired); Sherry Krest (USFWS);  
Albert Rizzo (USFWS); Karissa Hendershot (DNREC);  
Peter Knight (NOAA); Ron Gouguet (Windward);  
Bruce Bayne (URS)**

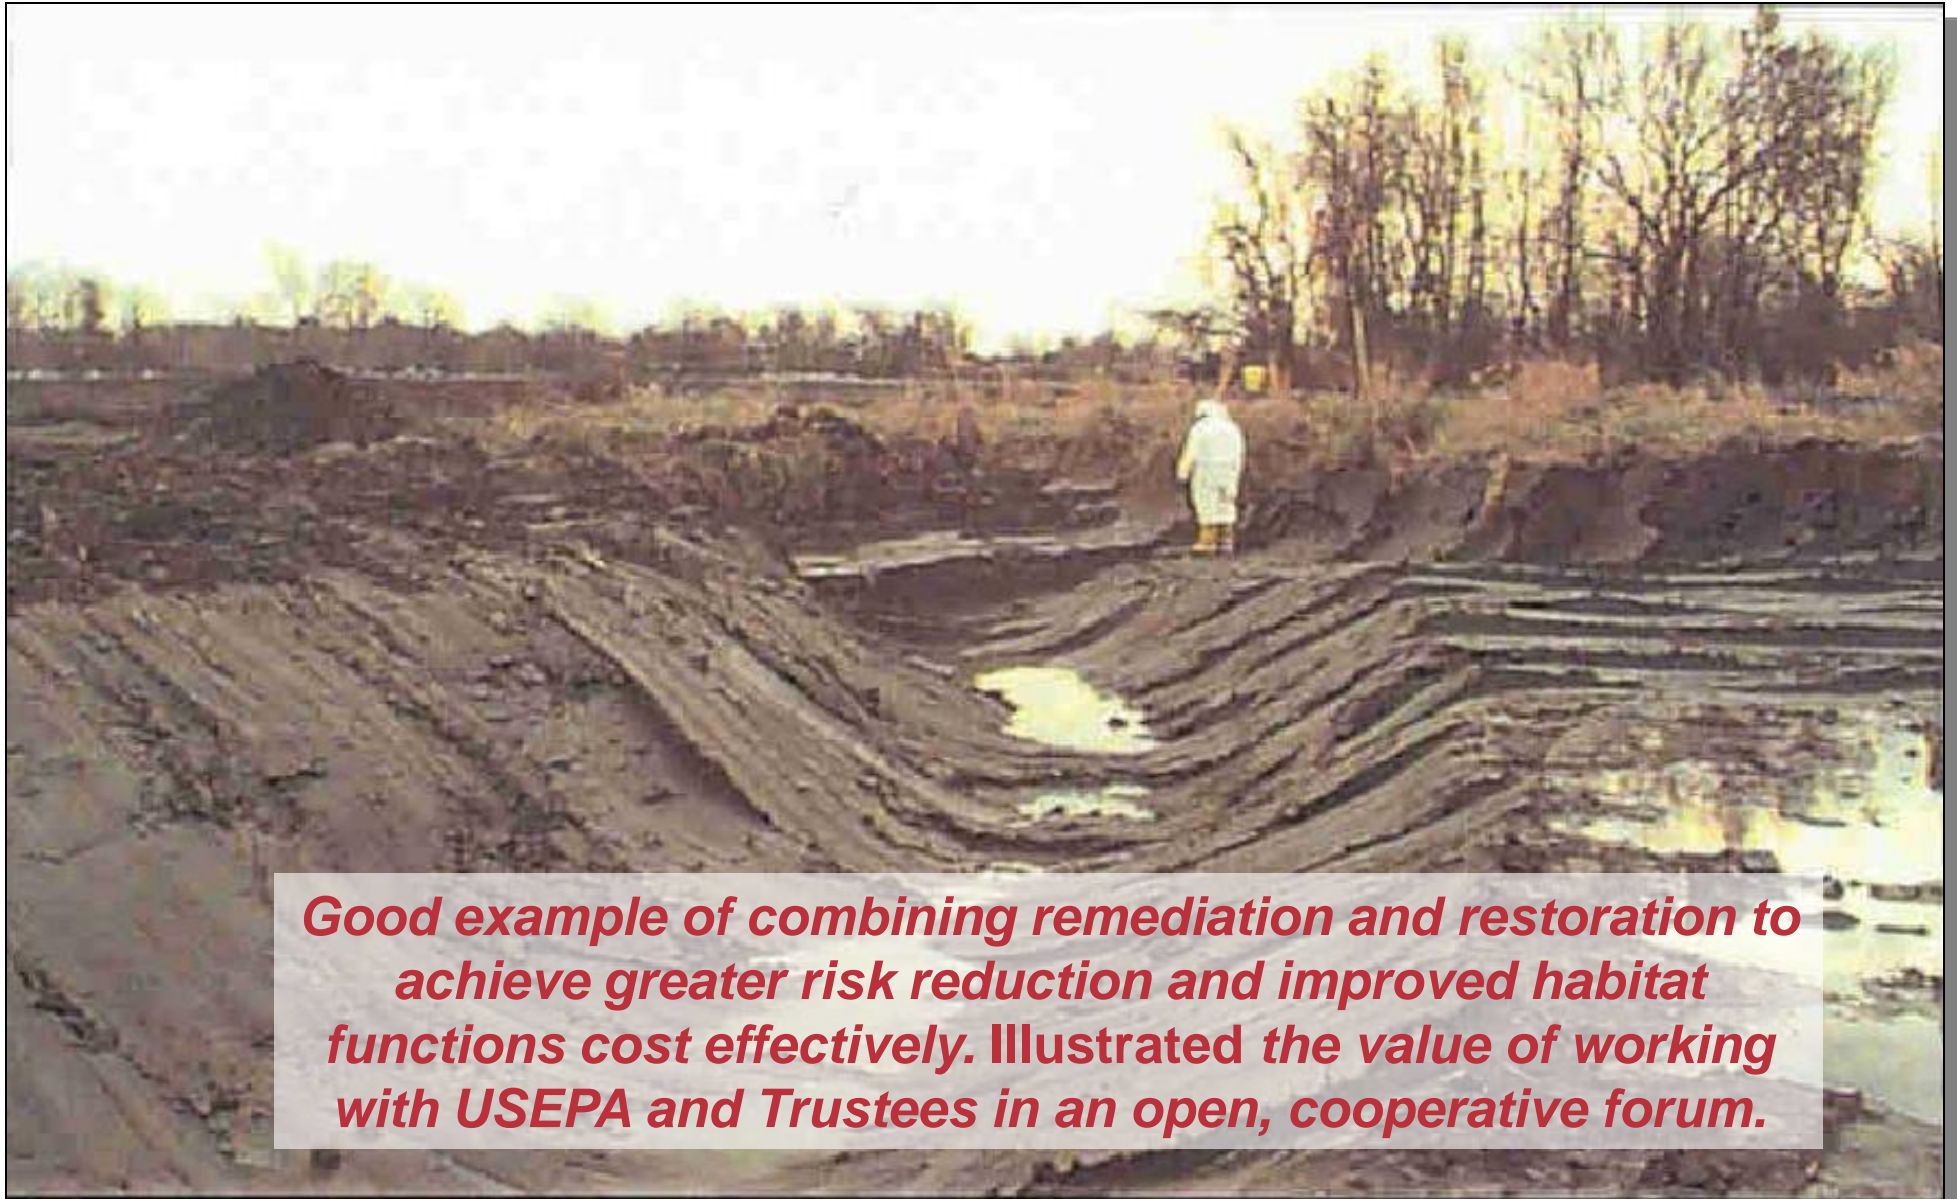
# Integrated Remediation and Restoration - North Wetlands: Construction Phase

*Good example of combining remediation and restoration to achieve greater risk reduction and improved habitat functions cost effectively. Illustrated the value of working with USEPA and Trustees in an open, cooperative forum.*

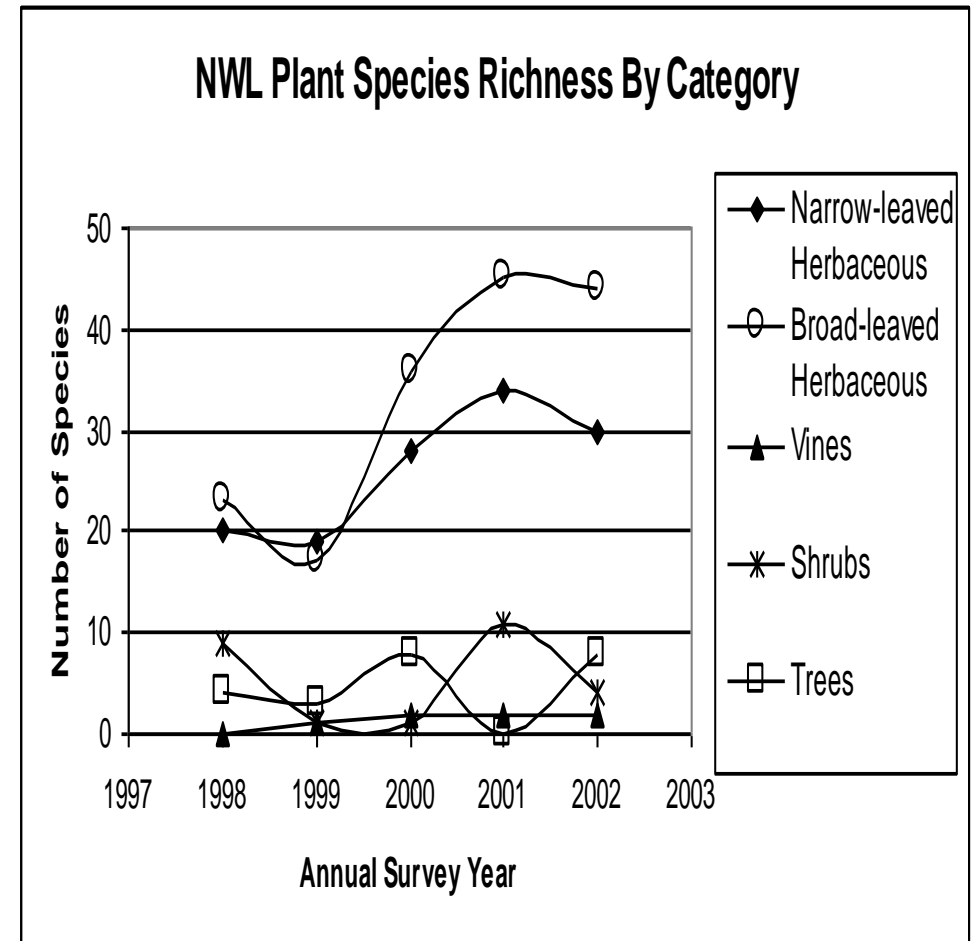
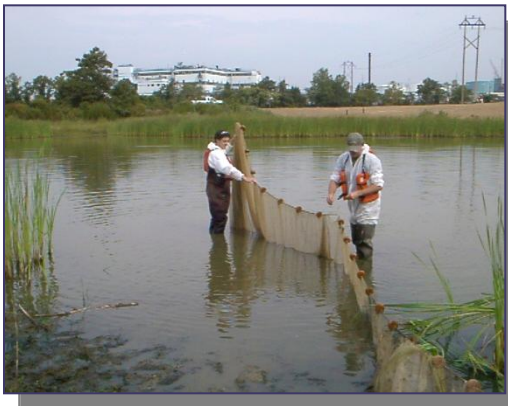
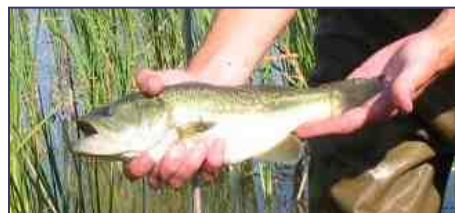
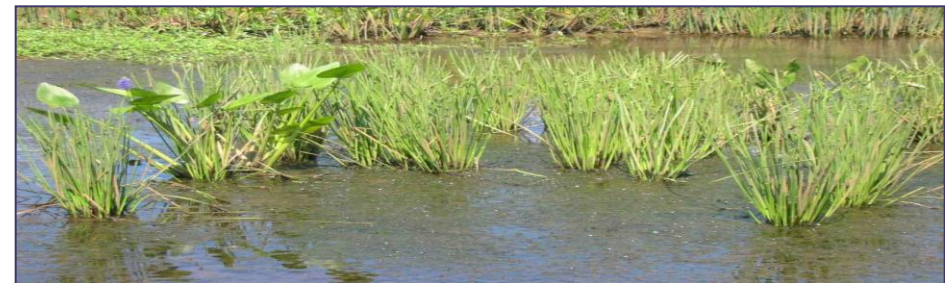
# North Wetlands - Restoration

Tidal and Non-Tidal Wetland Habitats,  
High & Low Marsh, Tidal Open Water  
9-Fold Gain in Plant Species Richness (Yr 5)  
Fine Grained Sediment Accumulation &  
Viable Algal Community (Yr 1)  
83% Cover in Non-Tidal (Yr 5)  
98.5% Cover in Tidal (Yr 5)  
Loosestrife Observed (Yr 1)  
Loss of 0.21 Acres of Wetlands

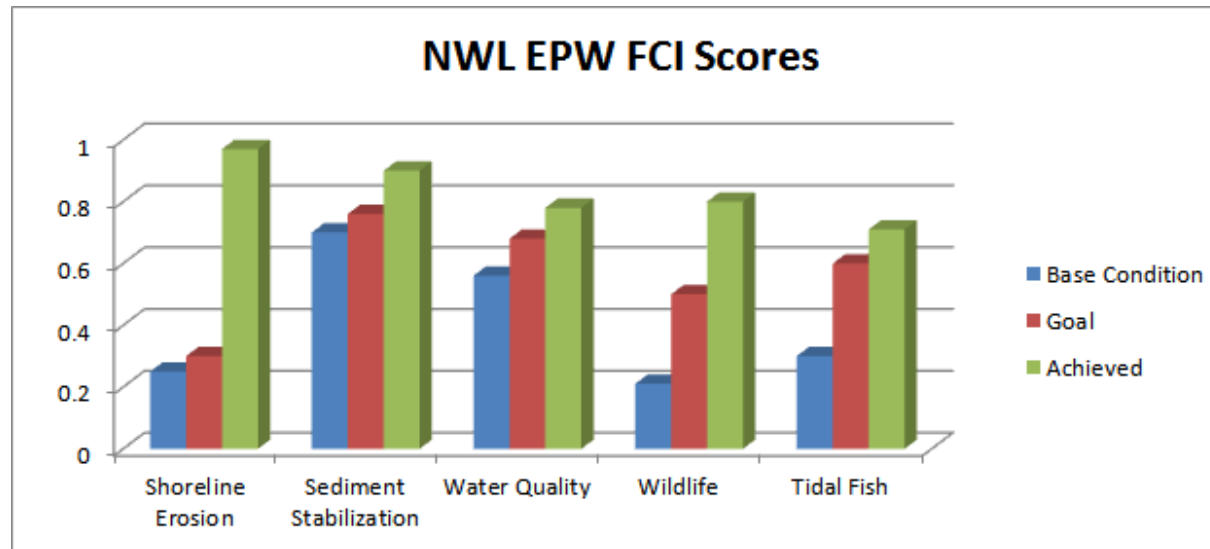
# Pre- and Post-Remediation and Restoration Metrics

North Wetlands	Pre-Remediation (Base Condition)			ROD Required (Goal)			Post-Remediation/Restoration (Achieved 2002)		
	FCI	Area	FCU	FCI	Area	FCU	FCI	Area	FCU
Function									
Shoreline Erosion	0.25	0.34	0.09	0.30	0.34	0.10	0.97	0.77	0.75
Sediment Stabilization	0.70	2.70	1.89	0.76	2.70	2.05	0.90	2.70	2.43
Water Quality	0.56	2.70	1.51	0.68	2.70	1.84	0.78	2.70	2.11
Wildlife	0.21	2.70	0.57	0.50	2.70	1.35	0.80	2.70	2.16
Tidal Fish	0.30	2.00	0.60	0.60	2.00	1.20	0.71	2.00	1.42
Total			4.65			6.54			8.86
<b>Functional Ratio (FCU/Max. Potential FCU)</b>			<b>0.446</b>			<b>0.626</b>			<b>0.815</b>
