Envisioning a New River Future with Greater Societal and Wildlife Benefits

Large-scale Levee Setbacks Along the Missouri River

Brad Thompson, Randy Behm, and Dave Crane USACE
NCER
Chicago, IL
August 1, 2013

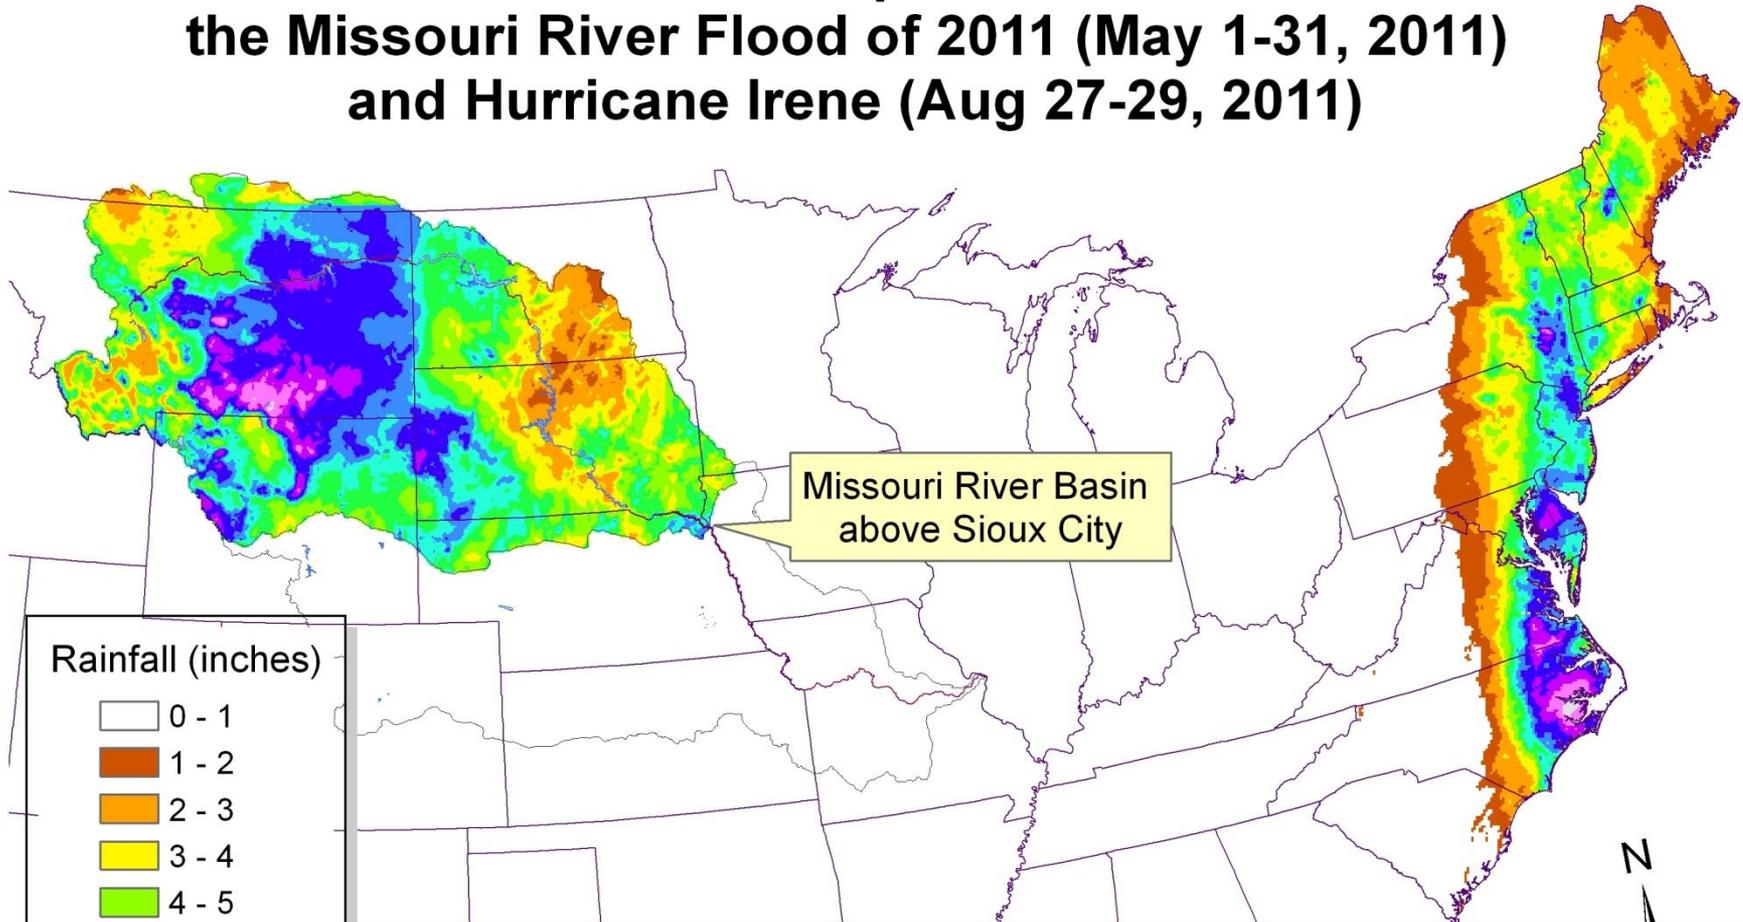
Rainfall Comparison for the Missouri River Flood of 2011 (May 1-31, 2011) and Hurricane Irene (Aug 27-29, 2011)

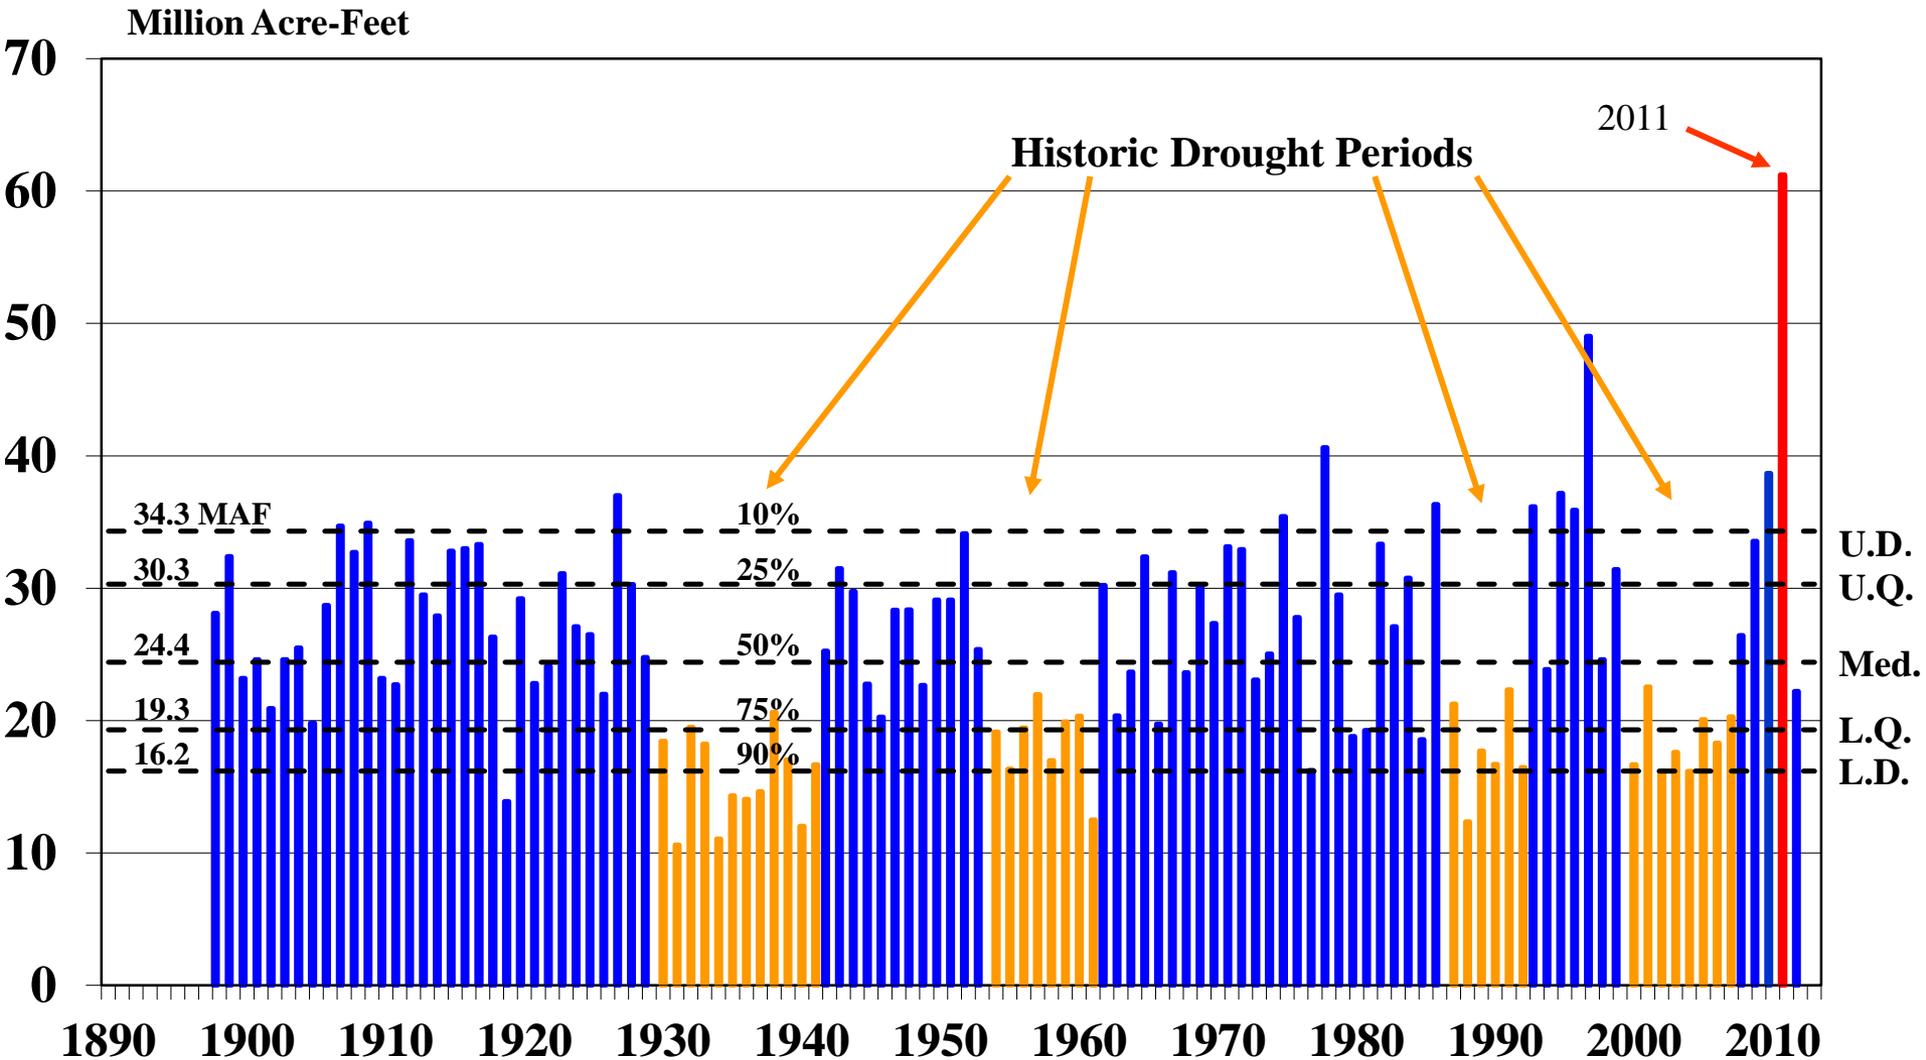
2011 Runoff = **61.0** MAF, 247 % above normal
Highest runoff in 115 years of record keeping
-combined 2011 May-July runoff of 34.3 MAF was
higher than 102 of 115 years of record keeping
Previous Record was 49.0 MAF in 1997

Missouri River Mainstem System Annual Runoff above Sioux City, IA

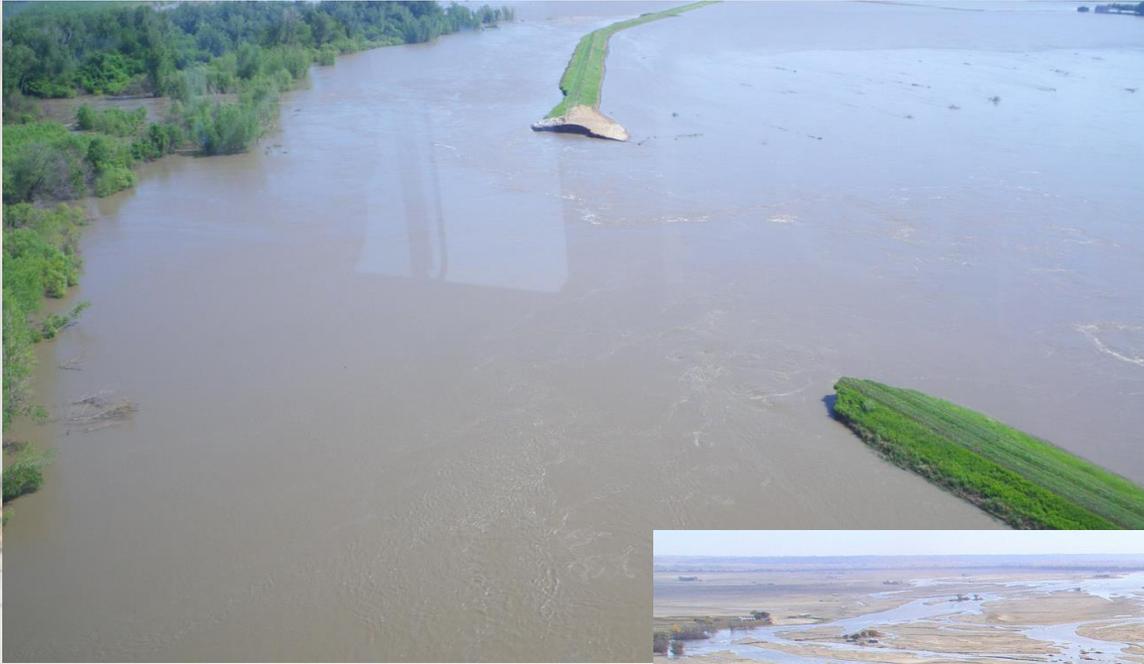
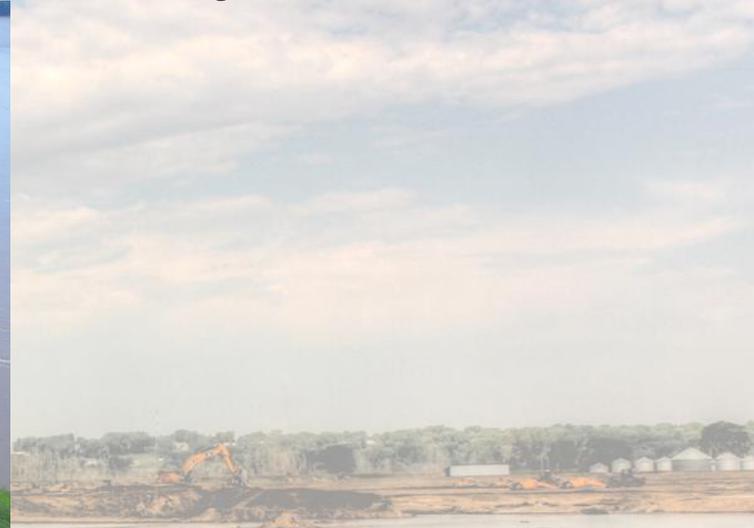
5 Levee Breaches on 2 Systems

L575 middle breach, during initial breaching and as water receded.

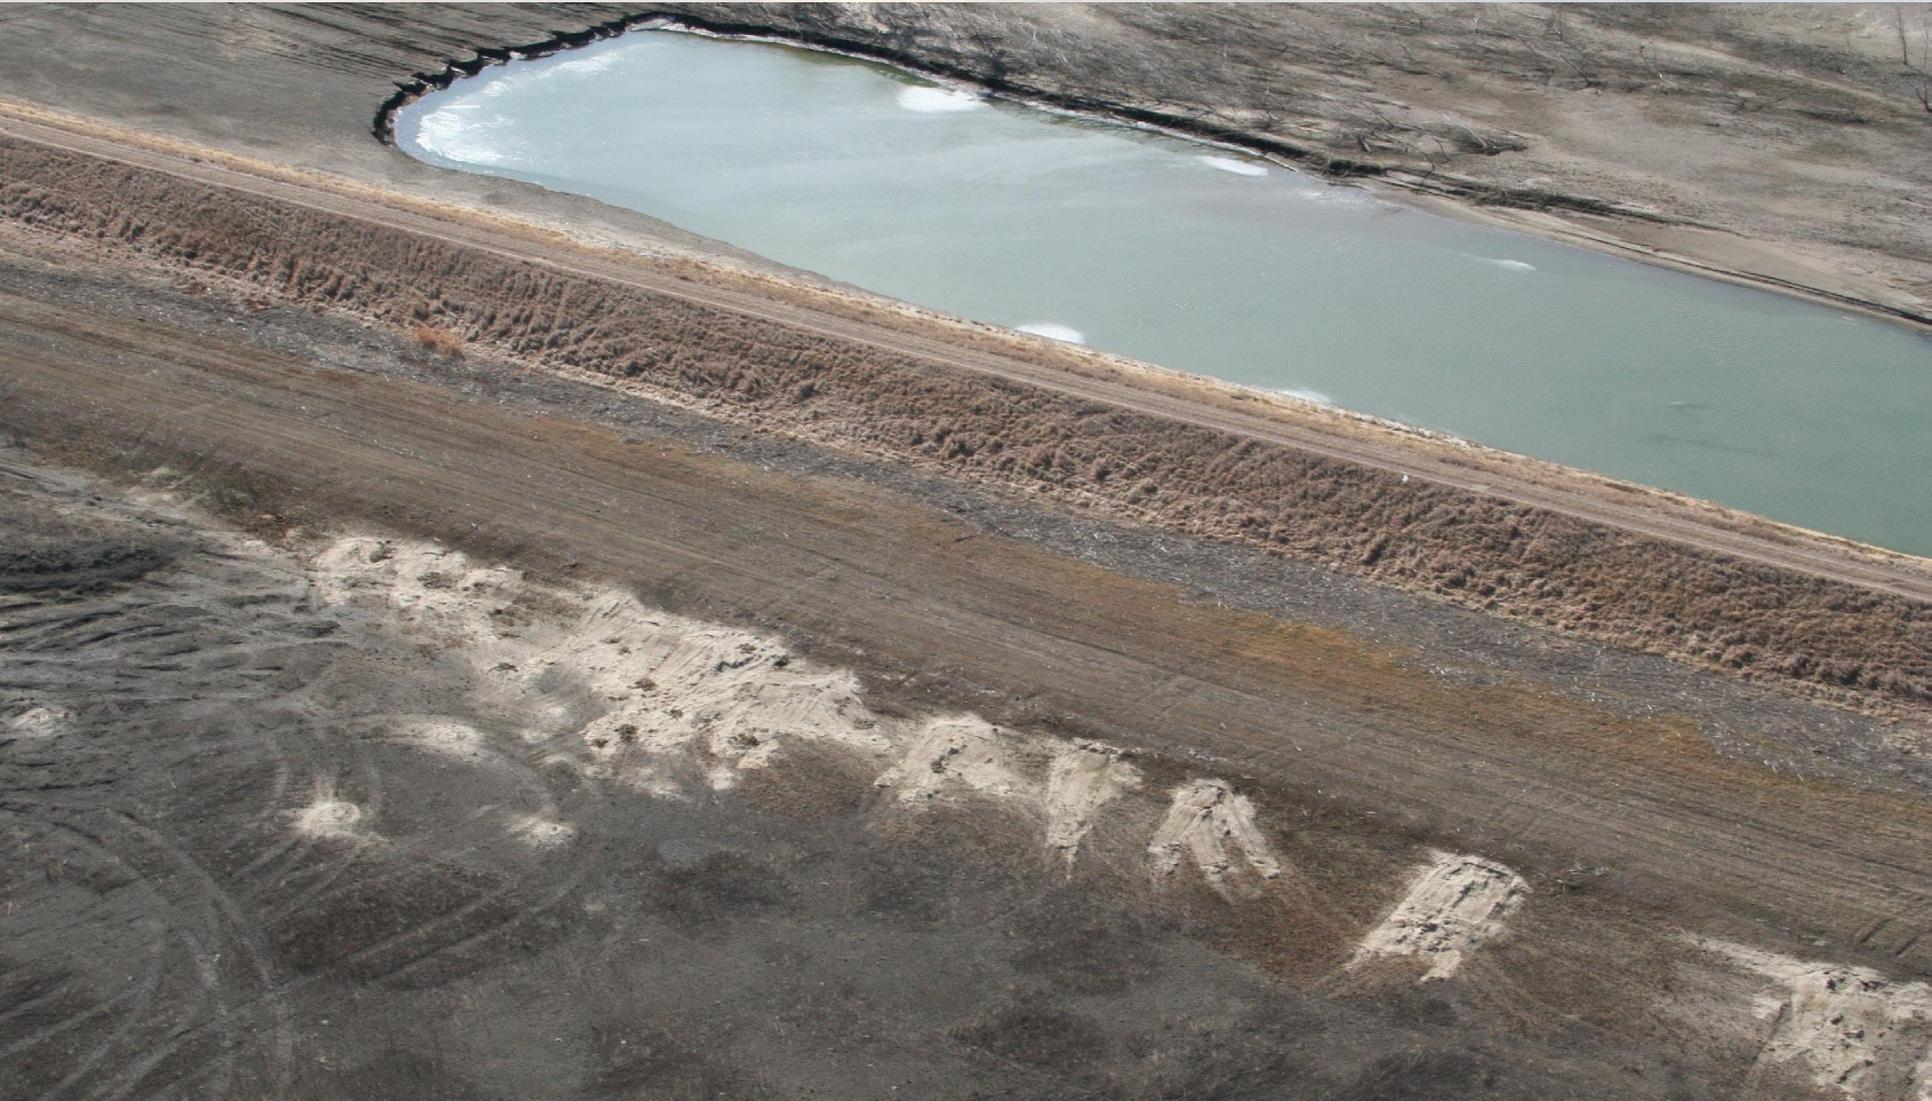
Levee Scour and Seepage Along L-575

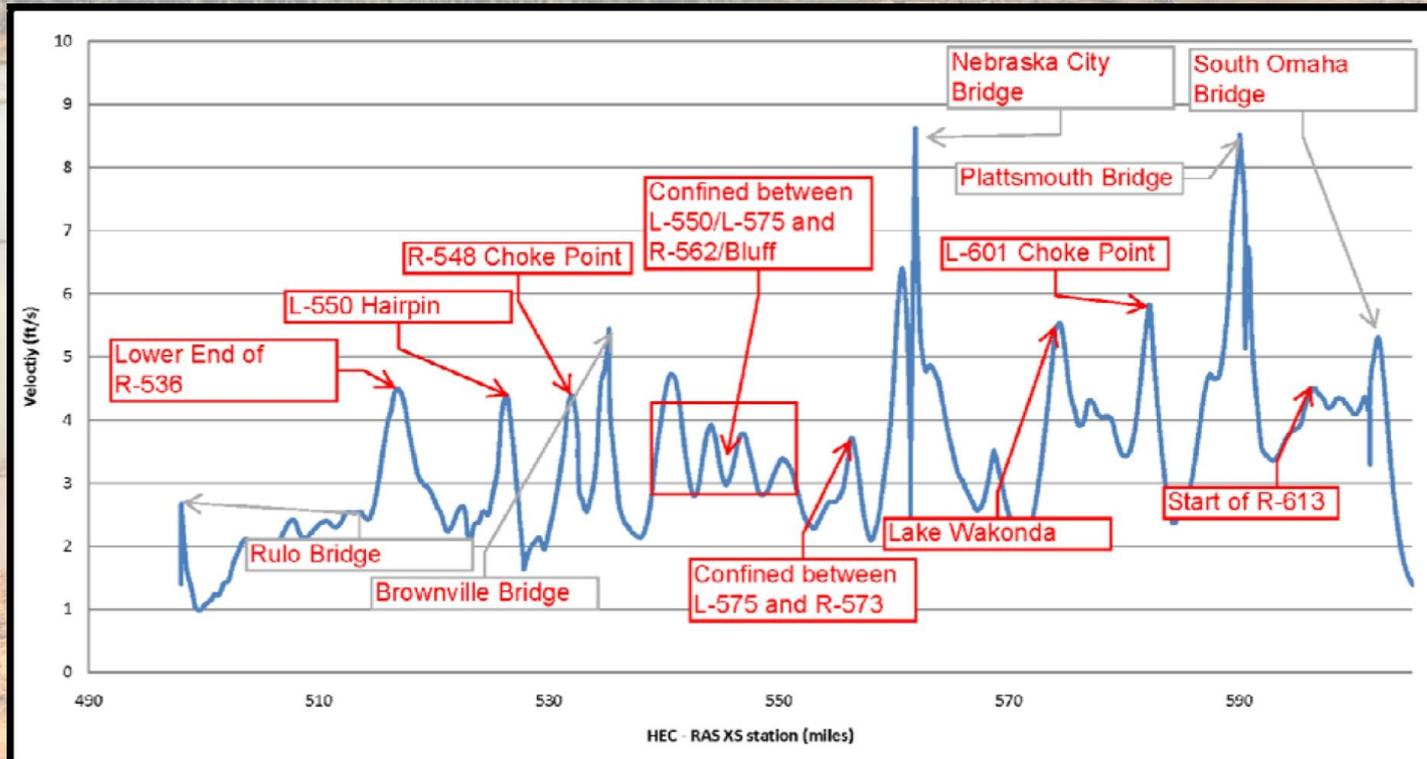
Conceptual Levee Setback Report

- Question do we do something different – Report April 2012
- Considered results of prior studies (e.g., 1993 Galloway Report)
- Potential to use or target federal lands to be part of solution
- Identification of 16 major constriction points:

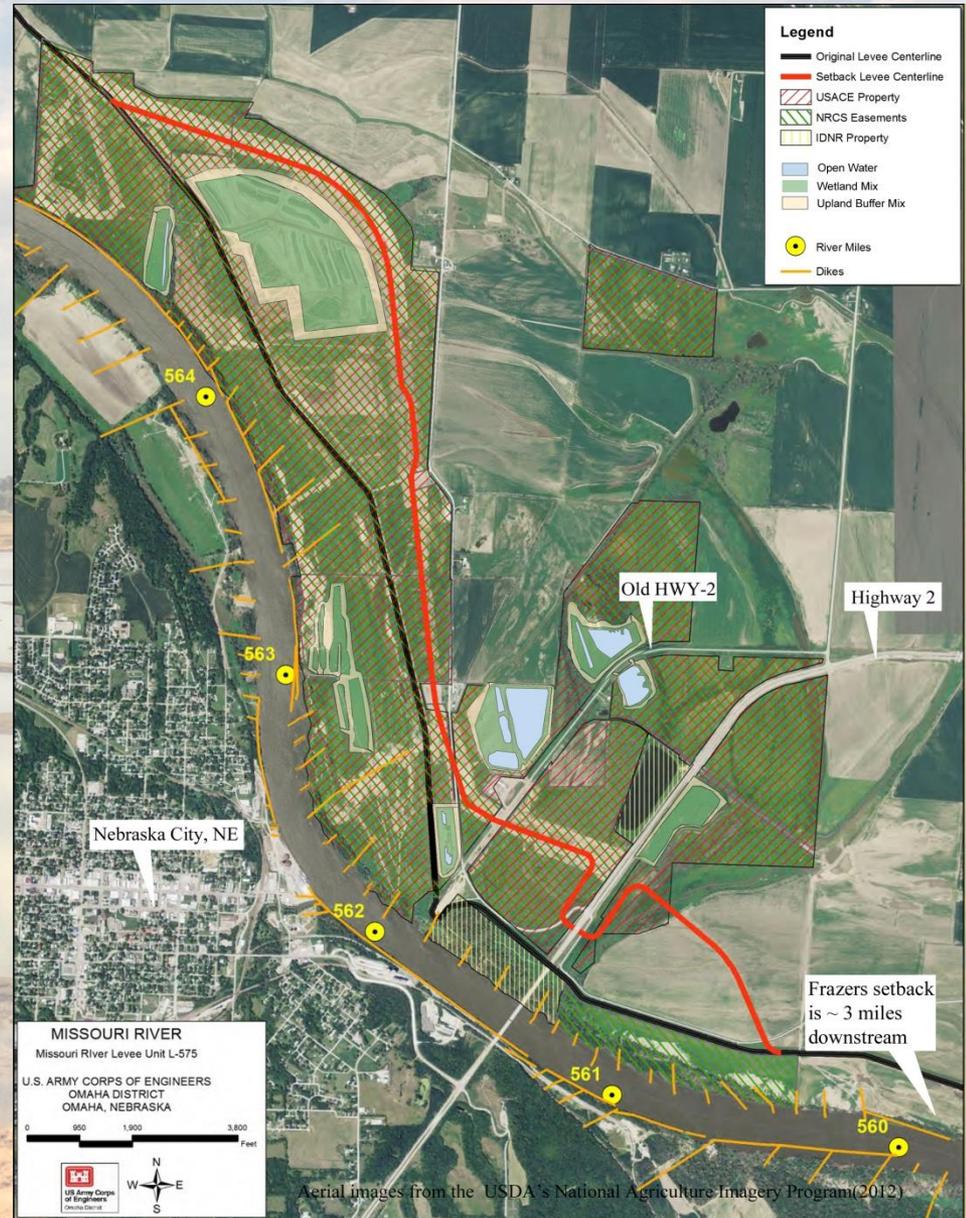
Highway 2 Setback

- Approx 760 acres of floodplain reconnected (MRRP Lands)
- Up to 1.5 feet flood stage reduction of 100-year event
- Up to 5.5 feet/second reduction of 100-year flood water velocity
- Levee was setback up to .5 miles
- Approx 200 acres of borrow pits treated for wetland establishment
- Eliminated the most constricted point on Missouri River mainstem

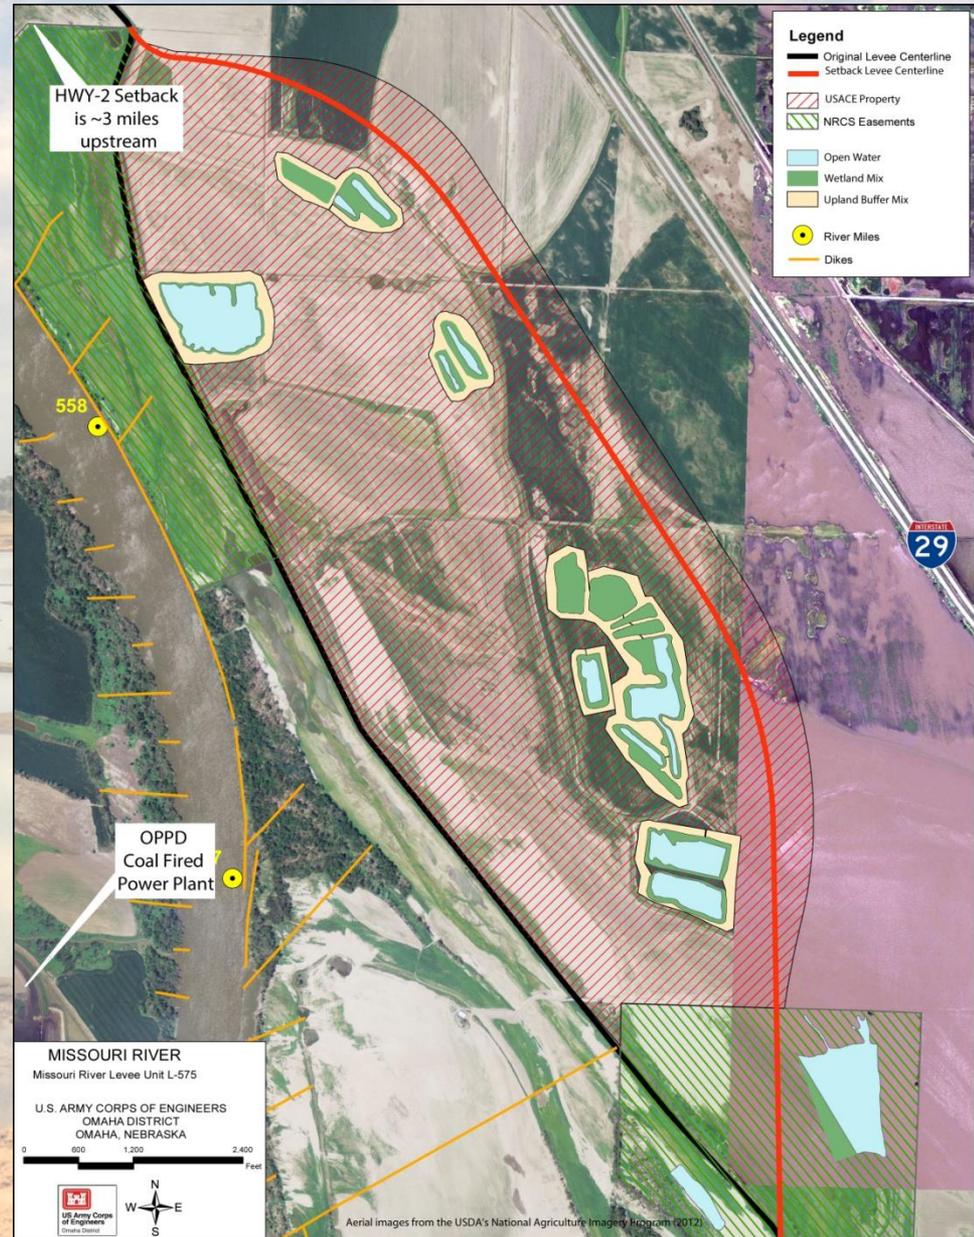
Frazers Bend Setback

- Approx. 970 acres of floodplain reconnected
- Up to 1.4 feet flood stage reduction of 100-year event
- Up to 1.4 feet/ second reduction of 100-year flood water velocity
-
- Levee was setback up to .7 miles
- Approx 120 acres of borrow pits treated for wetland establishment
- Will help OPPD Power Plant experience less powerful erosive flows during times of high water

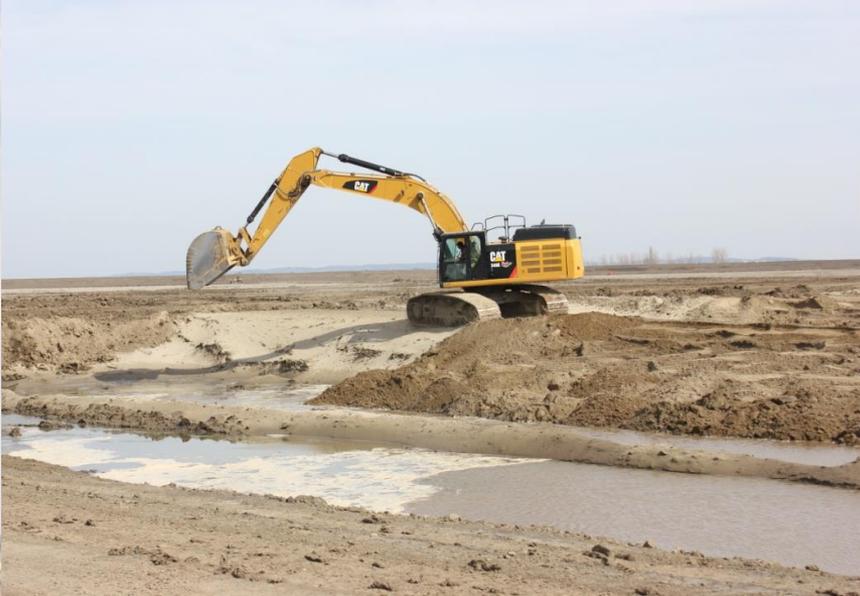
Adding depth diversity and irregular shorelines

Borrow Pits Treated for Wetland Establishment

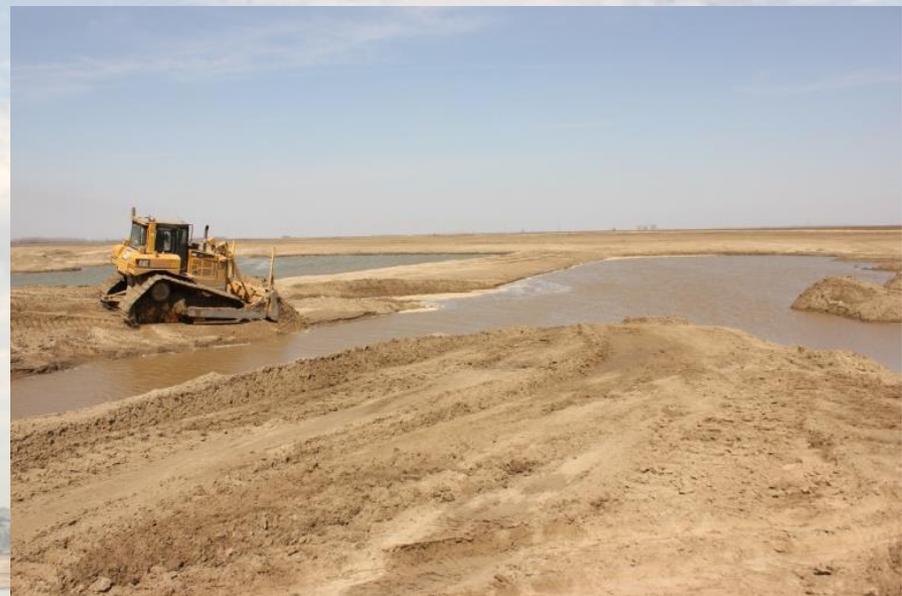
Shaping gentle side slopes

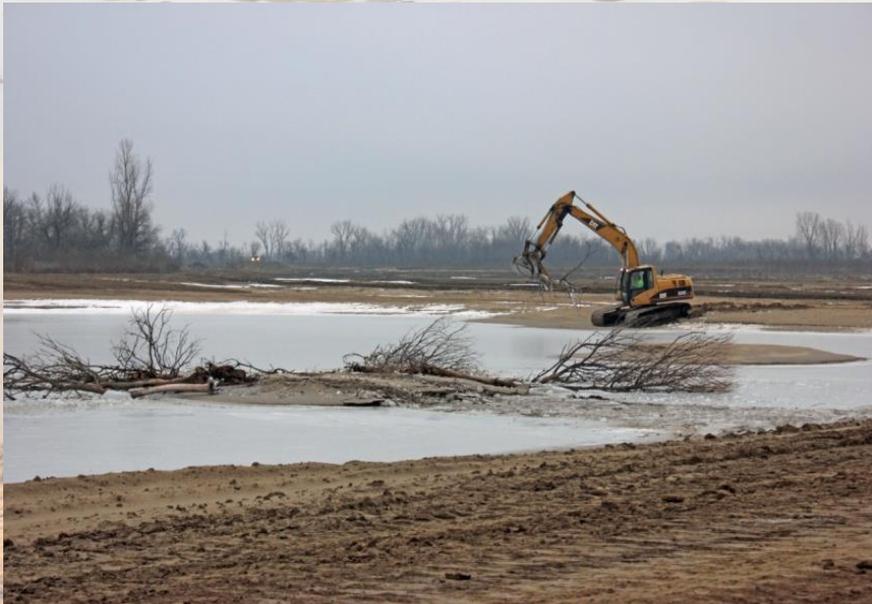
Adding wood debris habitat features

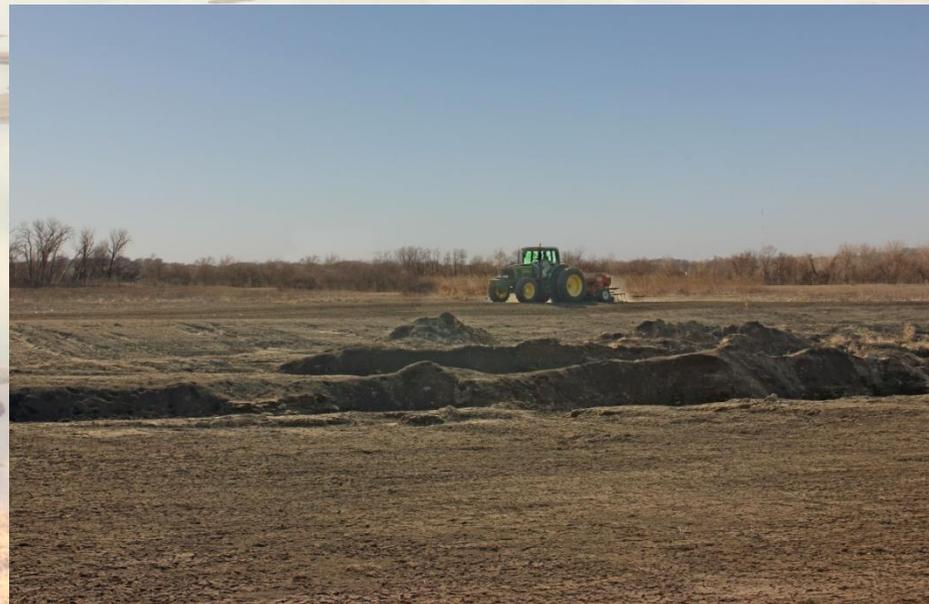
Planting hydrophytic vegetation
