GRASSY FLATS RESTORATION PROJECT

CREATIVELY CAPPING MUCK TO RESTORE THE LAKE WORTH LAGOON

Eric Anderson and Julie Mitchell, Palm Beach County Department of Environmental Resources Management
Erin McDevitt, Florida Fish and Wildlife Conservation Commission

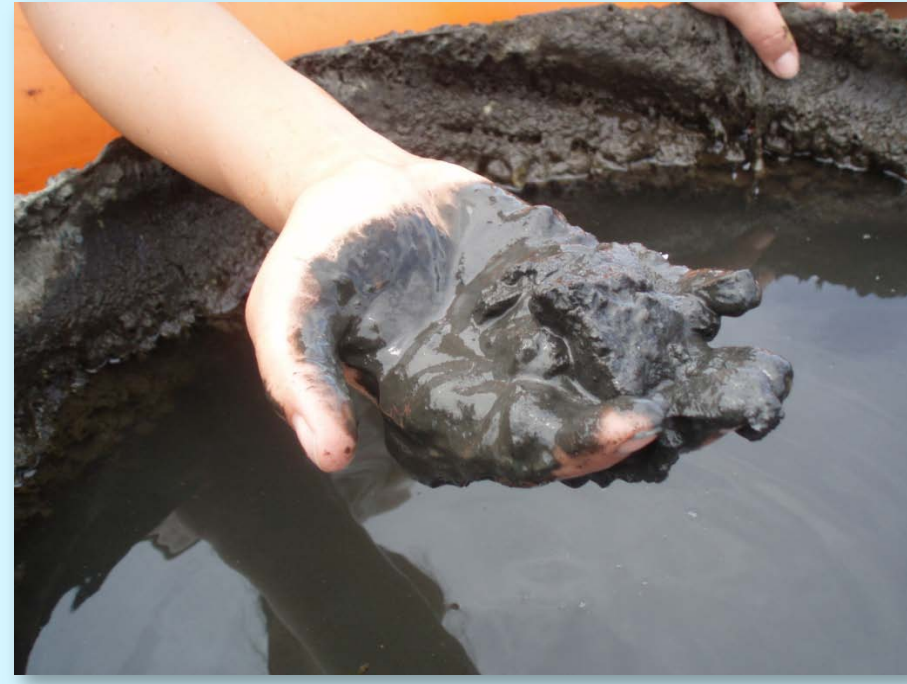
Figure 2: Muck sediment

- Over the past century, development in and around Palm Beach County's largest estuary, Lake Worth Lagoon (Figure 1), has resulted in water quality degradation and an extensive loss of coastal habitats.
- The Grassy Flats Project site, located in the town of Palm Beach, was selected for restoration due to its close proximity to the C-51 Canal, which discharges high volumes of sediment-loaded freshwater into the lagoon (Figure 2).

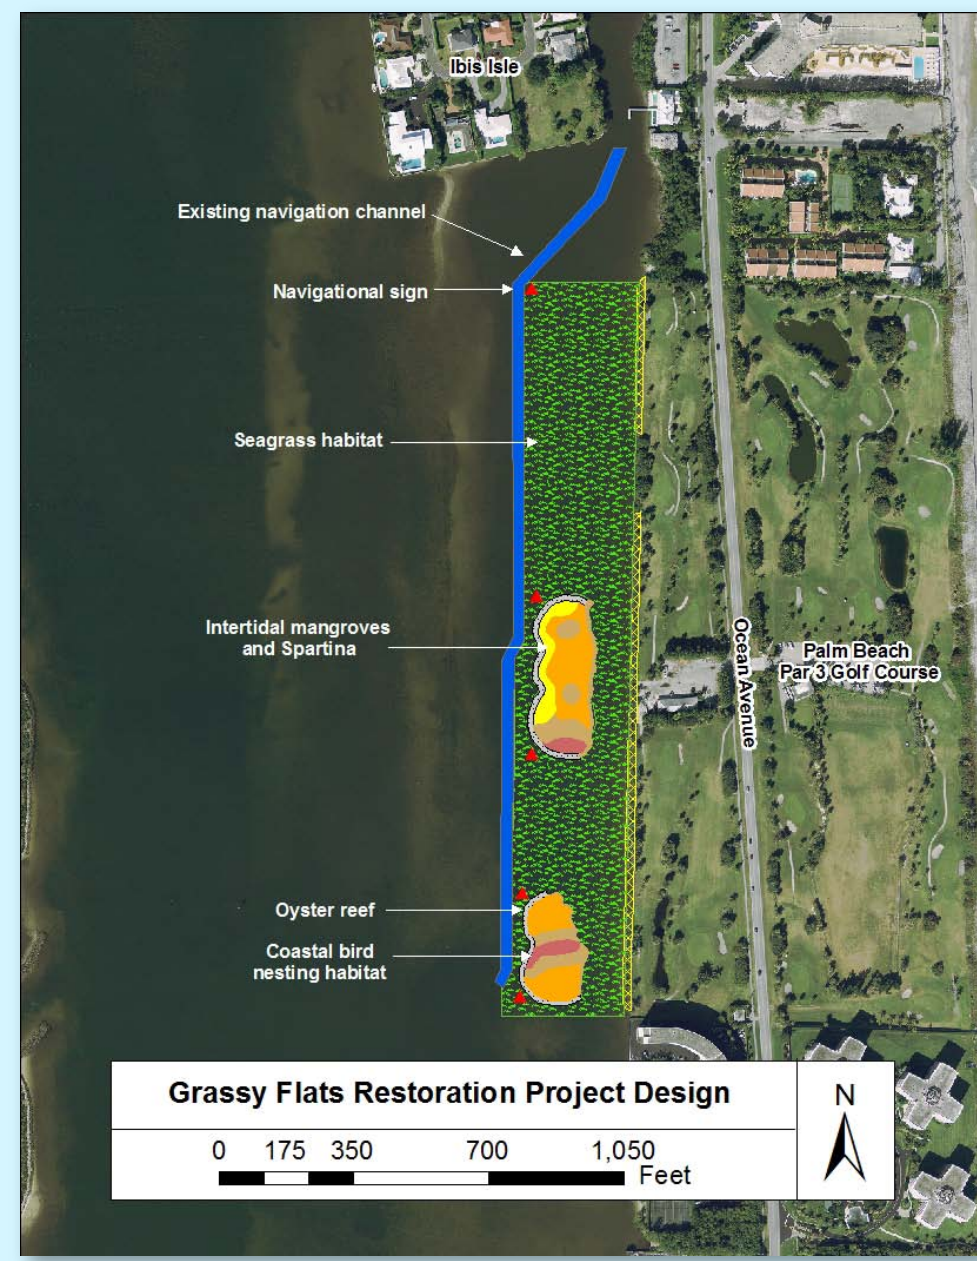
Figure 4: Grassy Flats project design plan view.

- The benthic community was dominated by approximately 30,000 cubic yards of muck sediments (Figure 3), characterized as low biodiversity, and occupied primarily by opportunistic feeding and deposit feeding mollusks.
- The site's shallow water conditions required creative and innovative methods to cap nearly 13 acres of muck sediments with sand and create valuable coastal habitats (Figure 4).

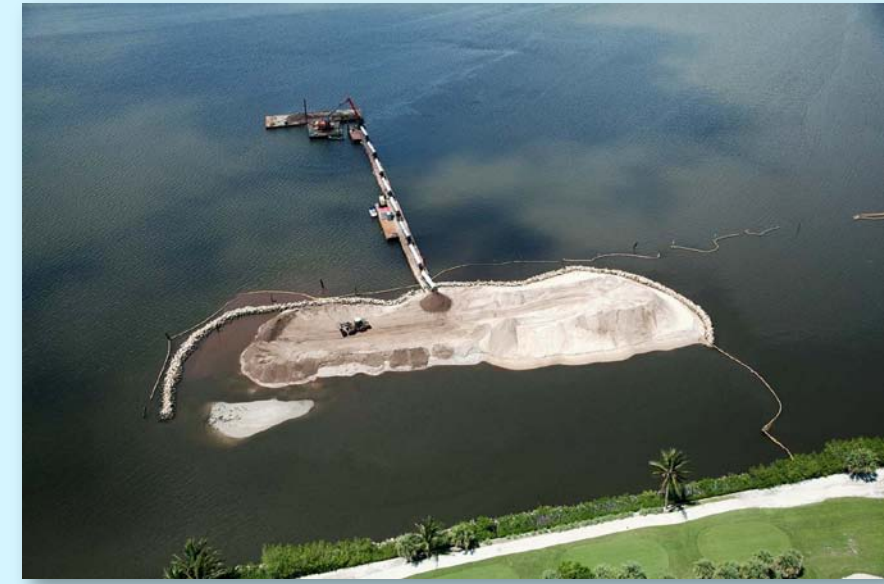
Figure 5: Unloading sand from barges using conveyor belts. Photo Credit: Eastman Aggregate Enterprises, LLC and Smith Aerial Photos.

- 52,000 cubic yards of sand was transported from three different sites: the South Lake Worth Inlet/Intracoastal Waterway maintenance dredging project, Okeehetee Park South, and Hypoluxo Scrub Natural Area.
- Shallow-water barges mounted with construction equipment and up to 800 linear feet of barge-mounted conveyor belts were used to transport sand and stockpile it at the project site (Figures 5 and 6).

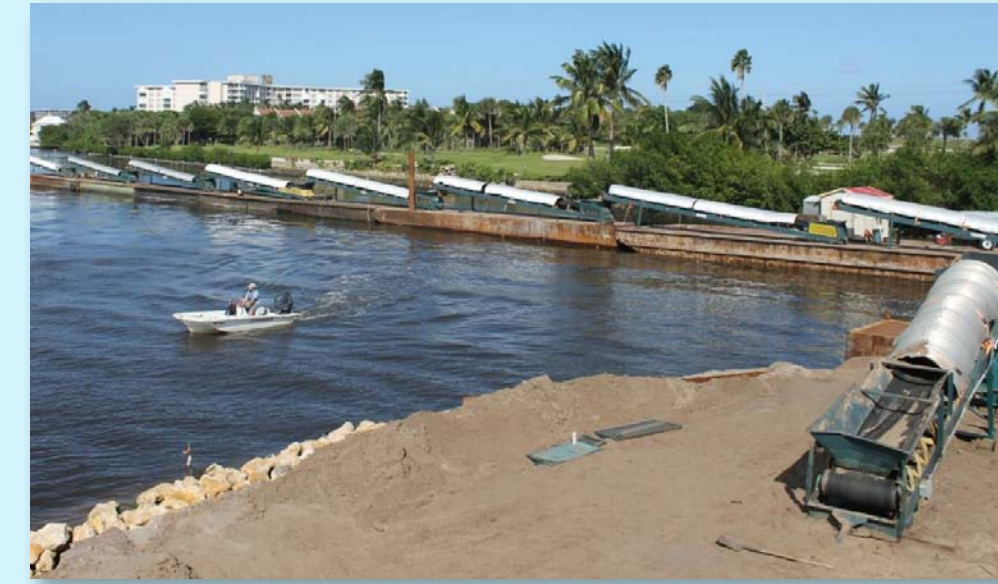
Figure 6: Conveyors transporting sand from island stockpile to sand shooter.

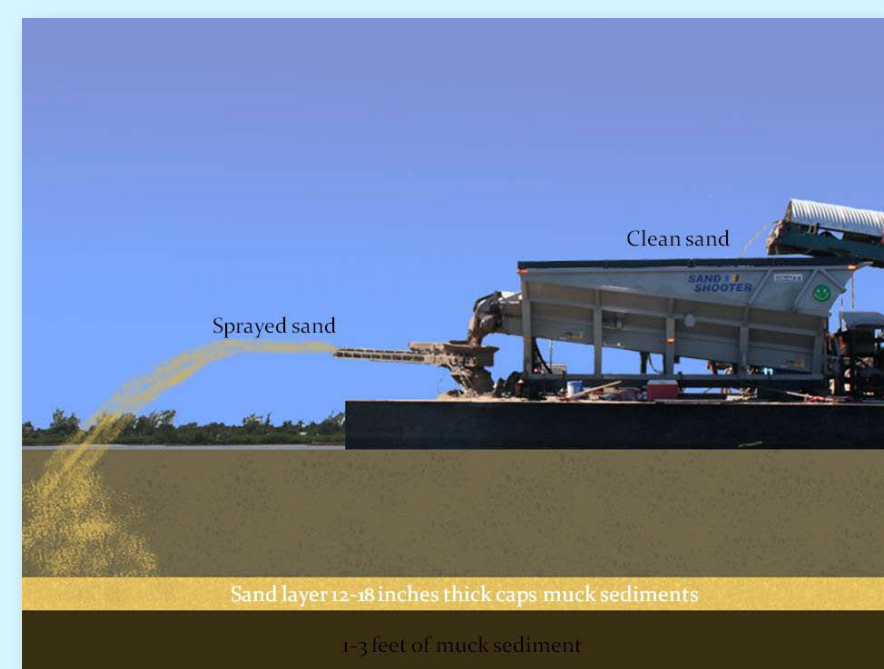
Figure 7: Sand shooter diagram.

- 2,800 tons of limestone rock was placed to protect the intertidal islands from erosion and provide oyster habitat.
- A high-speed conveyor belt ("Sand Shooter") distributed 22,500 cubic yards of sand evenly throughout the project area, "capping" the underlying muck (Figure 7 and 8).

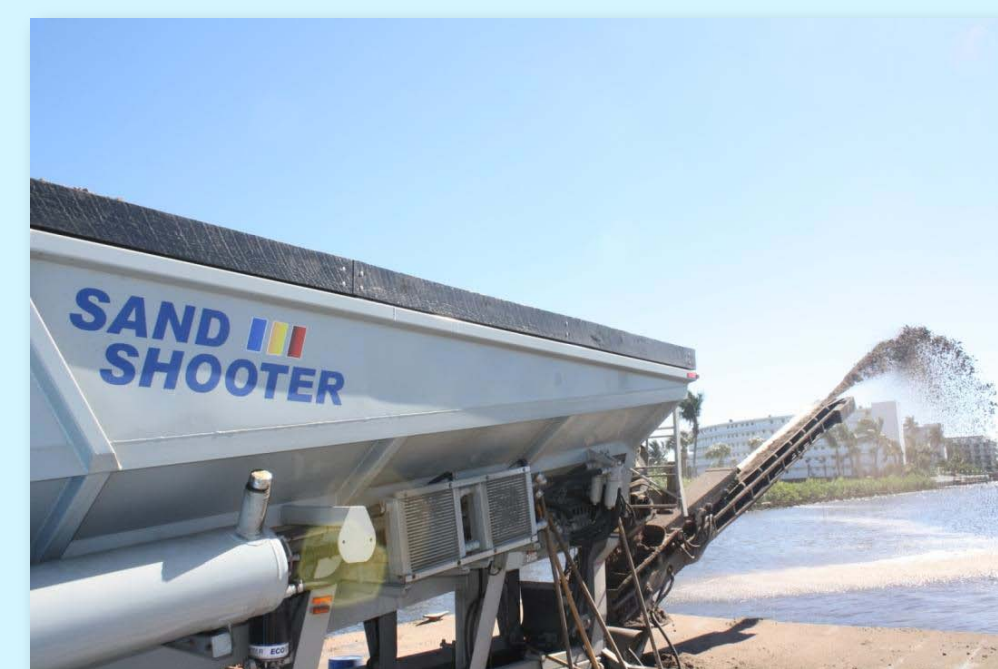
Figure 8: Sand shooter.

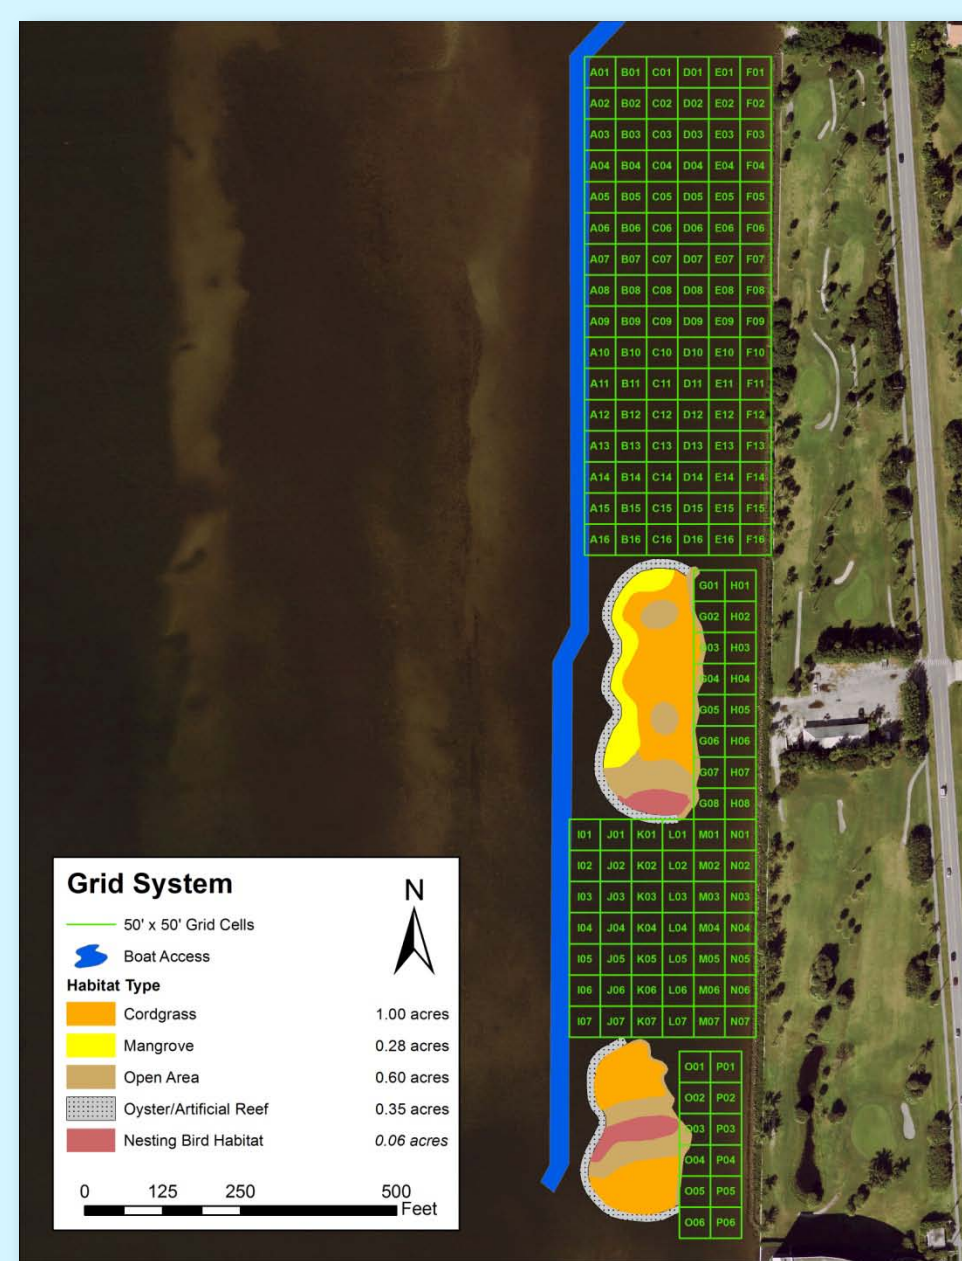
Figure 9: Grid system created in ArcMap 10.1 to evenly distribute sand.

- A grid system was used to ensure an even distribution of sand. Each grid cell received an amount of sand that ensured a uniform depth at project completion. The thickness of the sand cap within each cell was checked by both probing and weekly bathymetric surveys (Figure 9 and 10).
- 29,500 cubic yards of sand was graded to form the intertidal islands, leaving two areas of high ground for nesting shorebirds.

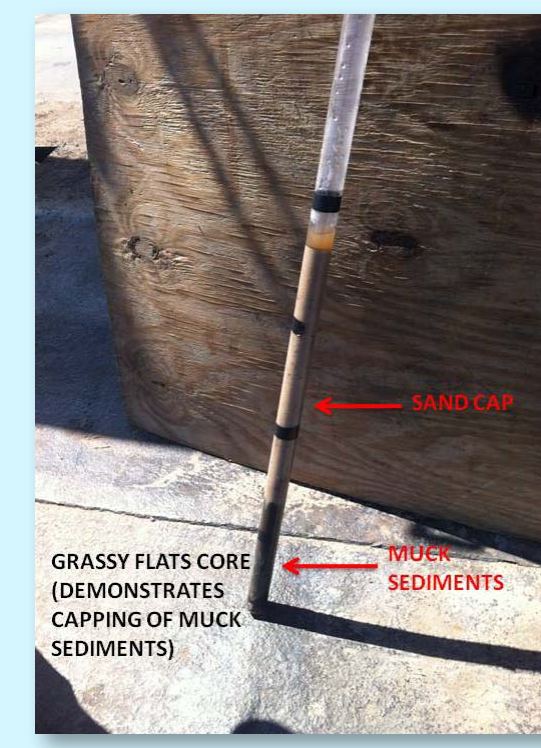
Figure 11: Core sample.

- Thirteen acres of critical wetland habitat were successfully restored through the capping of muck sediments with 12 to 18 inches of sand (Figure 11).
- Re-suspension of muck was reduced as a result of the sand cap, which also provides clean substrate and allows for the natural recruitment of seagrass.

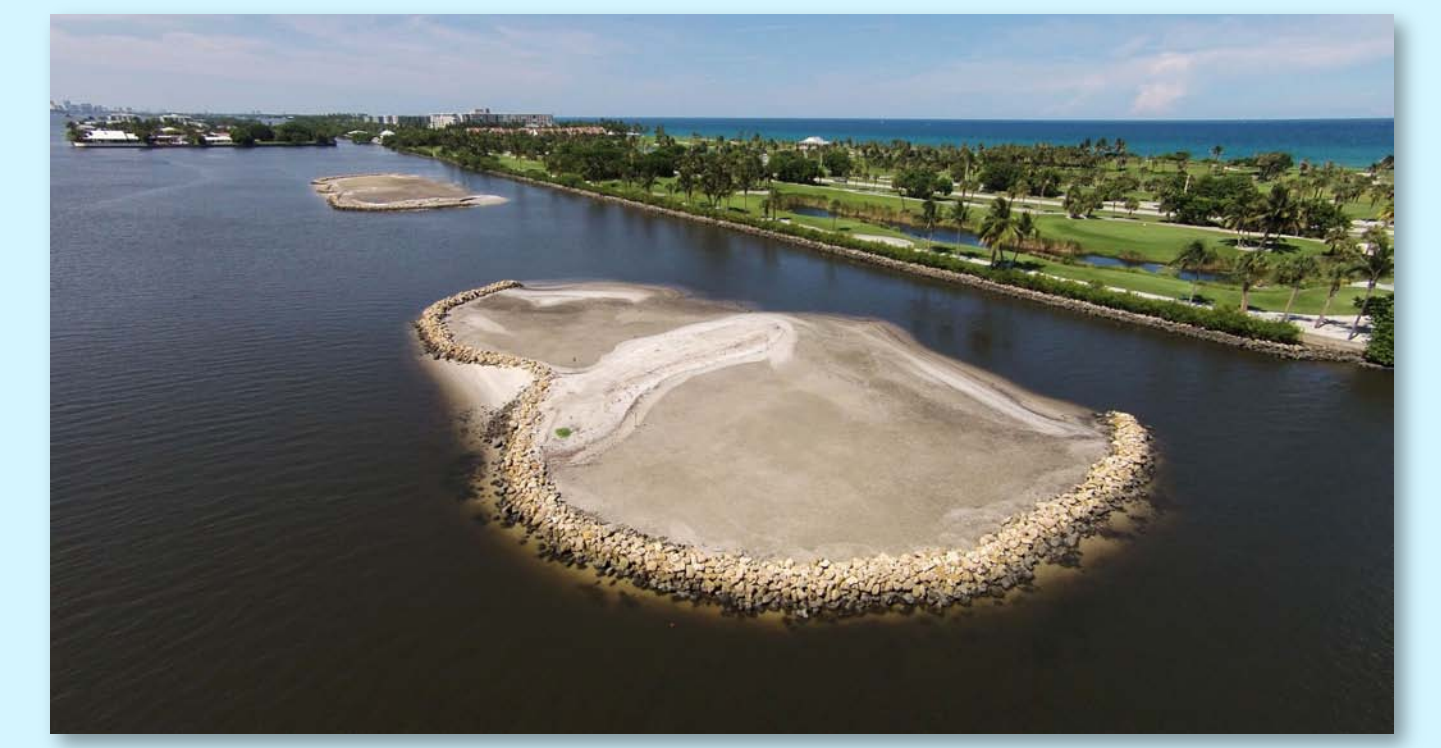
Figure 12: Grassy Flats post construction.

- Two intertidal islands were created (Figure 12) and planted with saltmarsh cordgrass (Figure 13) and red mangroves (Figure 14). Portions of the islands were left as open tidal flats and sandy shorelines for coastal birds to forage and nest.
- A pair of American oystercatchers and several pairs of least terns, both state-listed imperiled species, nested on the newly-created islands immediately after project completion (Figures 15 -17).

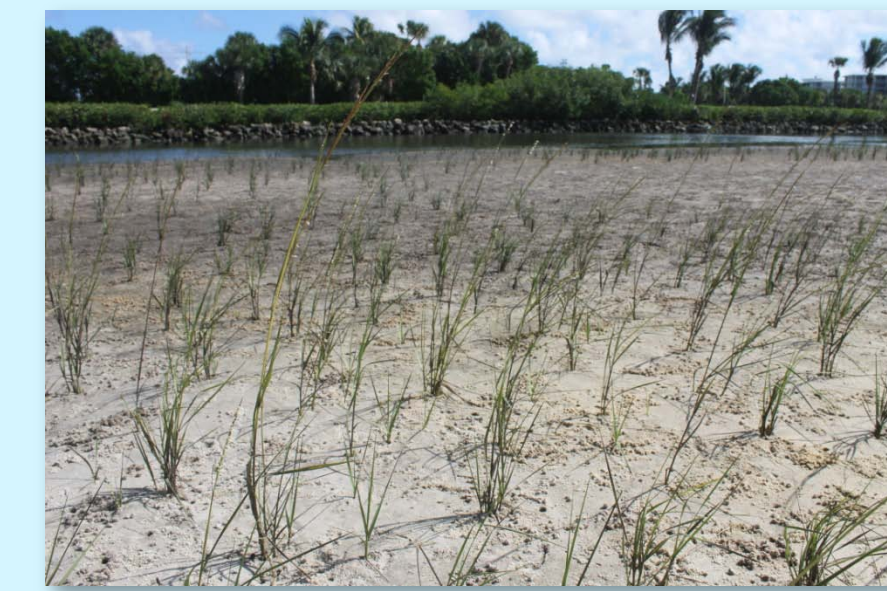
Figure 13: Saltmarsh cordgrass (*Spartina alterniflora*) after planting.

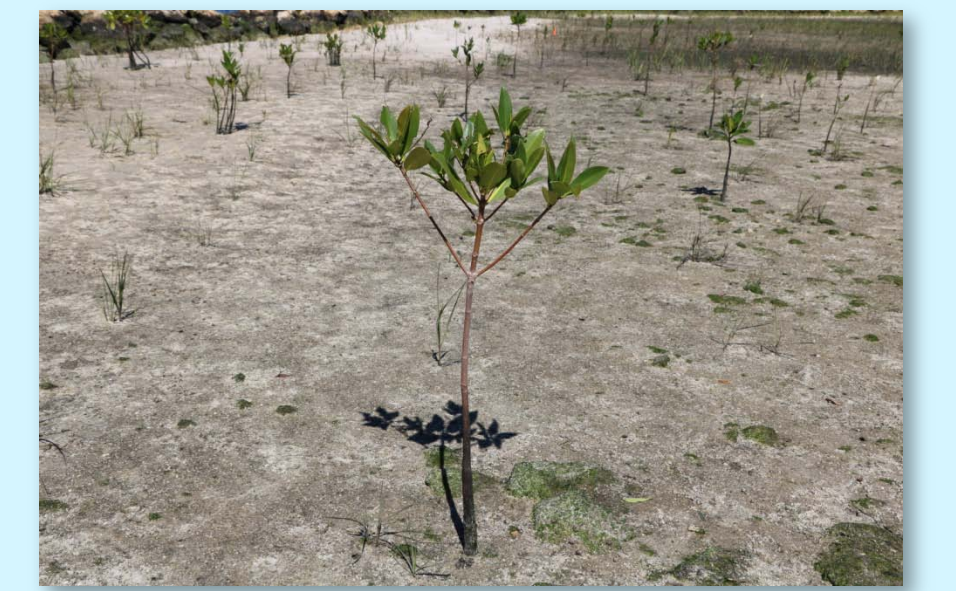
Figure 14: Red mangrove (*Rhizophora mangle*) after planting.
