Not Your Father's Tax Ditch

*Enhancing Delaware's Drainage Network Through the
Use of Natural Channel Design Techniques*

**Division of Watershed Stewardship
Drainage Program**

Presented at the National Conference on Ecological Restoration
April 21, 2016
Presented by: Brooks Cahall, Drainage Program Manager
Co-Authors: Matthew Grabowski, Sara Esposito P.E.

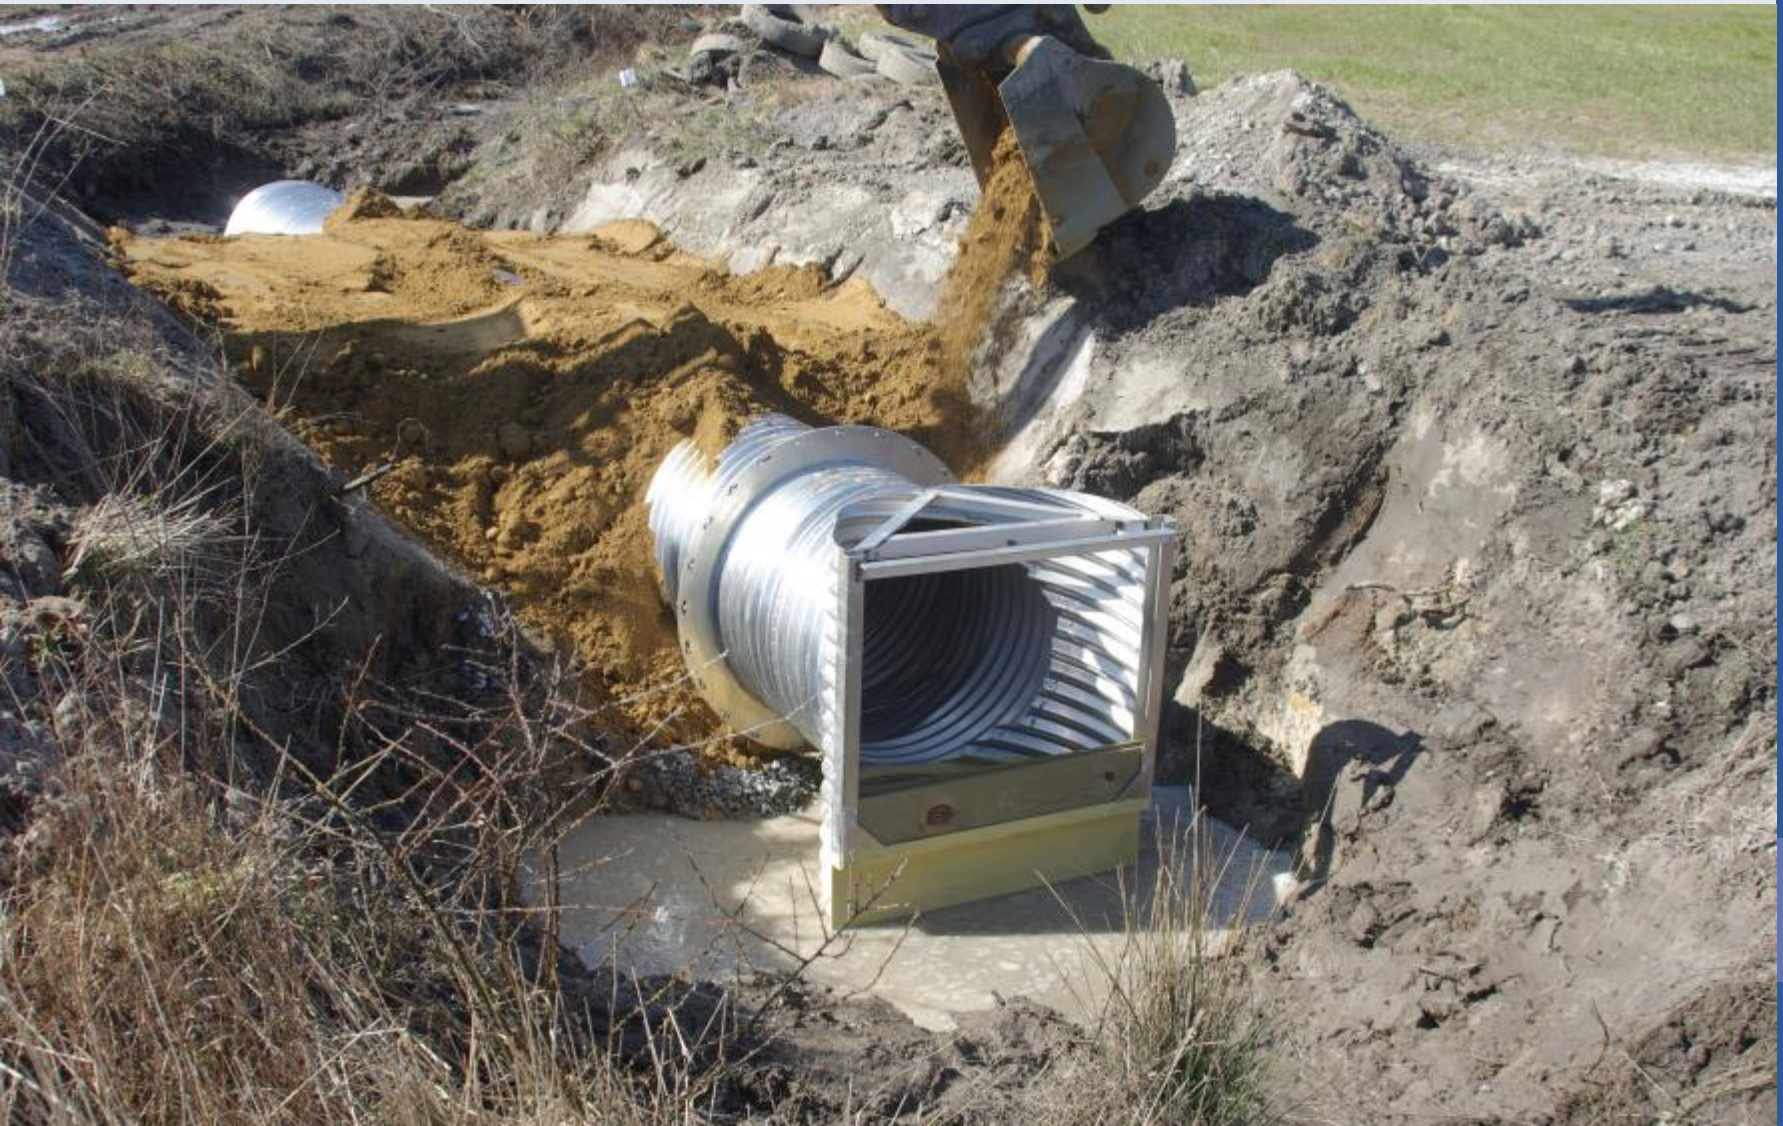
Hrupsa WCS Project

Installation of Structure

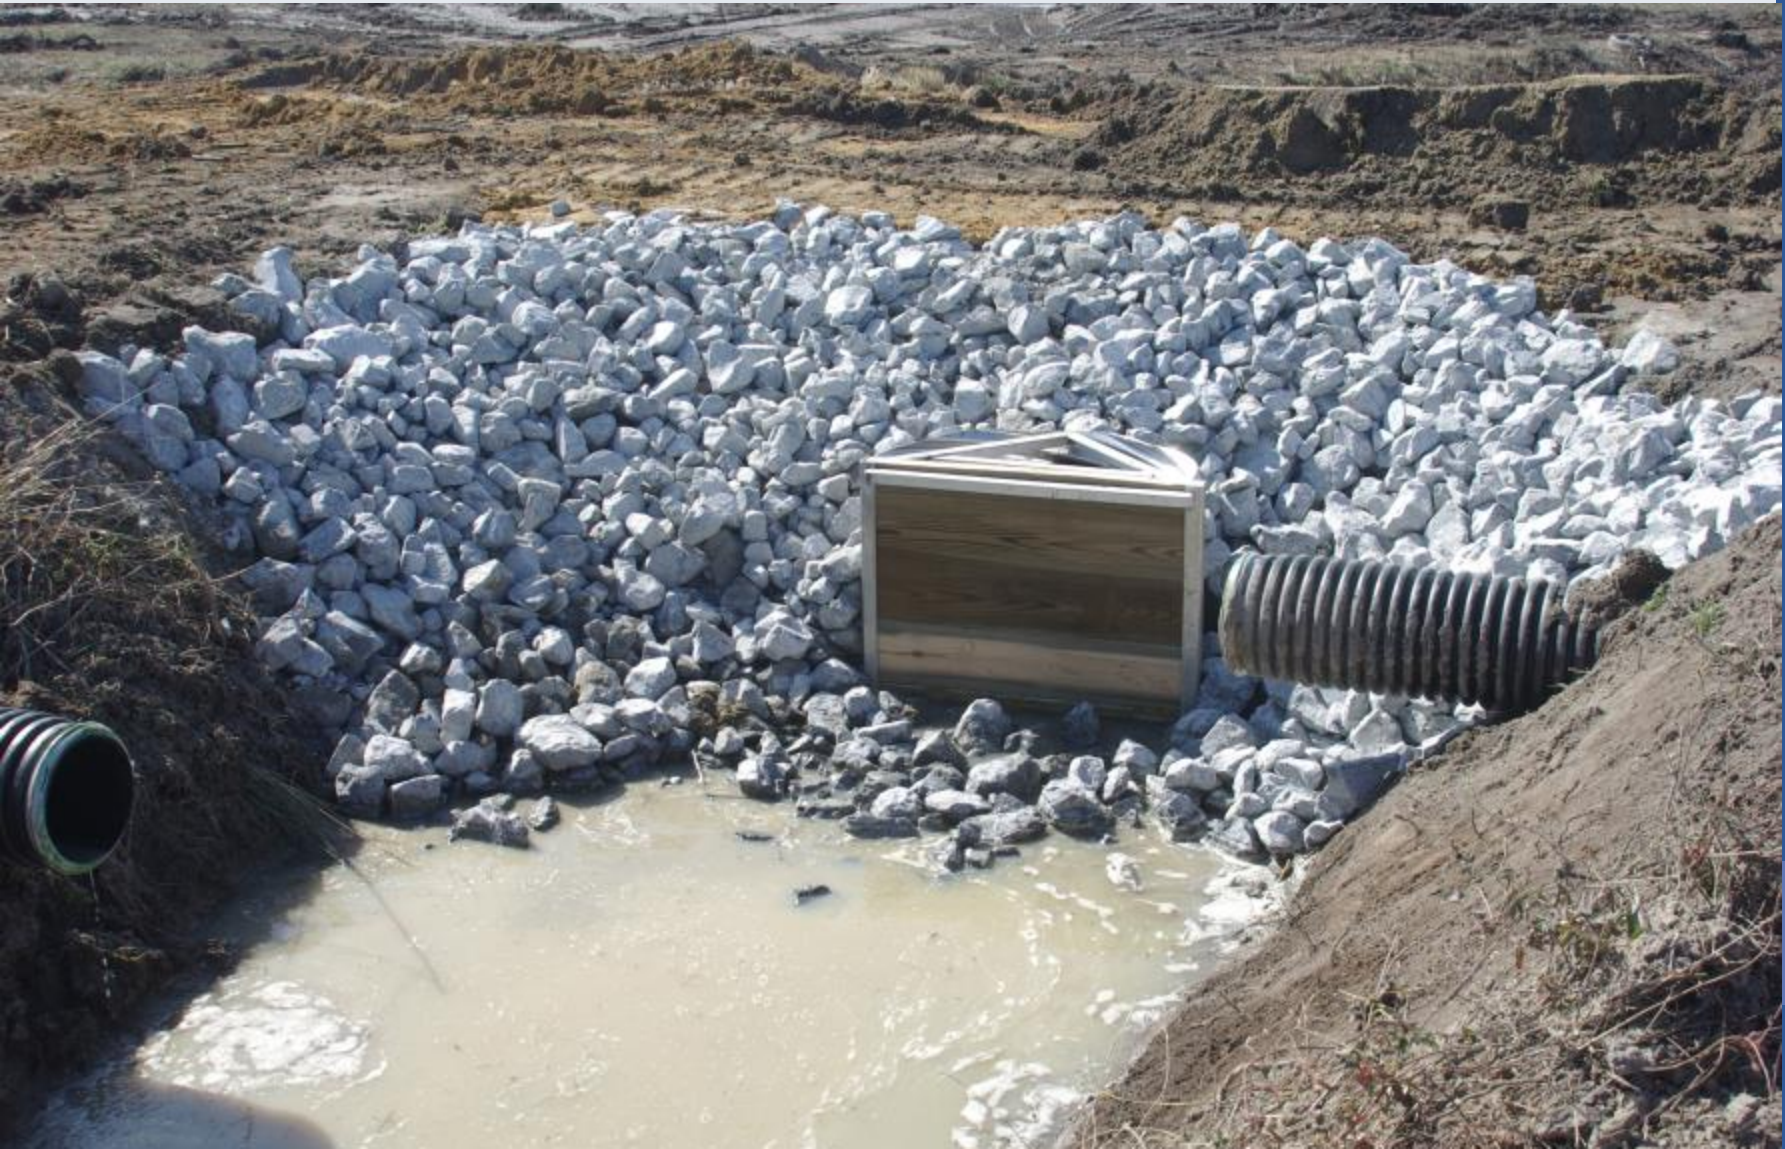
Hrupsa WCS Project

Installed

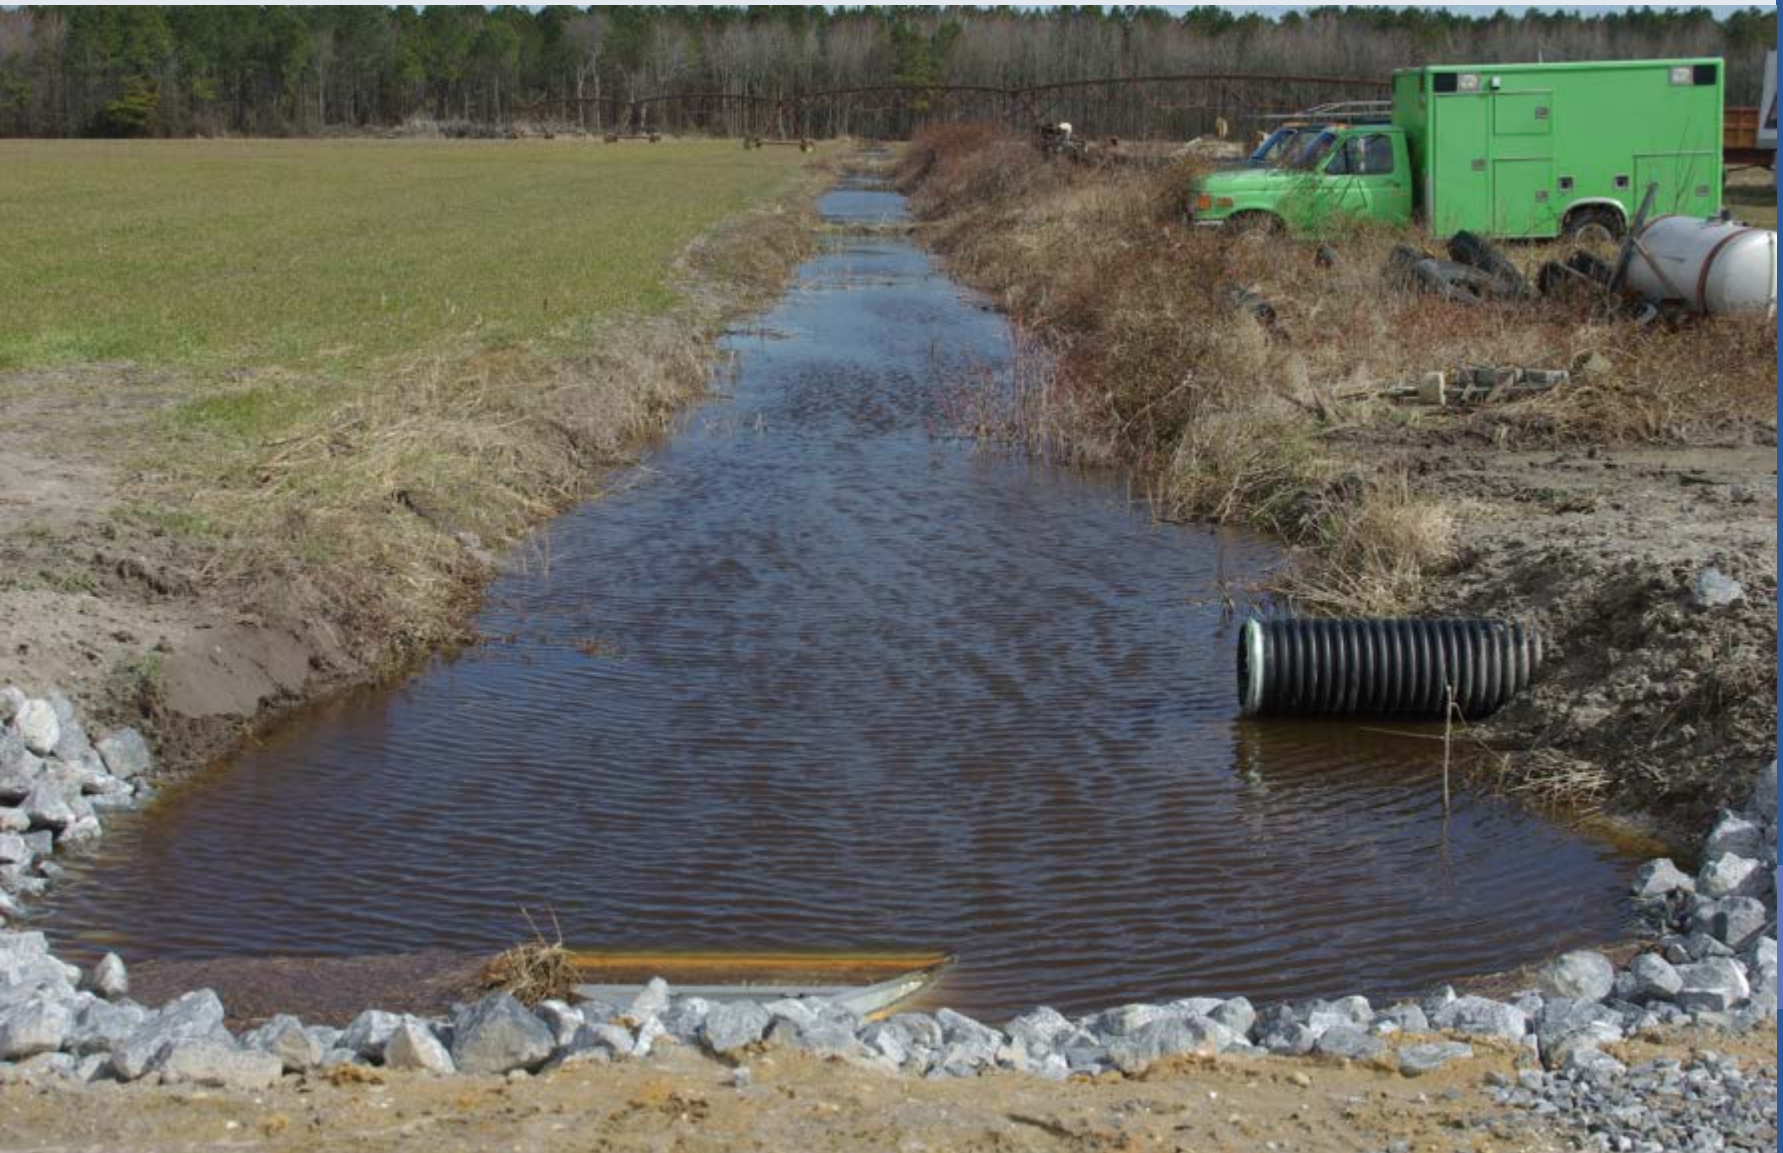
Hrupsa WCS Project

Complete

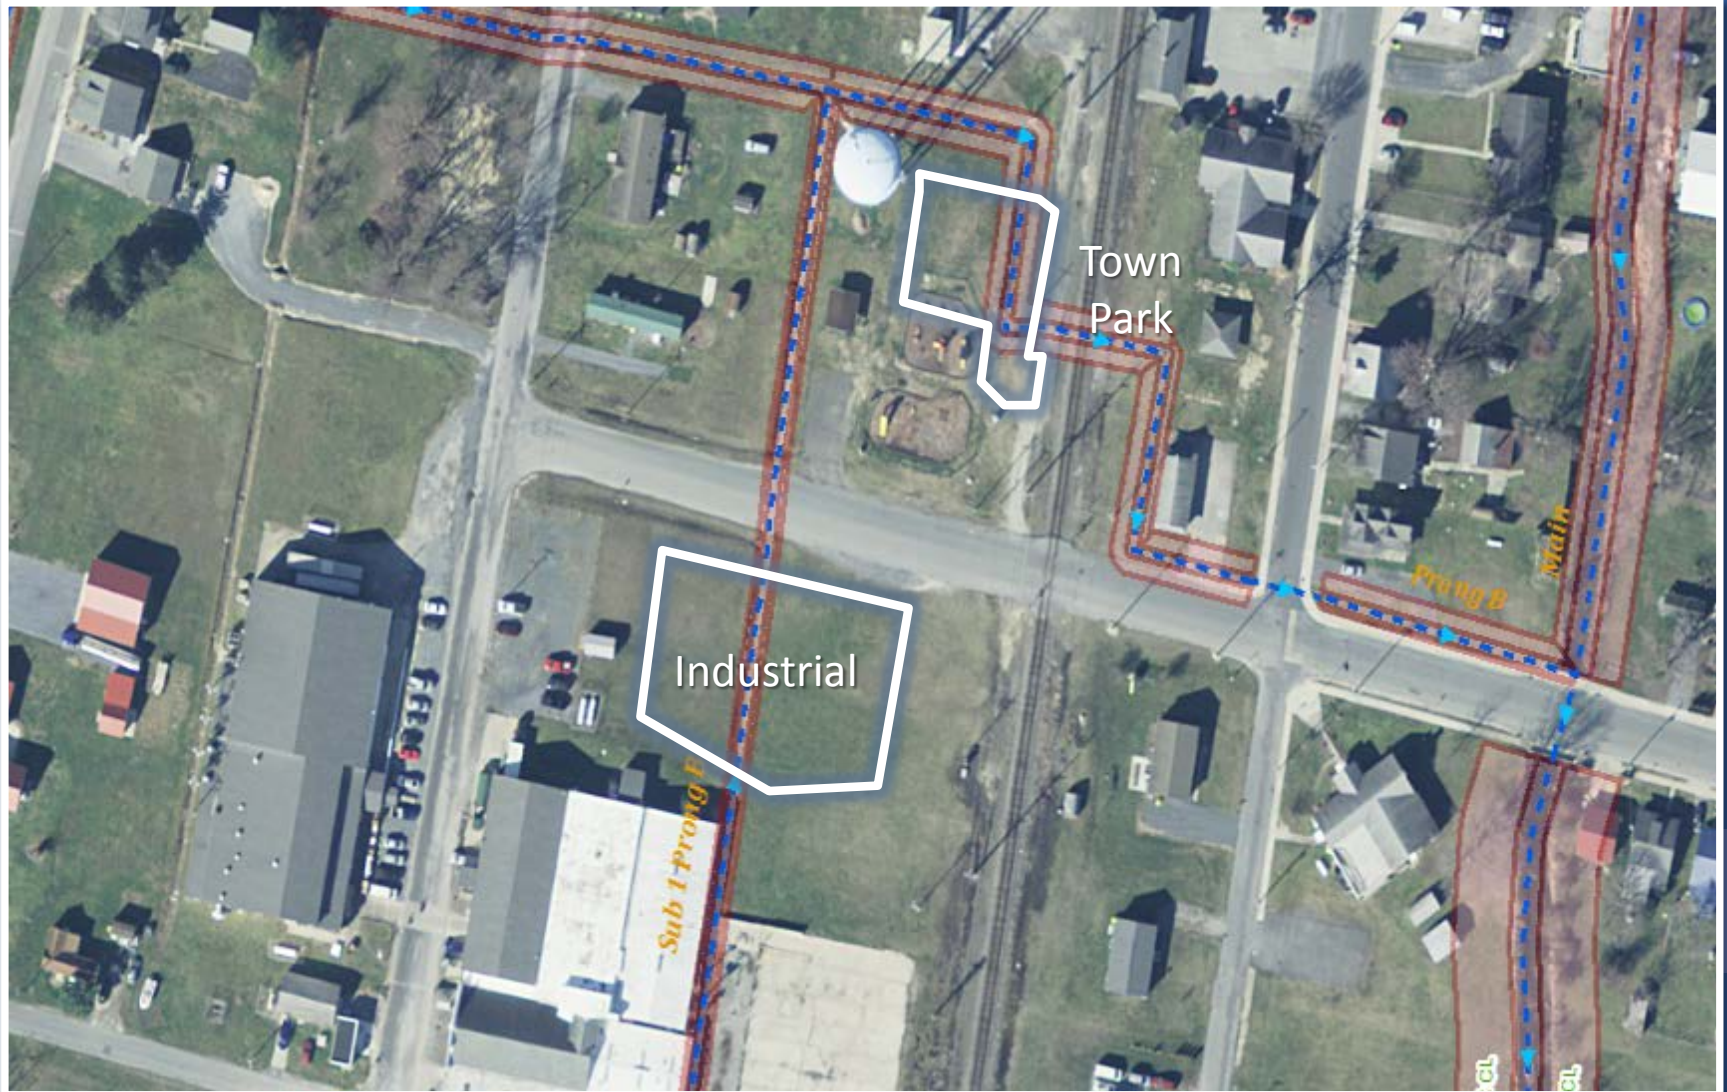
Cart Branch Tax Ditch

Floodplain Creation and Compost Log/Scour Stop Stabilization

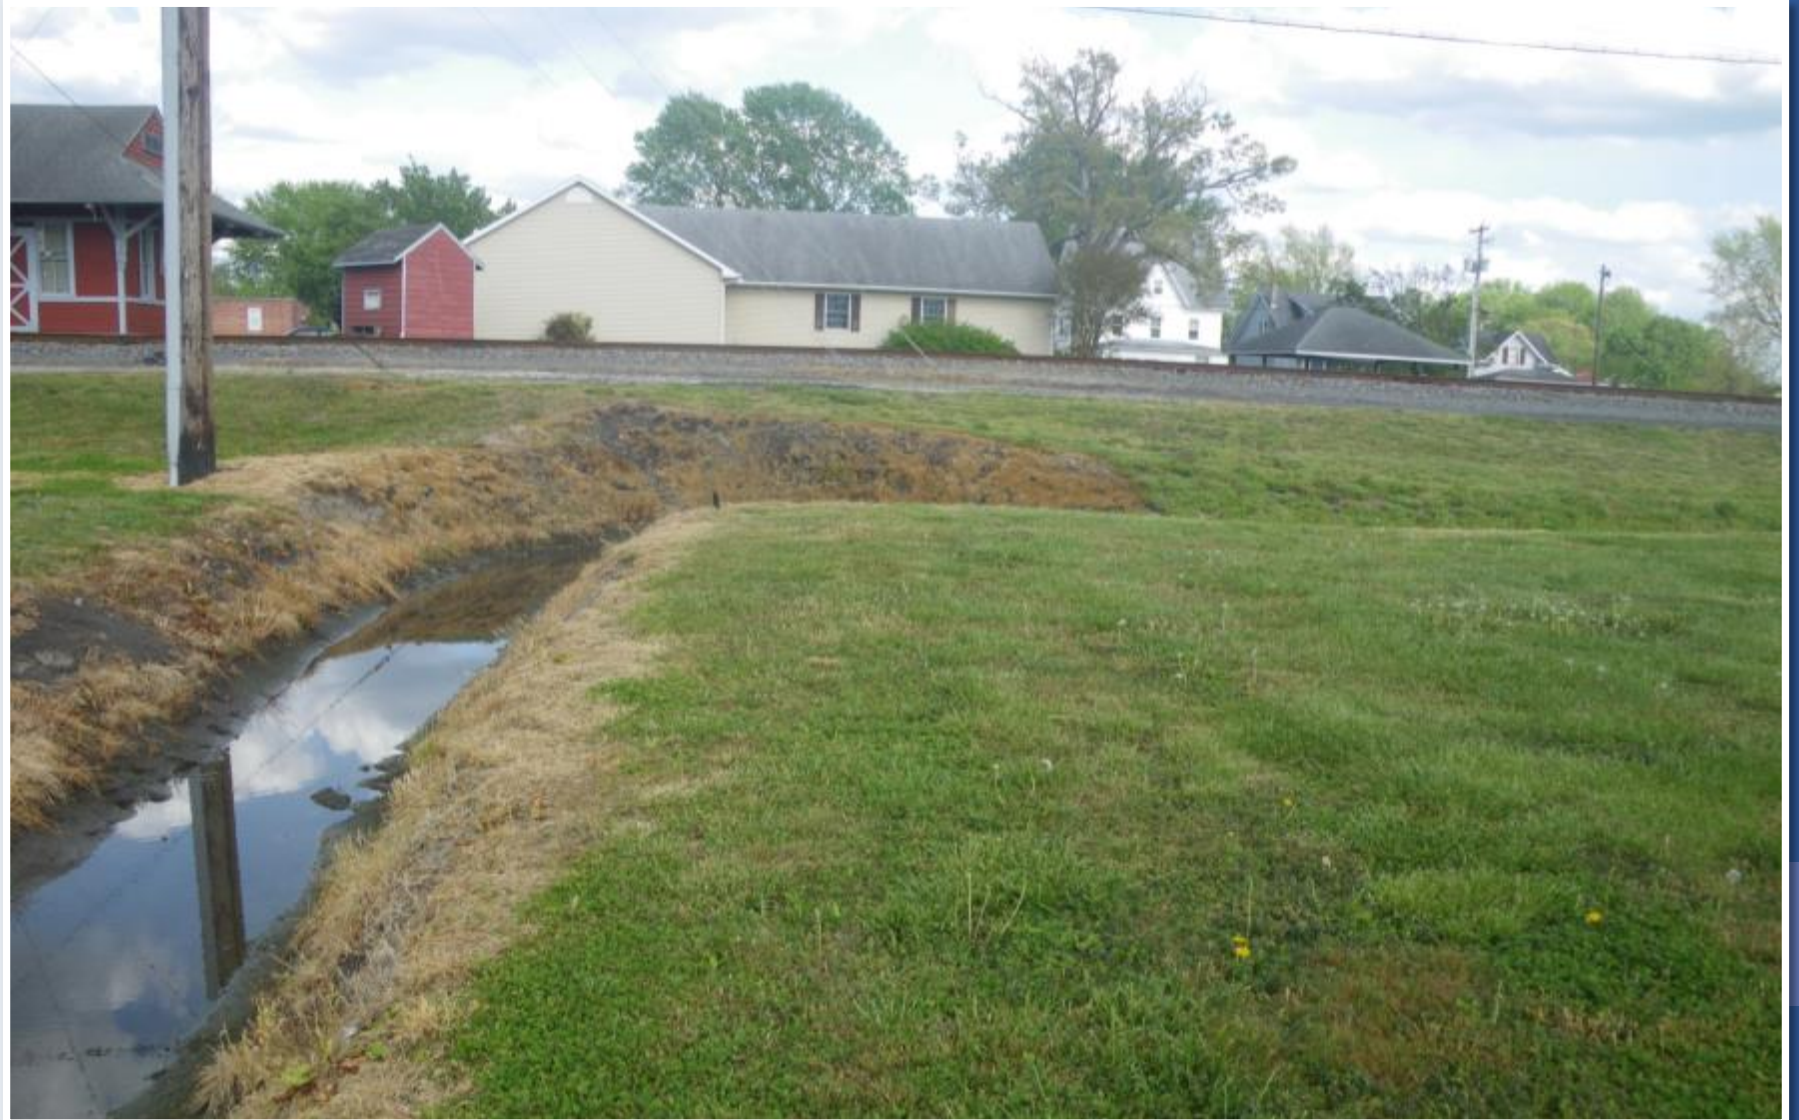
Cart Branch Tax Ditch

Before – Town Park – Outer Bend Erosion and Confined Channel

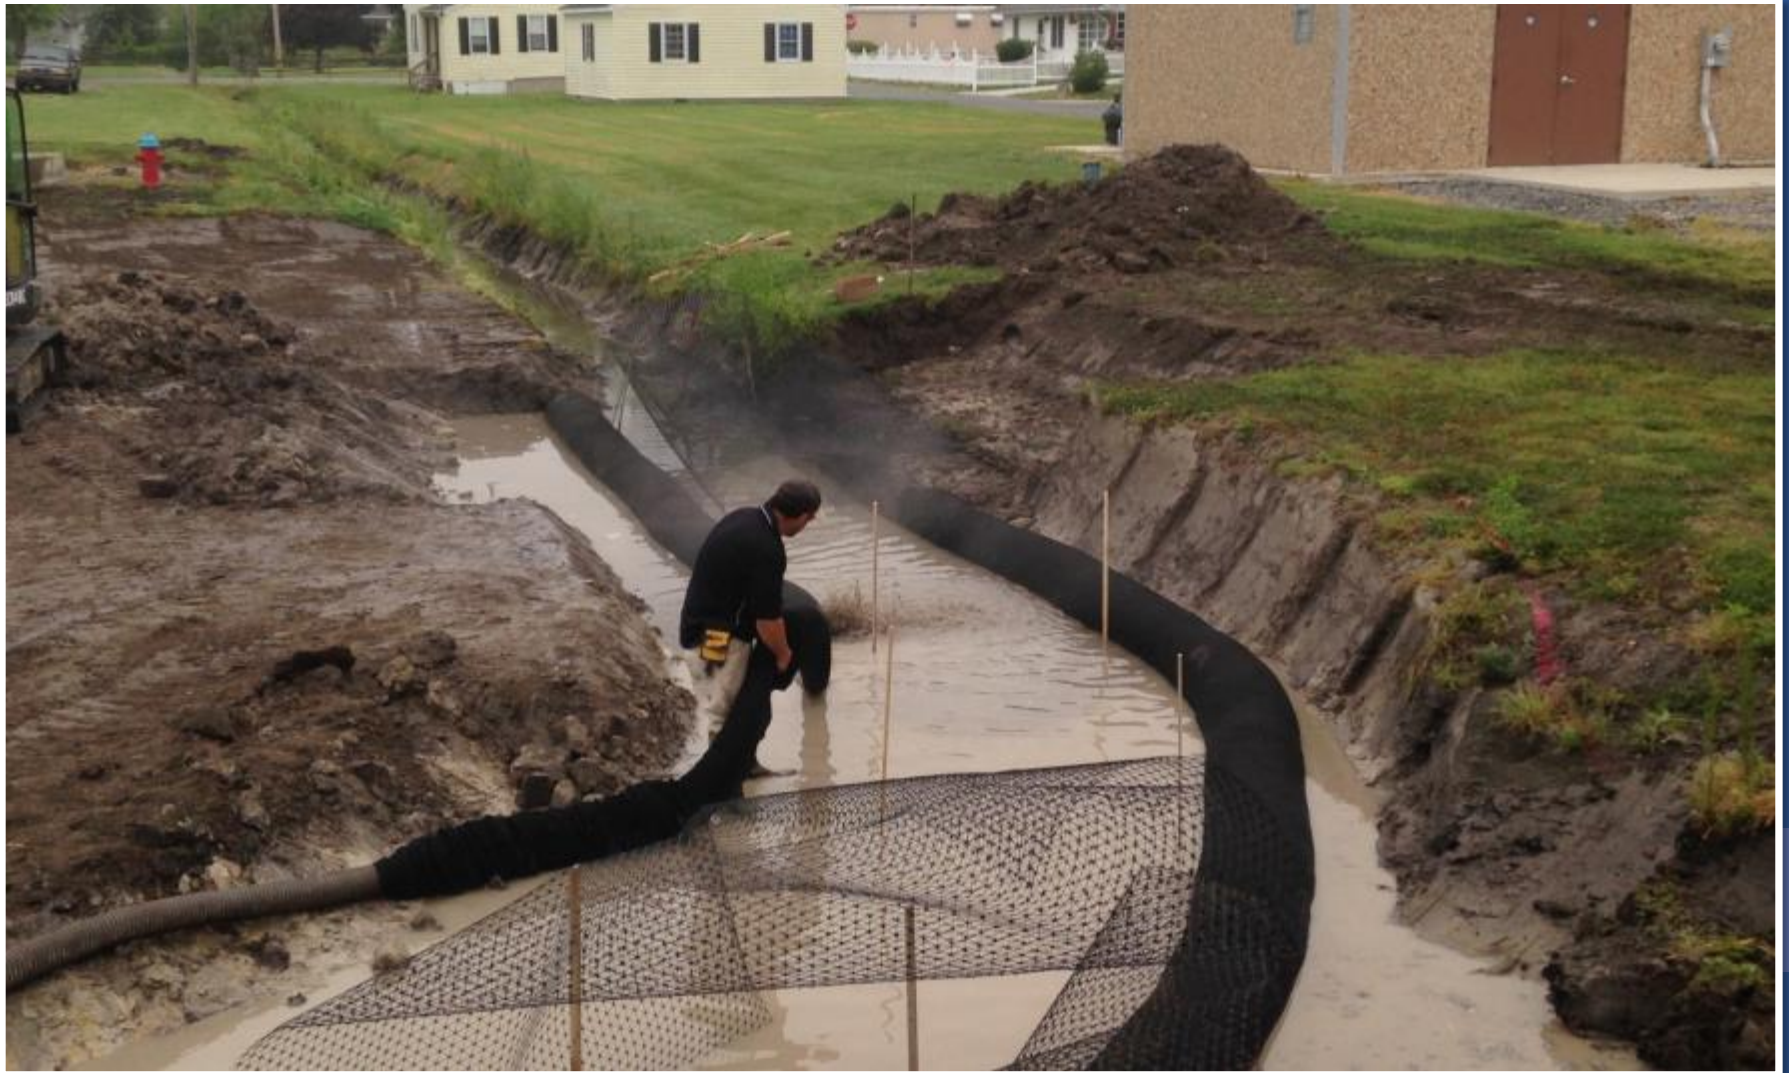
Cart Branch Tax Ditch

During – Town Park – Compost Log Stabilization for Outer Bend

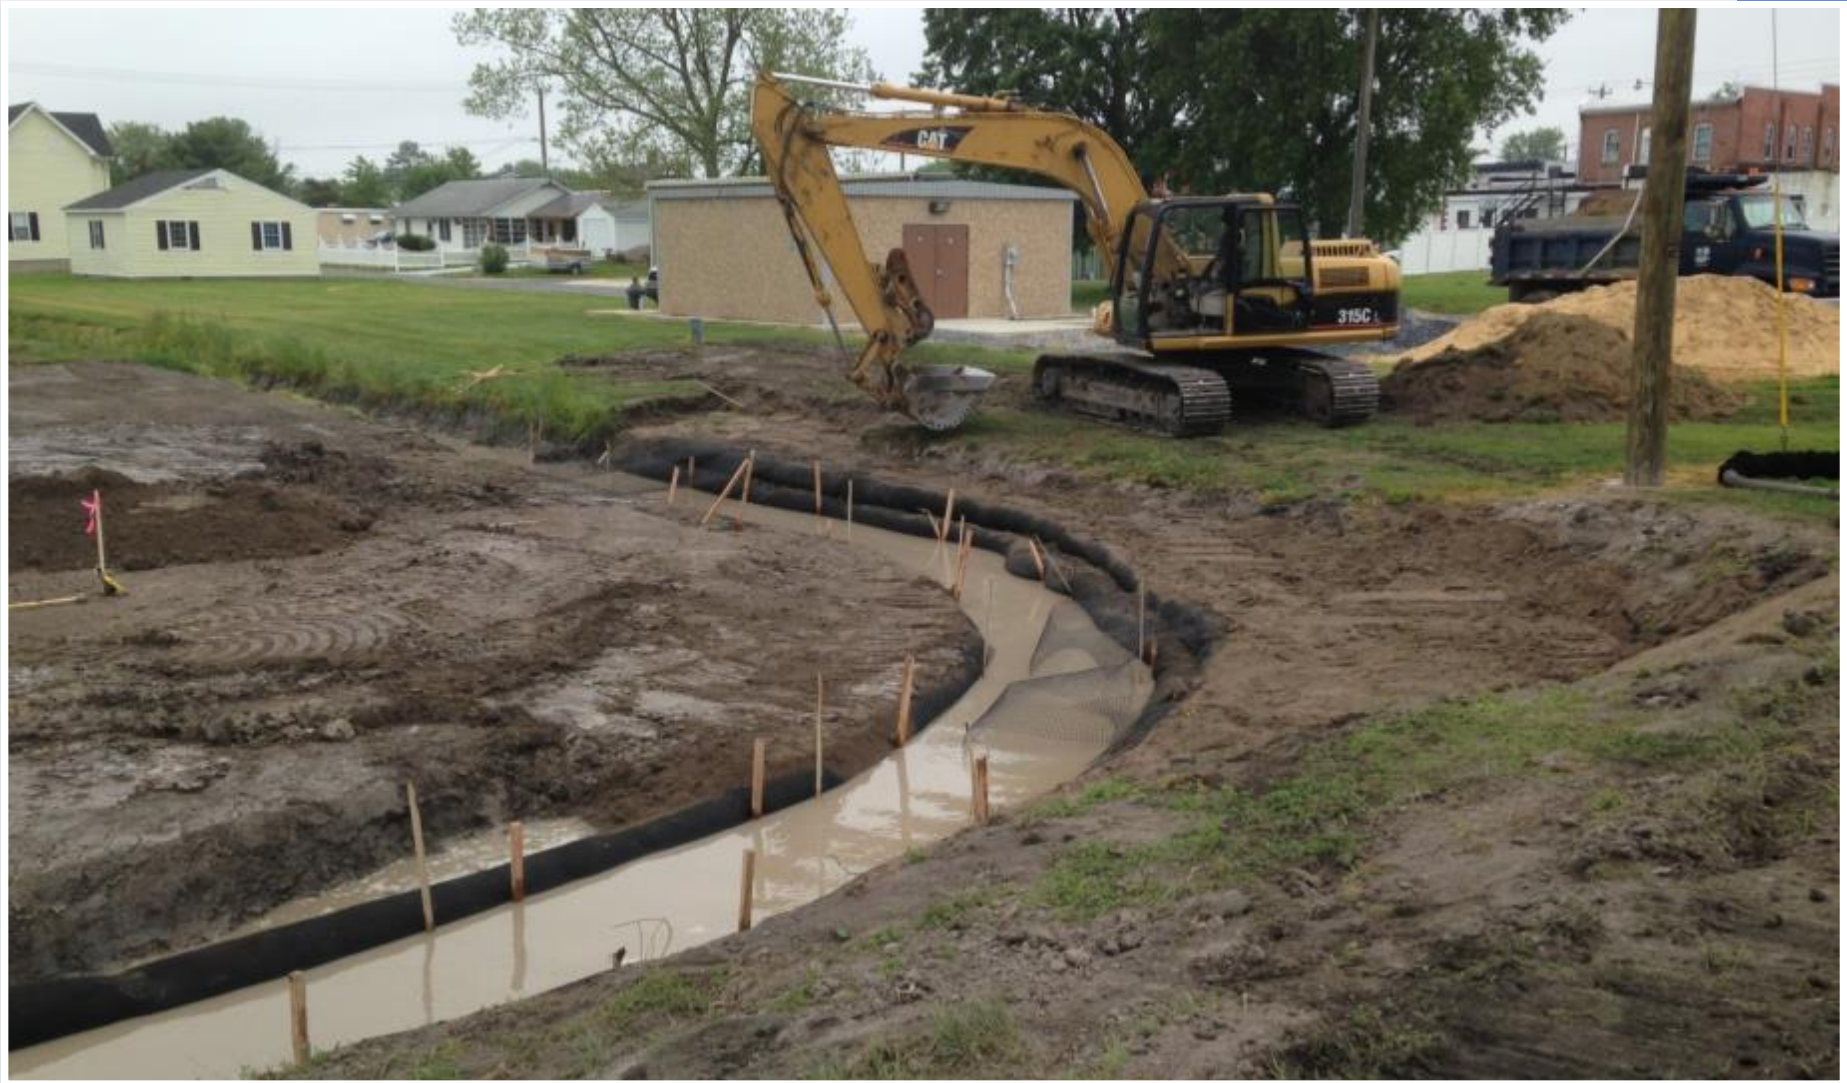
Cart Branch Tax Ditch

During – Town Park – Compost Log Stabilization and Floodplain

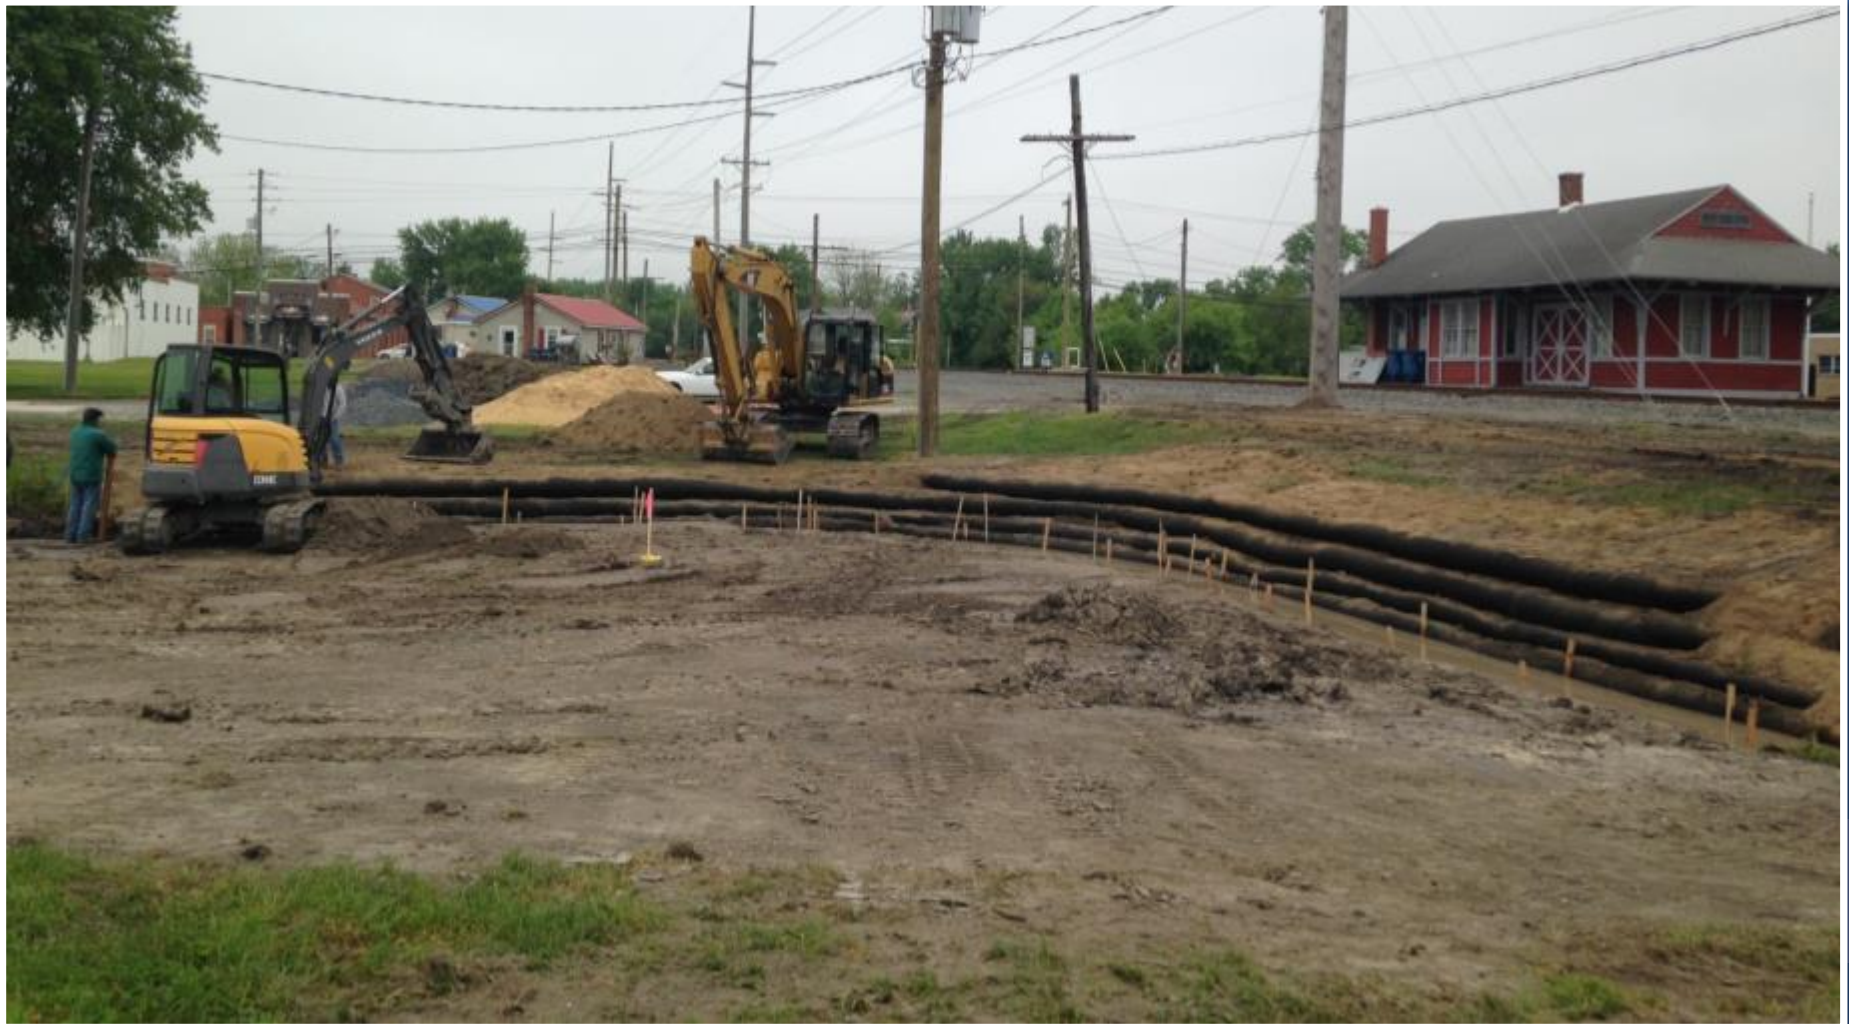
Cart Branch Tax Ditch

During – Town Park – Compost Log Stabilization and Floodplain

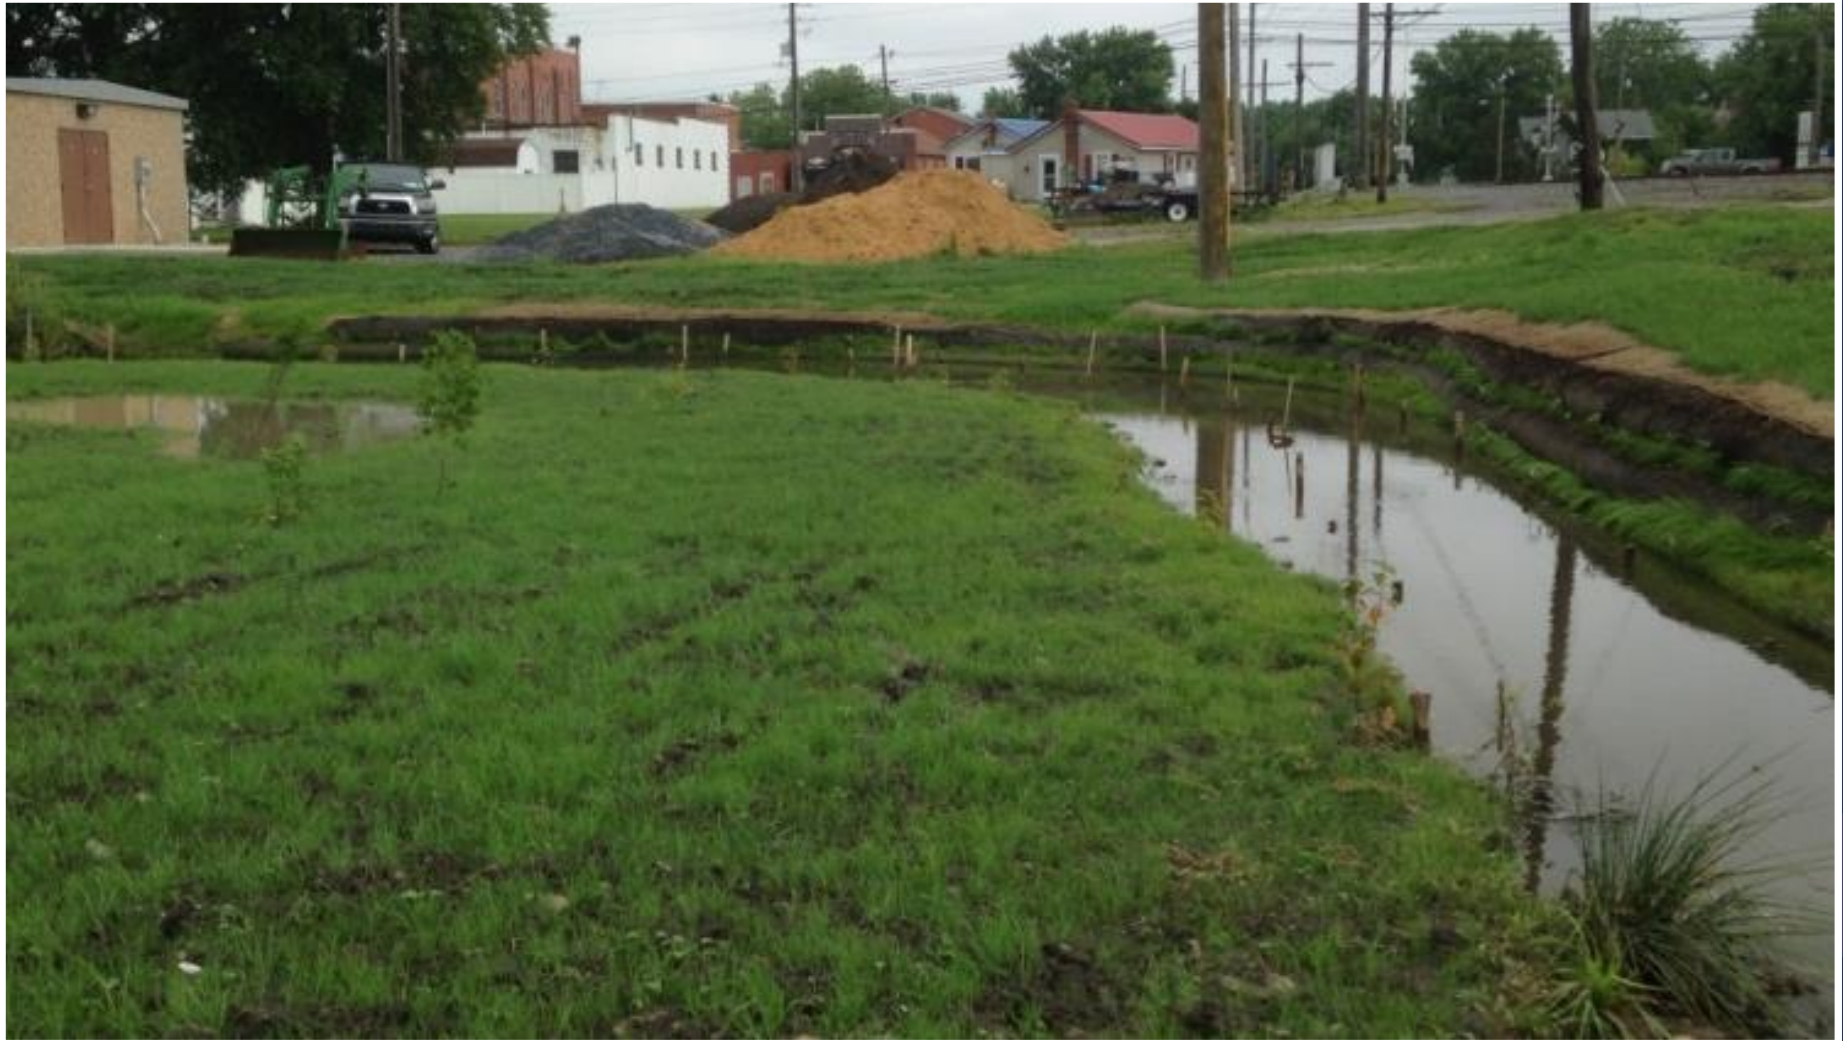
Cart Branch Tax Ditch

After – Town Park – Compost Log Stabilization and Floodplain

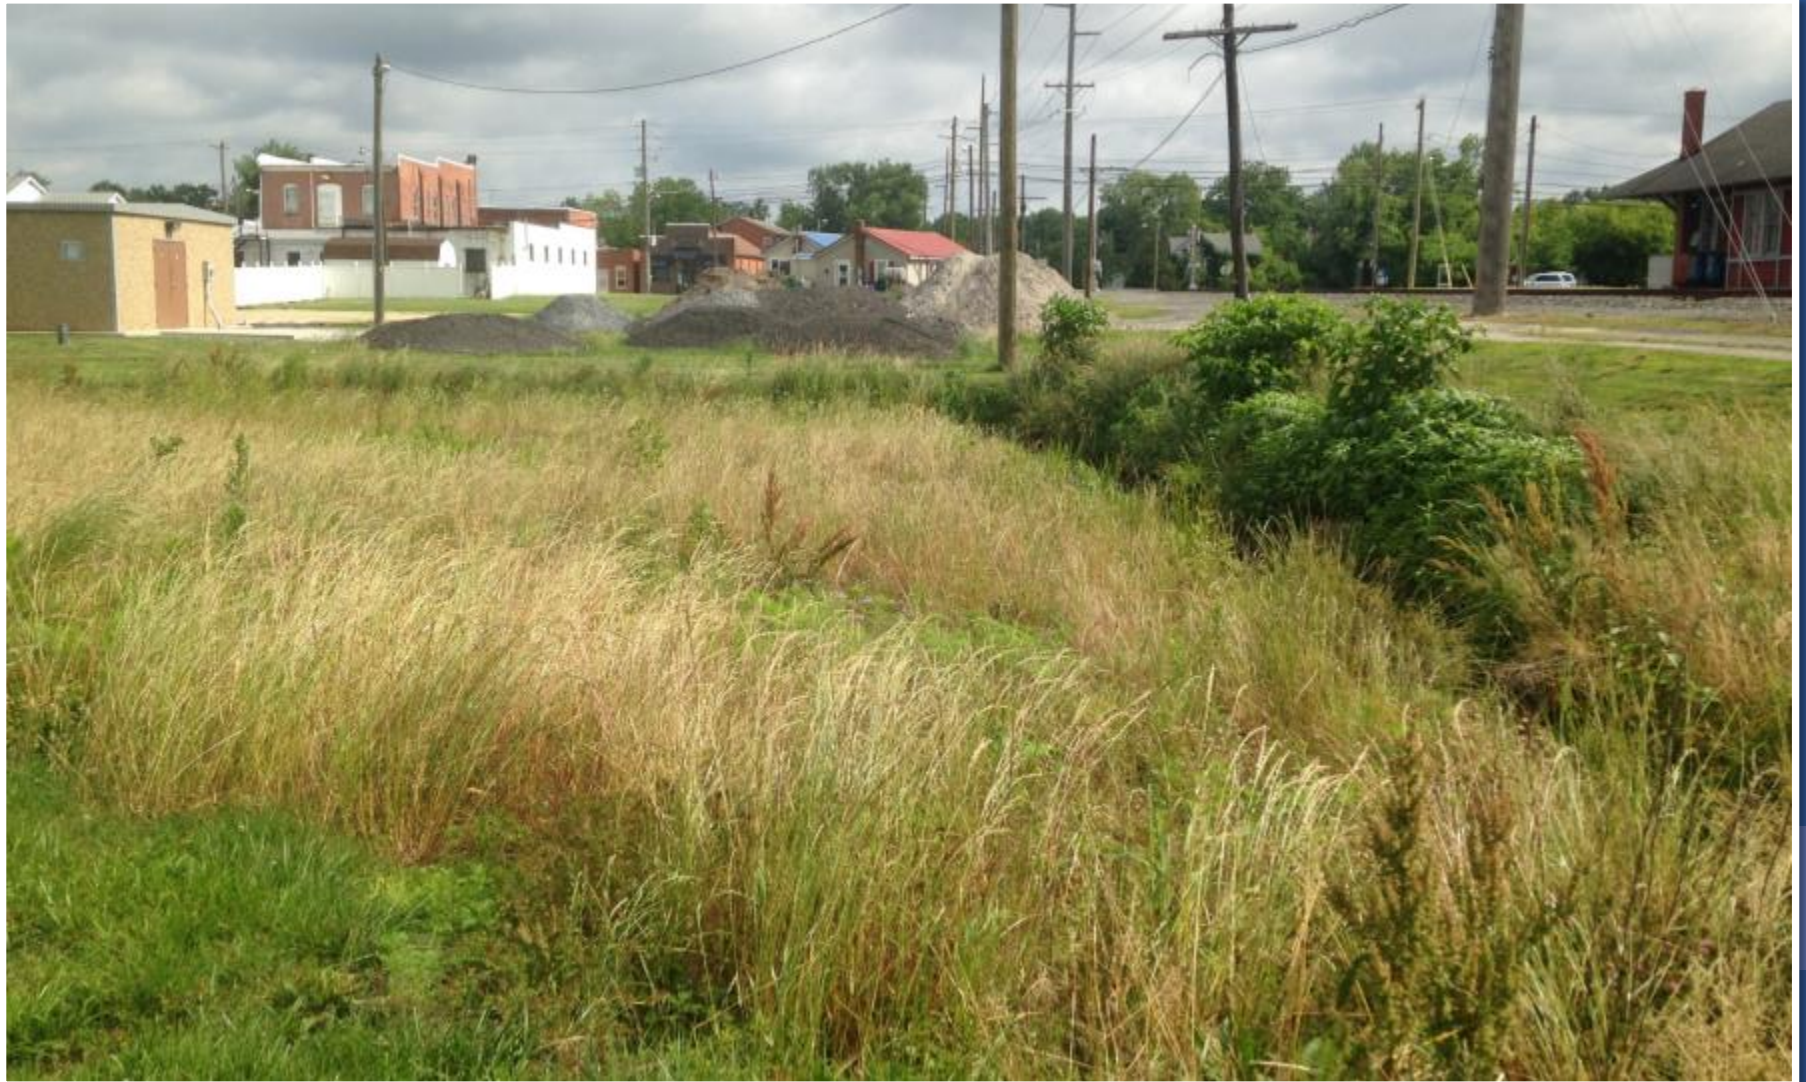
Cart Branch Tax Ditch

After – Town Park – Compost Log Stabilization and Floodplain

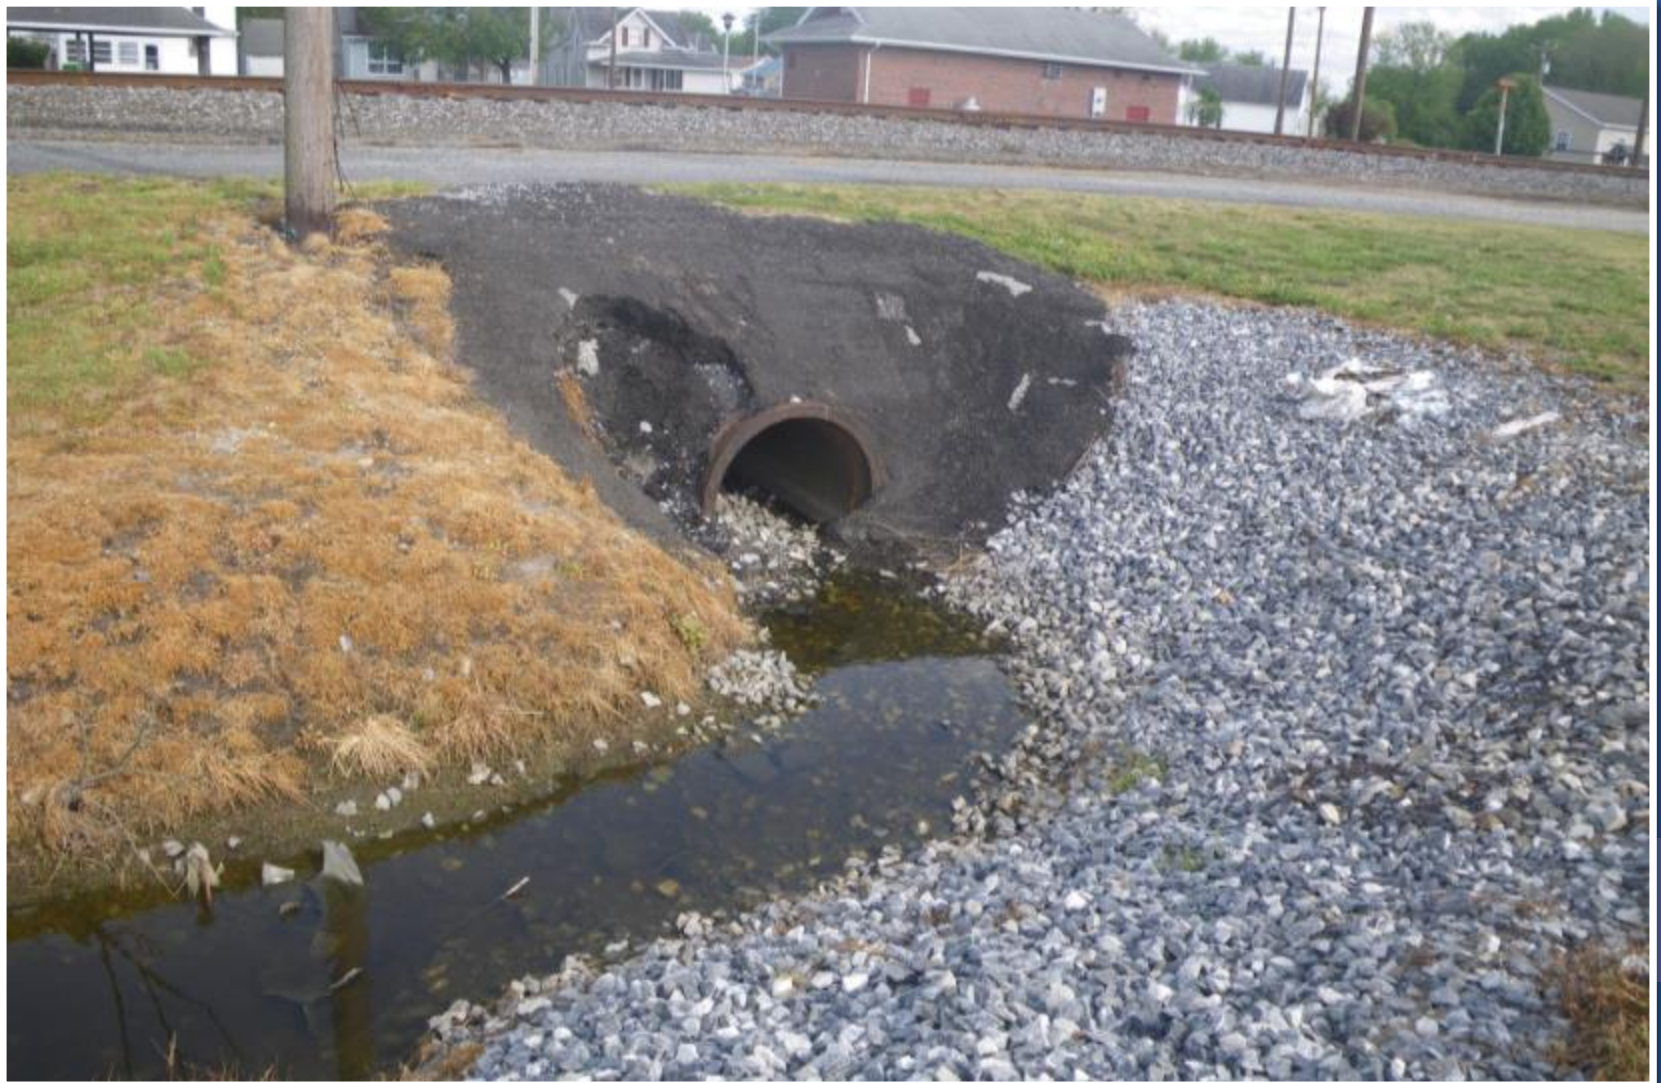
Cart Branch Tax Ditch

Before – Town Park – Outer Bend and Culvert Erosion
