Not Your Father's Tax Ditch

*Enhancing Delaware's Drainage Network Through the
Use of Natural Channel Design Techniques*

**Division of Watershed Stewardship
Drainage Program**

Presented at the National Conference on Ecological Restoration
April 21, 2016
Presented by: Brooks Cahall, Drainage Program Manager
Co-Authors: Matthew Grabowski, Sara Esposito P.E.

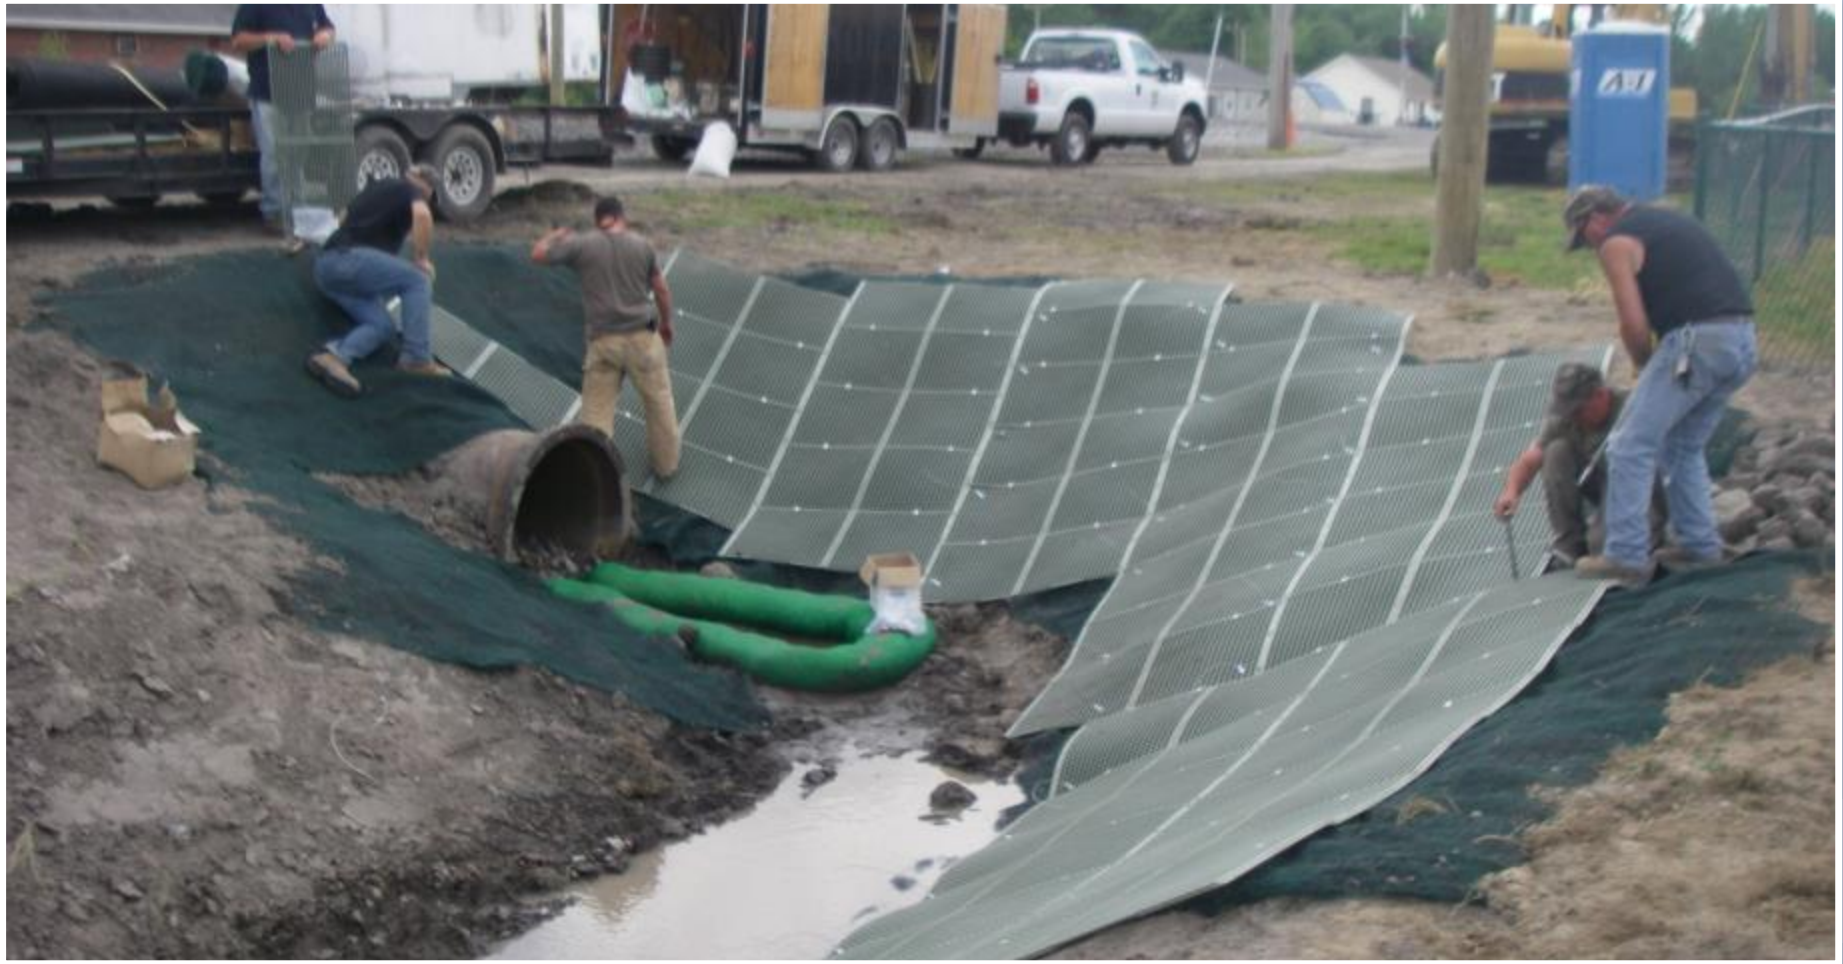
Cart Branch Tax Ditch

During – Town Park – Scour-Stop Culvert and Bend Protection

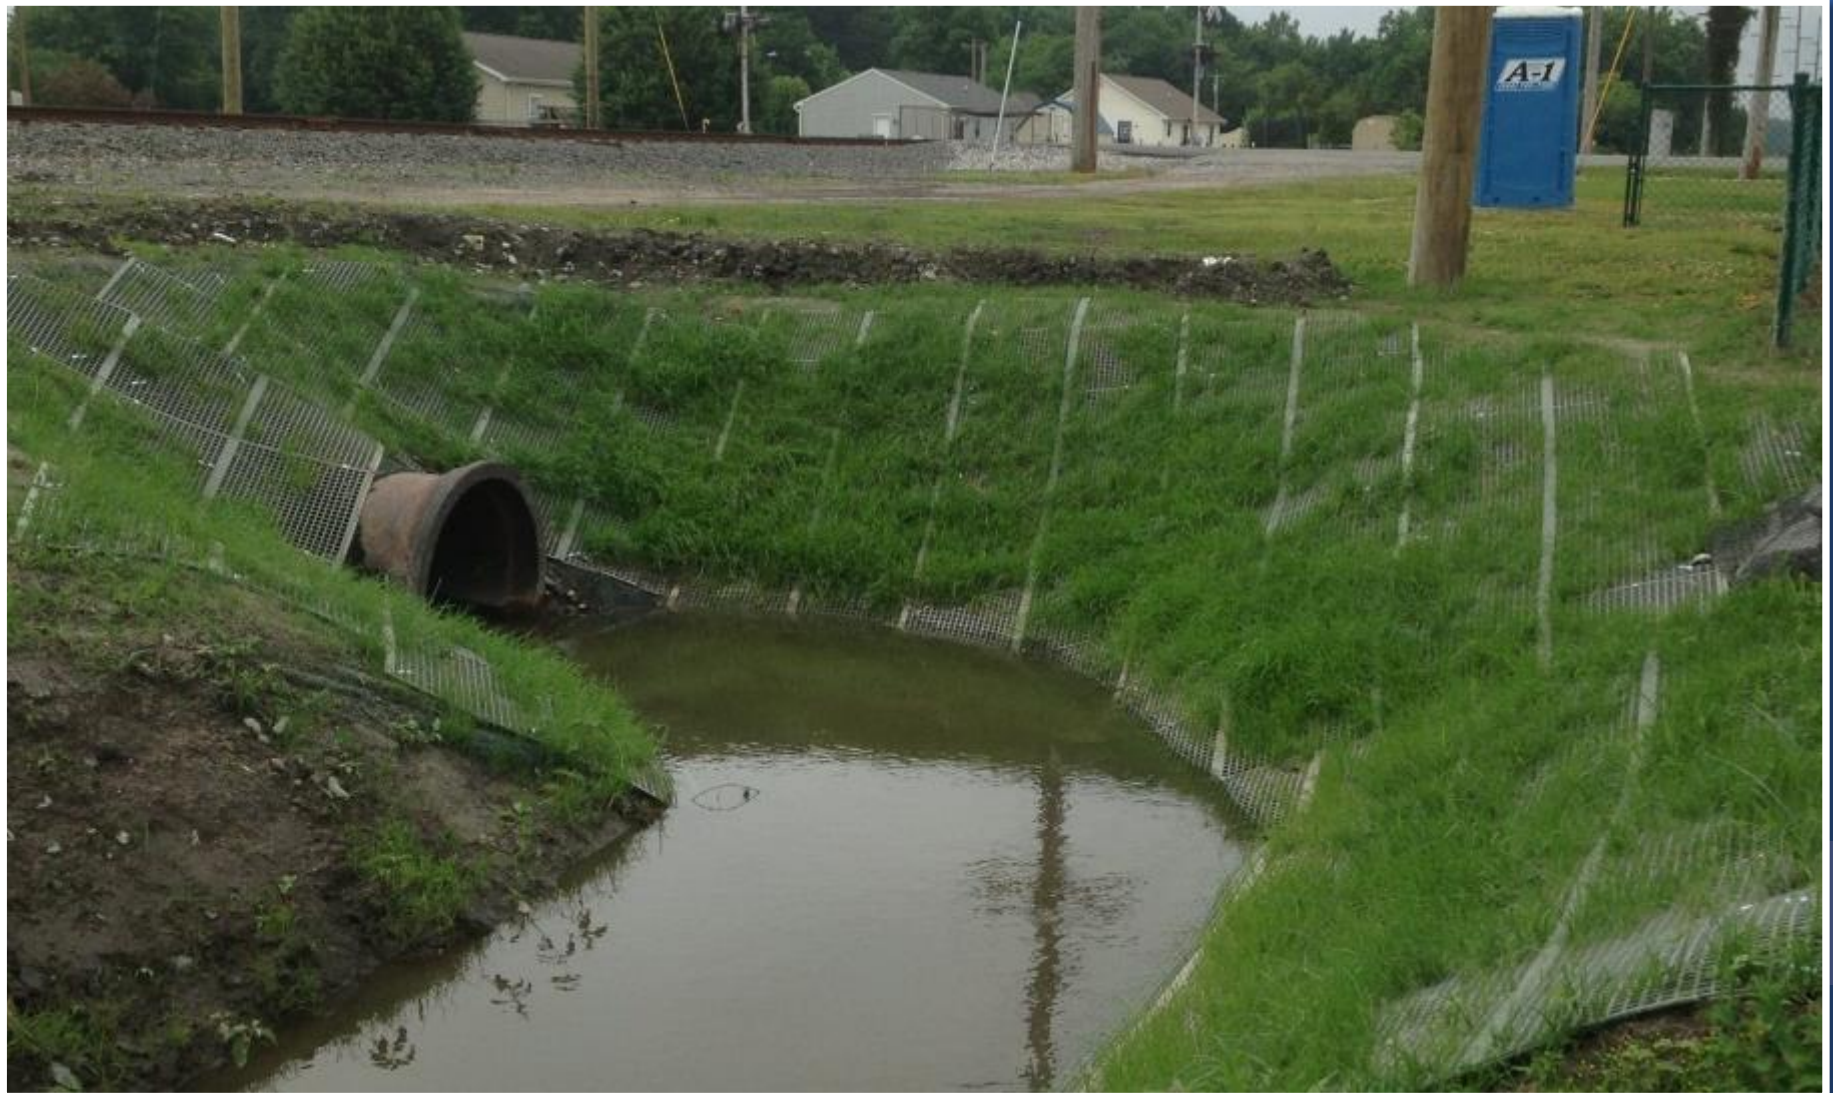
Cart Branch Tax Ditch

After – Town Park – Scour-Stop Culvert and Bend Protection

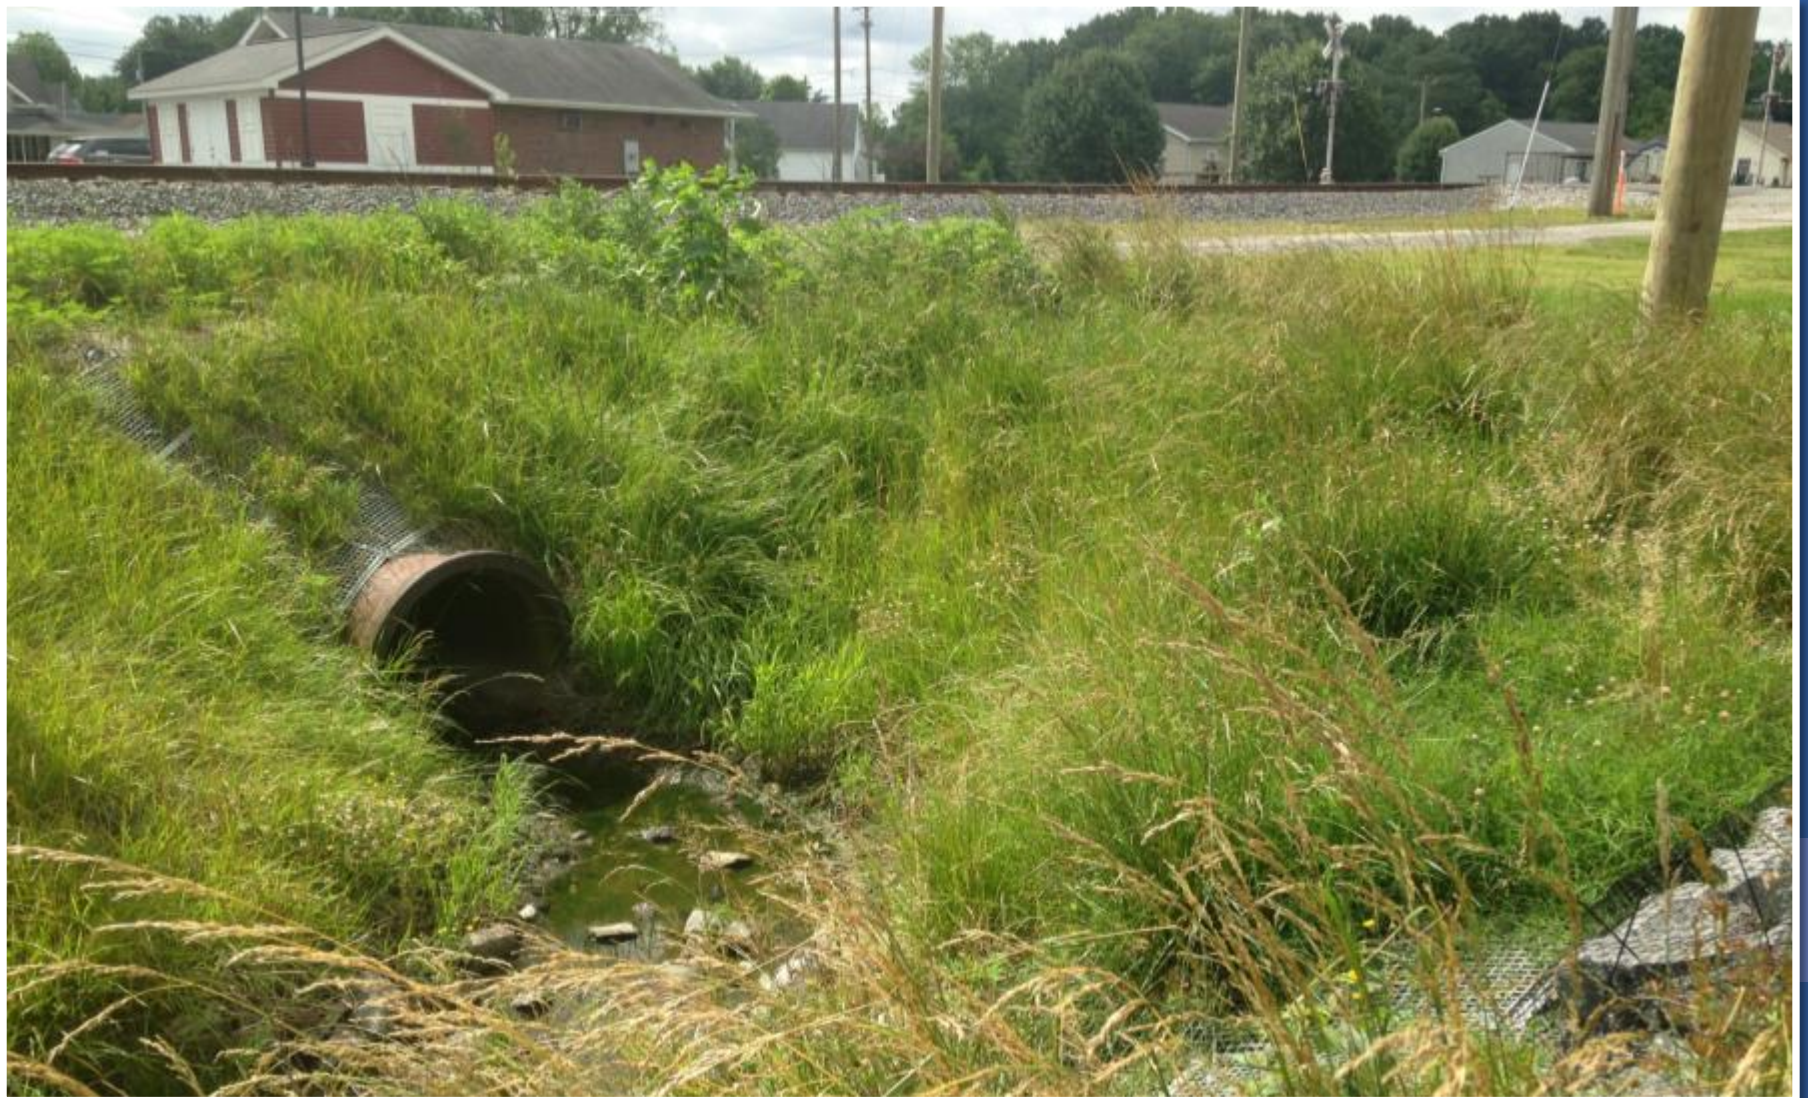
Cart Branch Tax Ditch

After – Town Park – Scour-Stop Culvert and Bend Protection

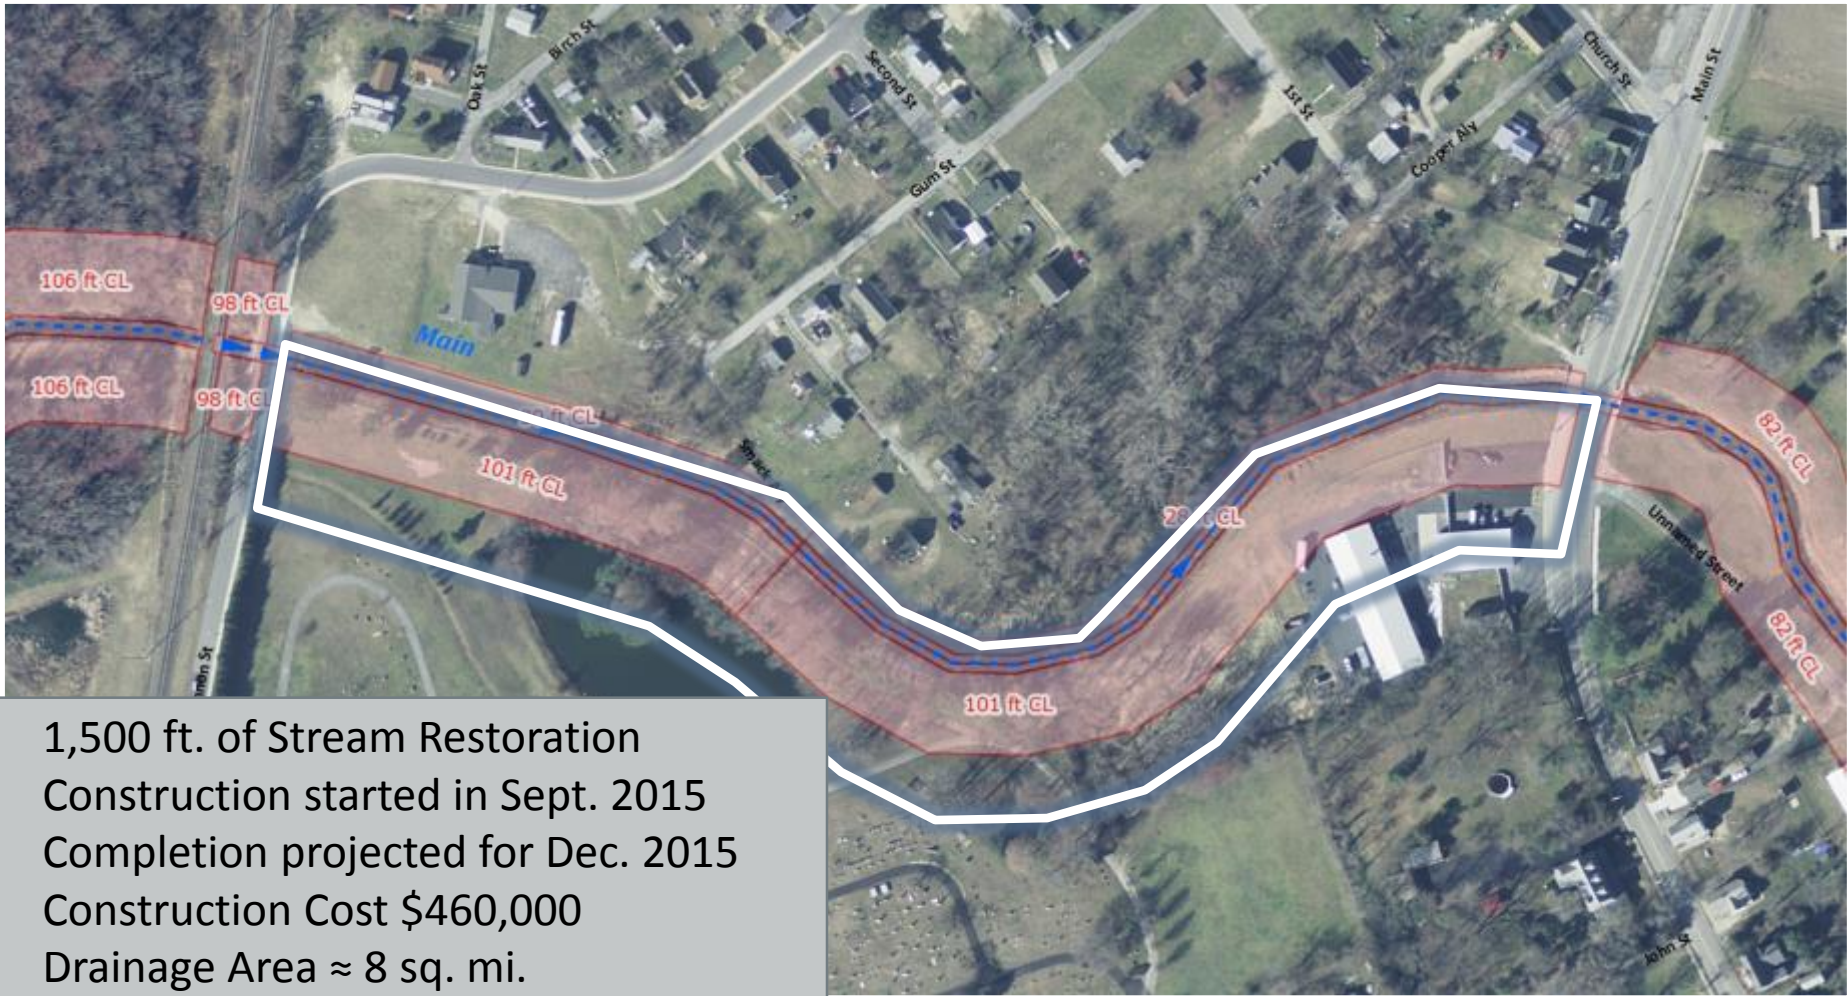
Bridgeville Branch Tax Ditch

Restoration Project

- 1,500 ft. of Stream Restoration
- Construction started in Sept. 2015
- Completion projected for Dec. 2015
- Construction Cost \$460,000
- Drainage Area \approx 8 sq. mi.
- TD Design Bottom Width = 20'
- Bank Full Discharge = 82 cfs

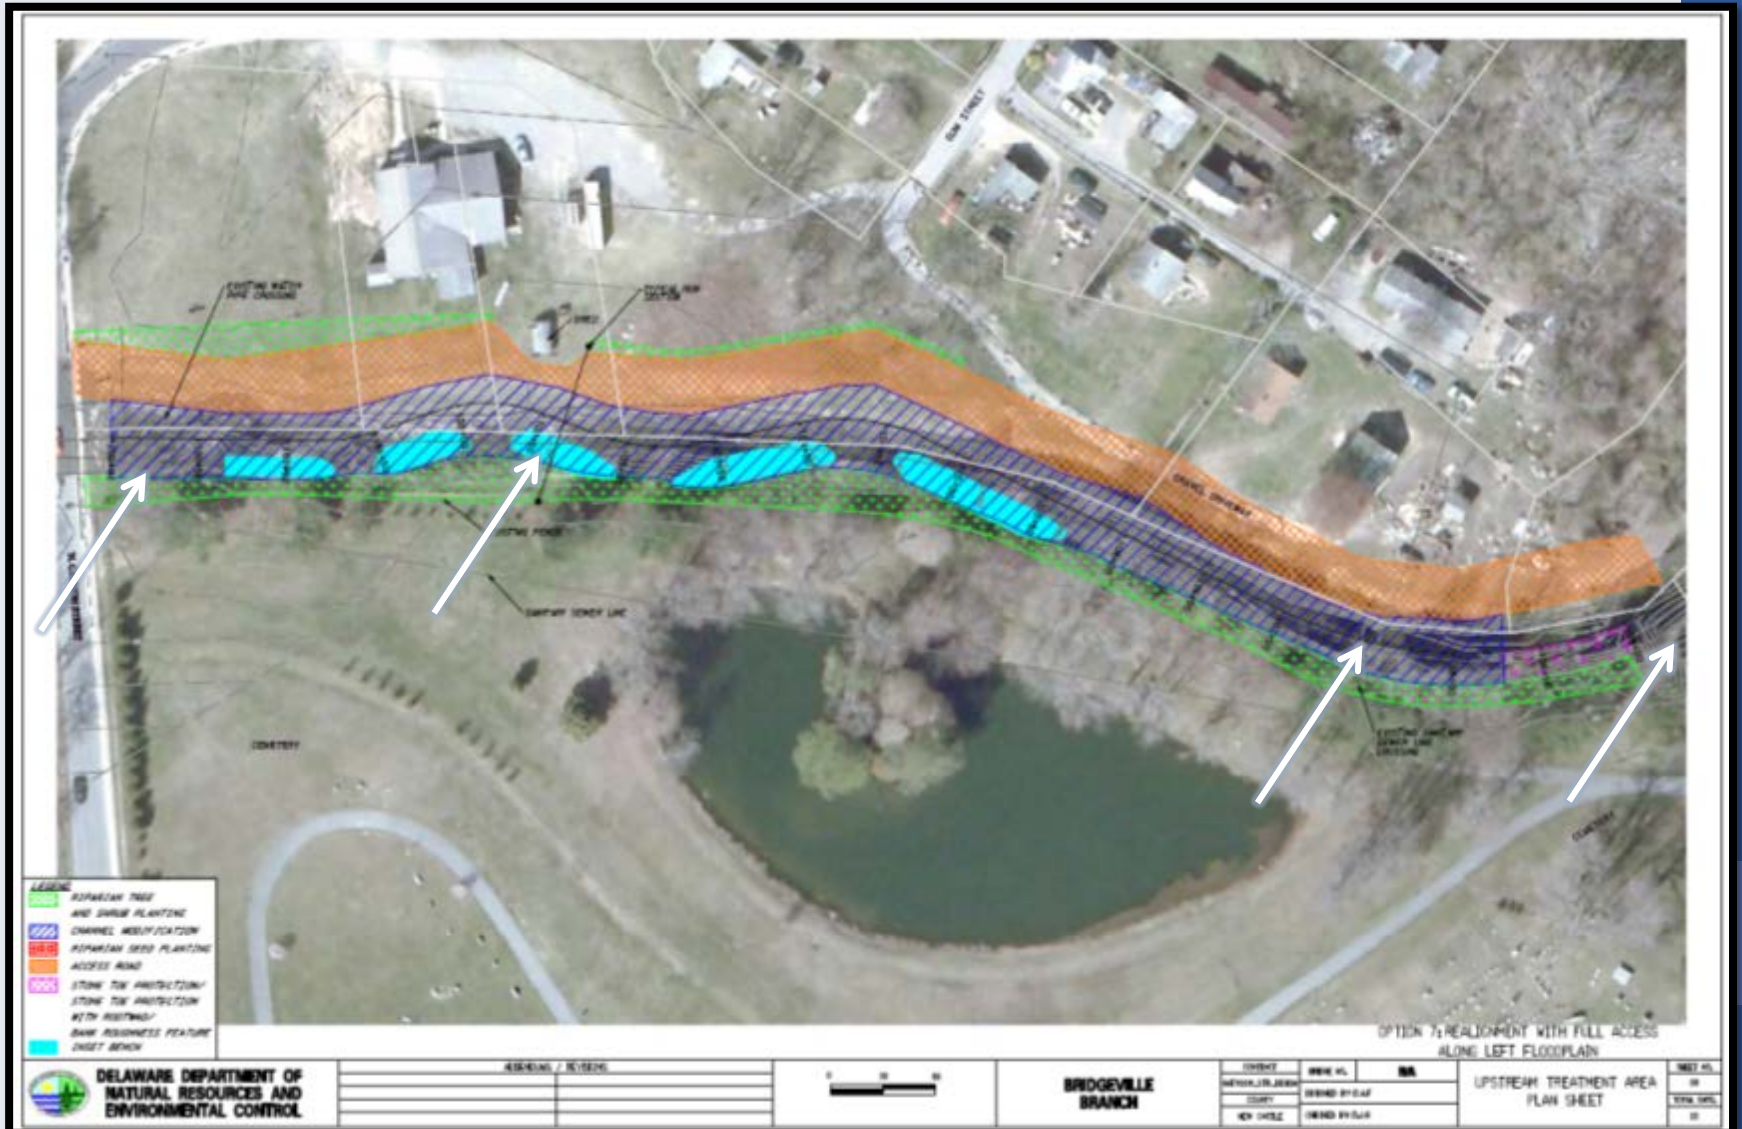
Bridgeville Branch Tax Ditch

Design – Concept Plan

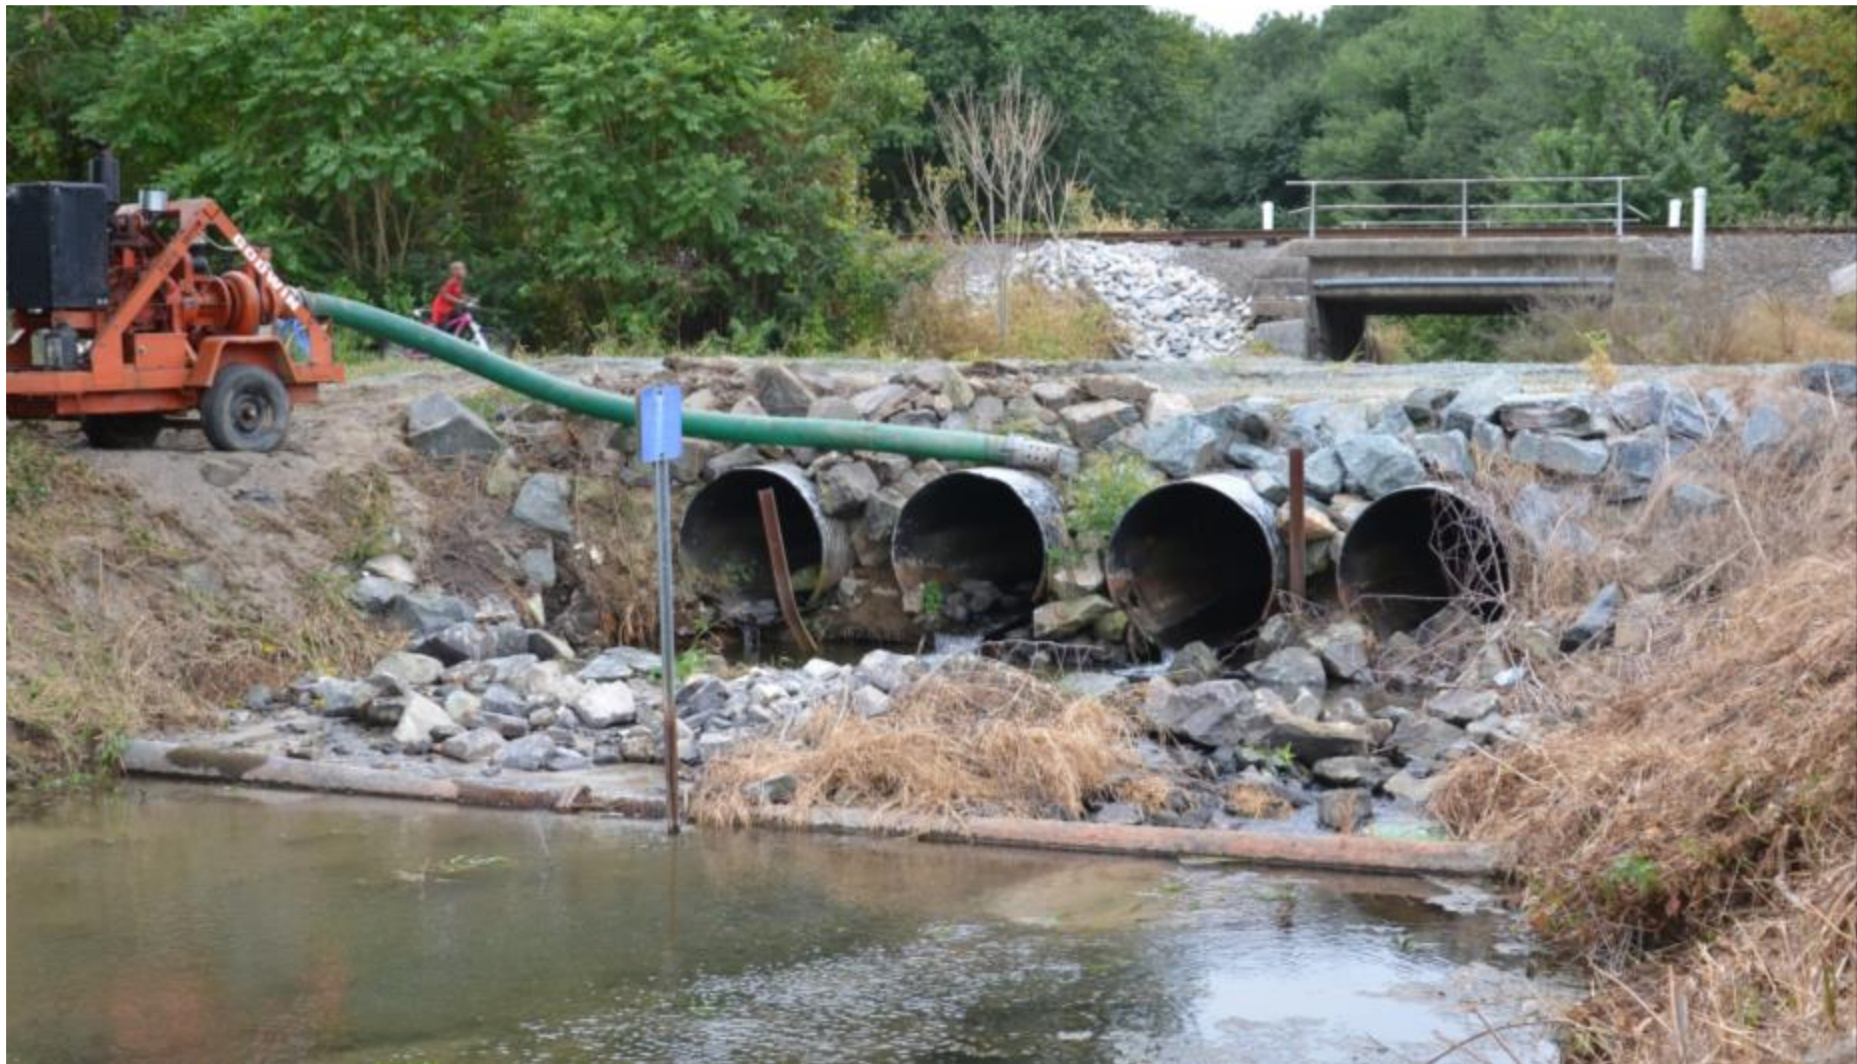
Bridgeville Branch Tax Ditch

Before – Exposed Water Main

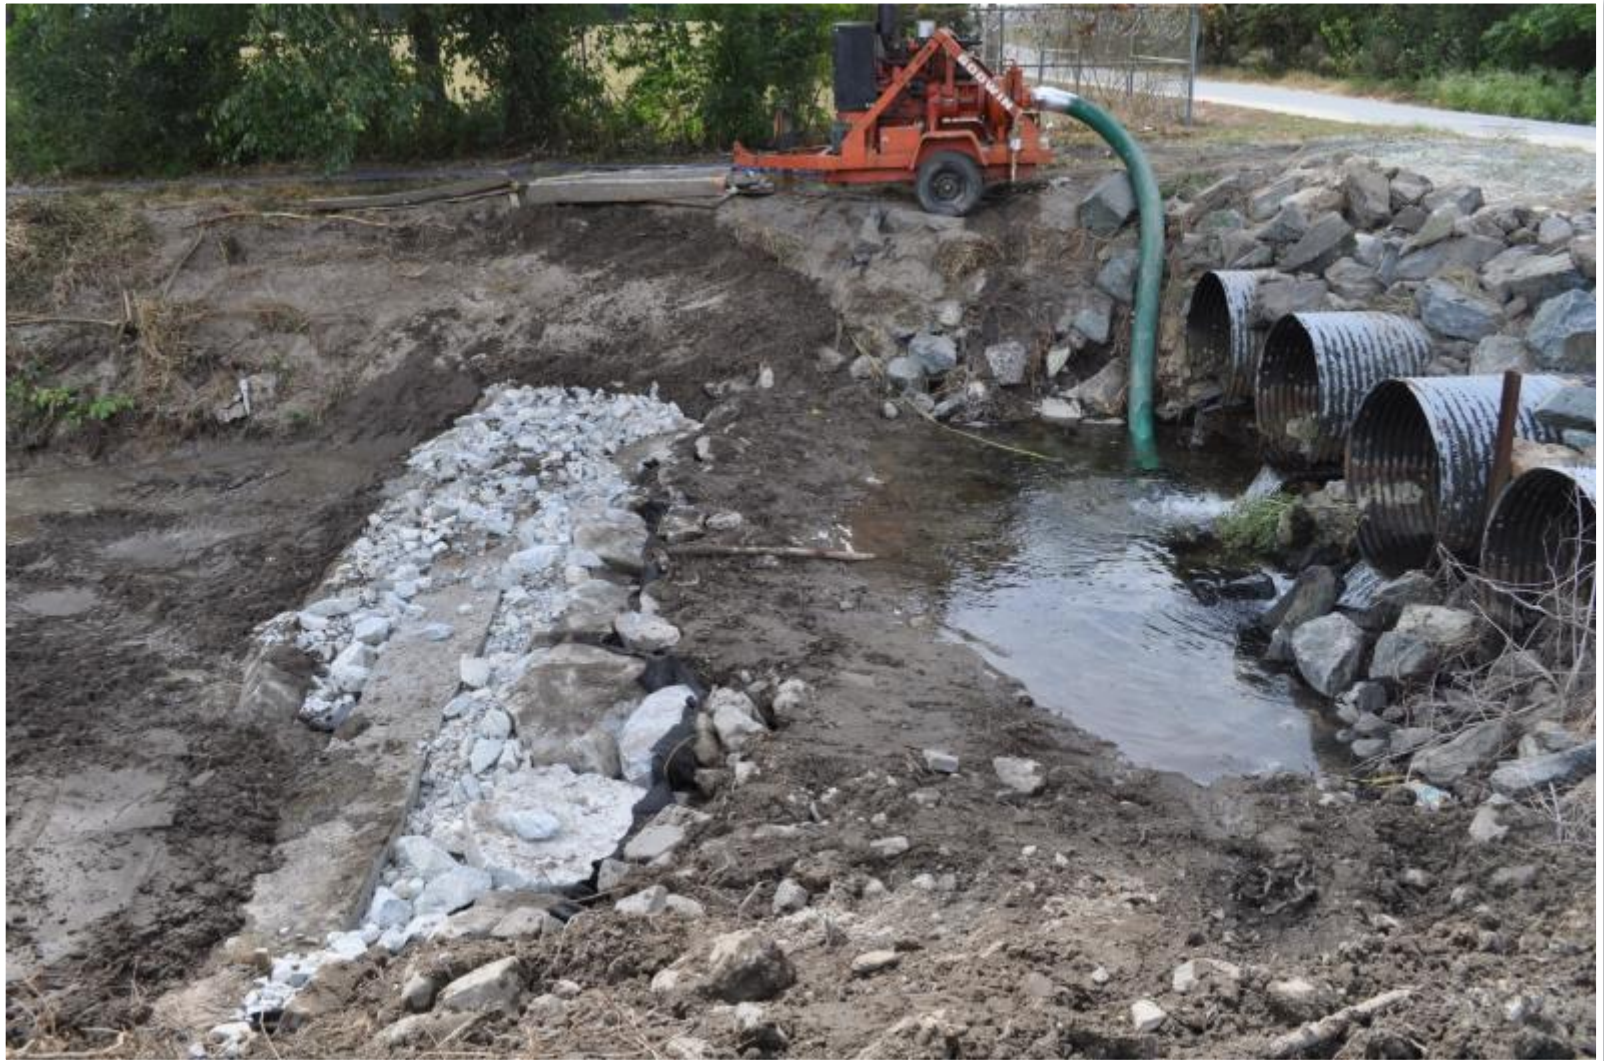
Bridgeville Branch Tax Ditch

During – Protected Water Main

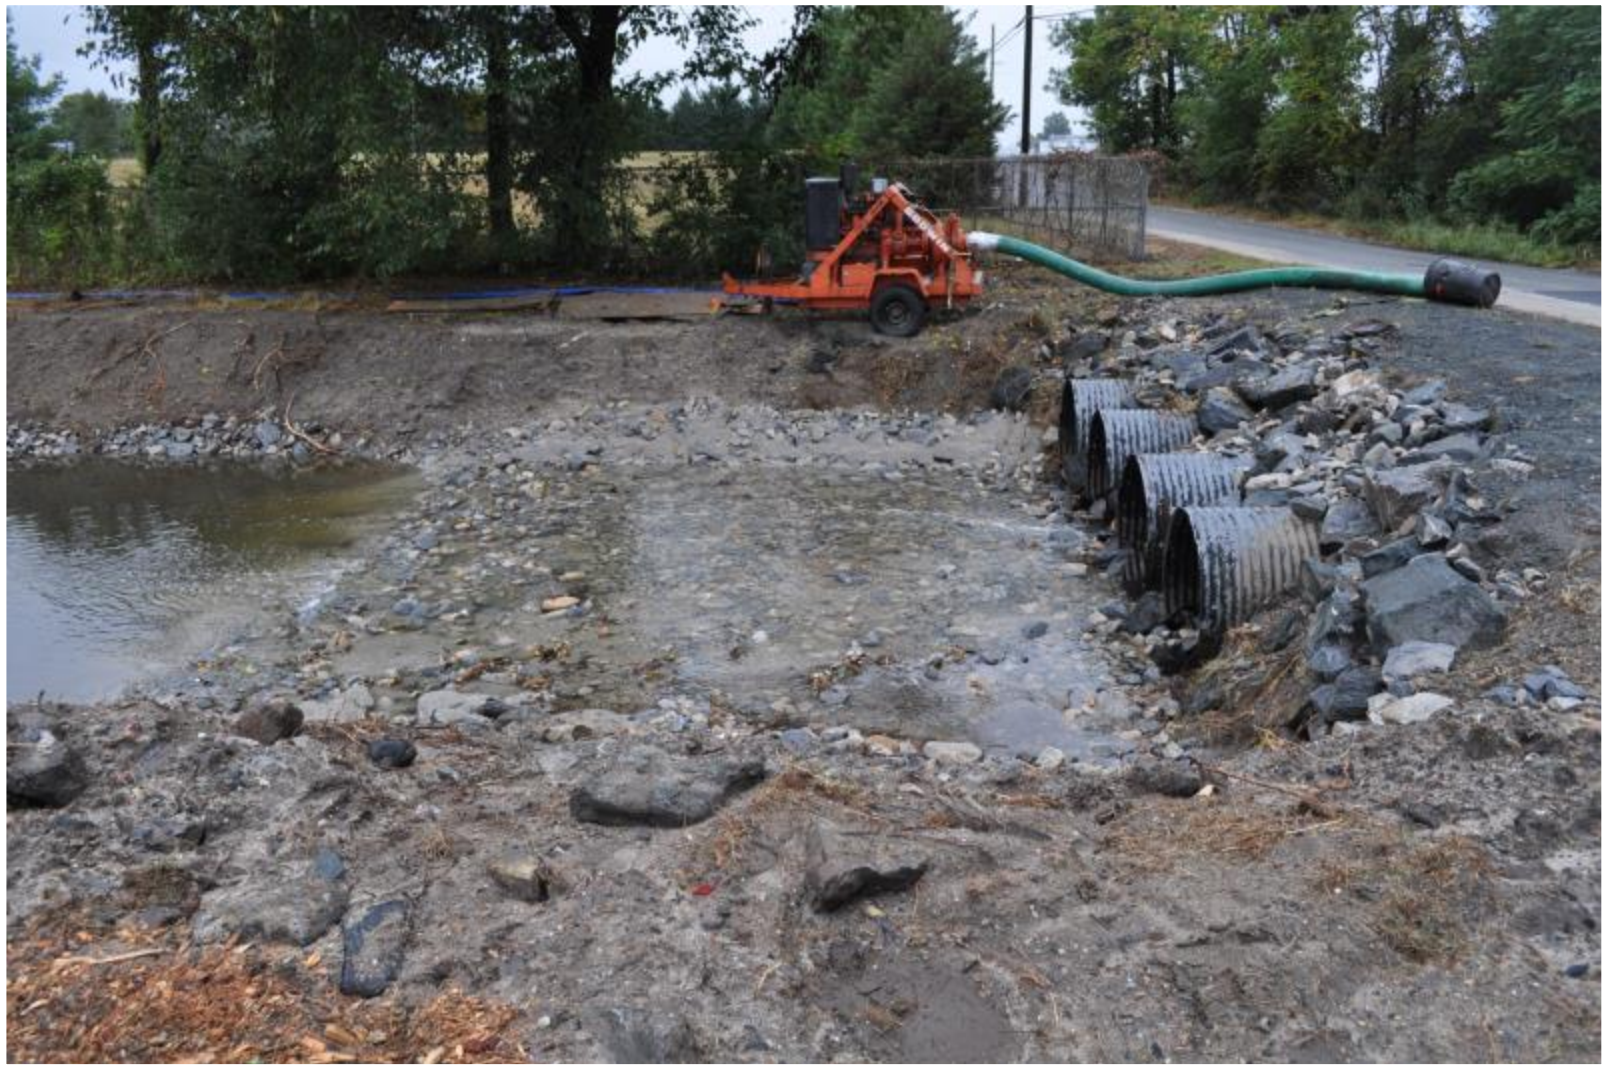
Bridgeville Branch Tax Ditch

After – Protected Water Main

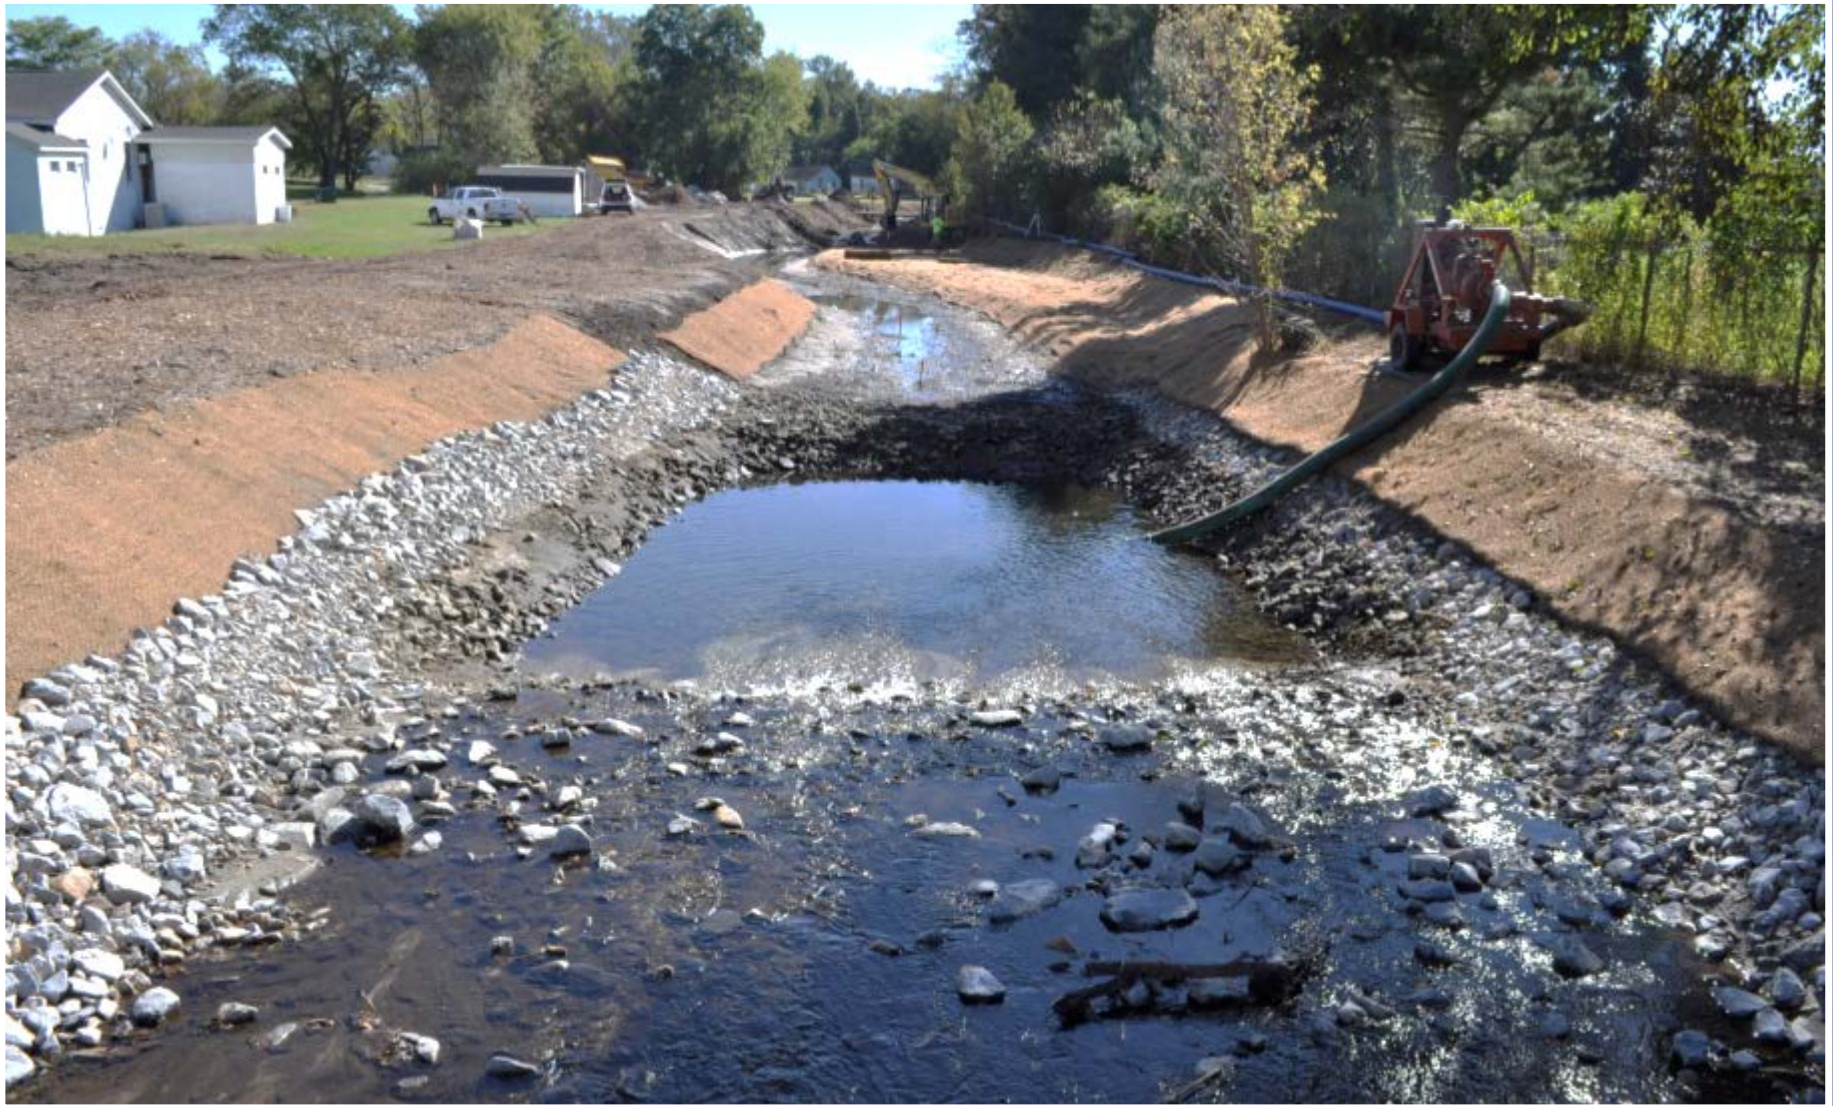
Bridgeville Branch Tax Ditch

During – Transformed Tax Ditch with Floodplain and Scour Protection

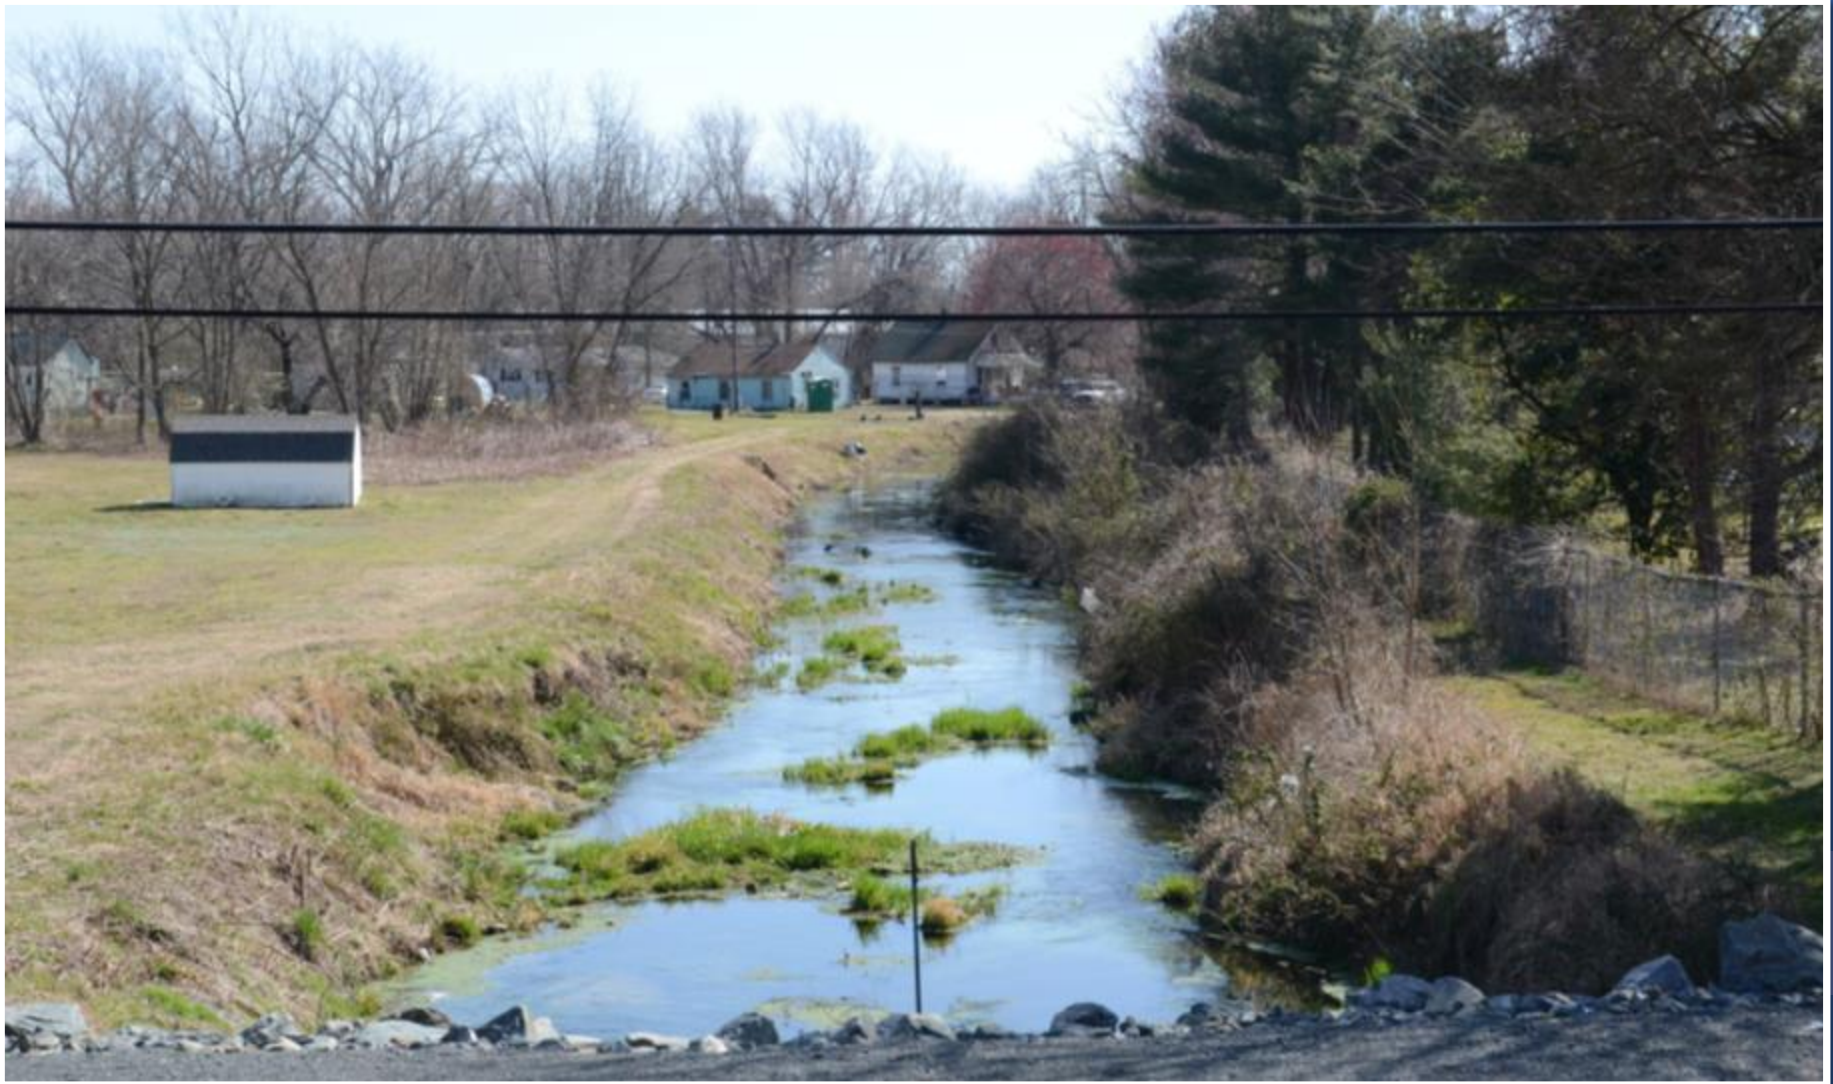
Bridgeville Branch Tax Ditch

Before – Traditional “Ditch” with 1:1 Side Slopes and Culvert Erosion

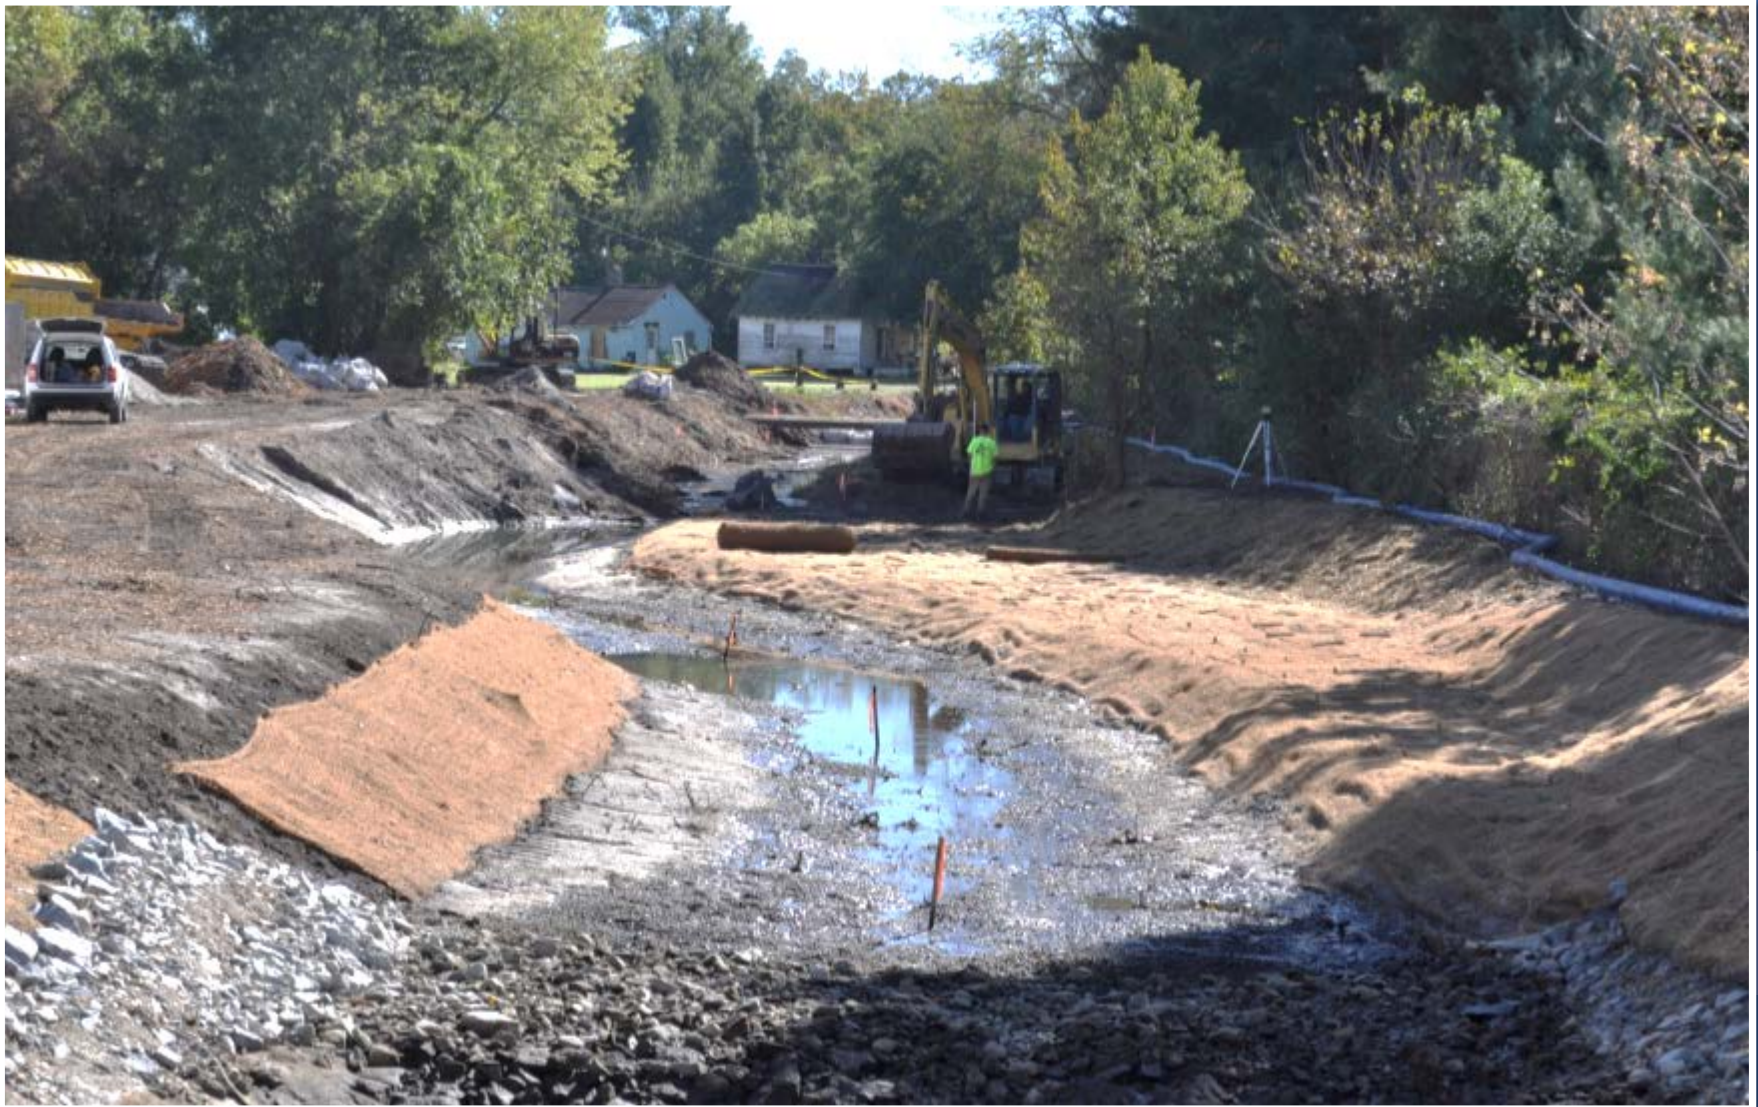
Bridgeville Branch Tax Ditch

During – Transformed Tax Ditch with Floodplain and Riffles/Pools

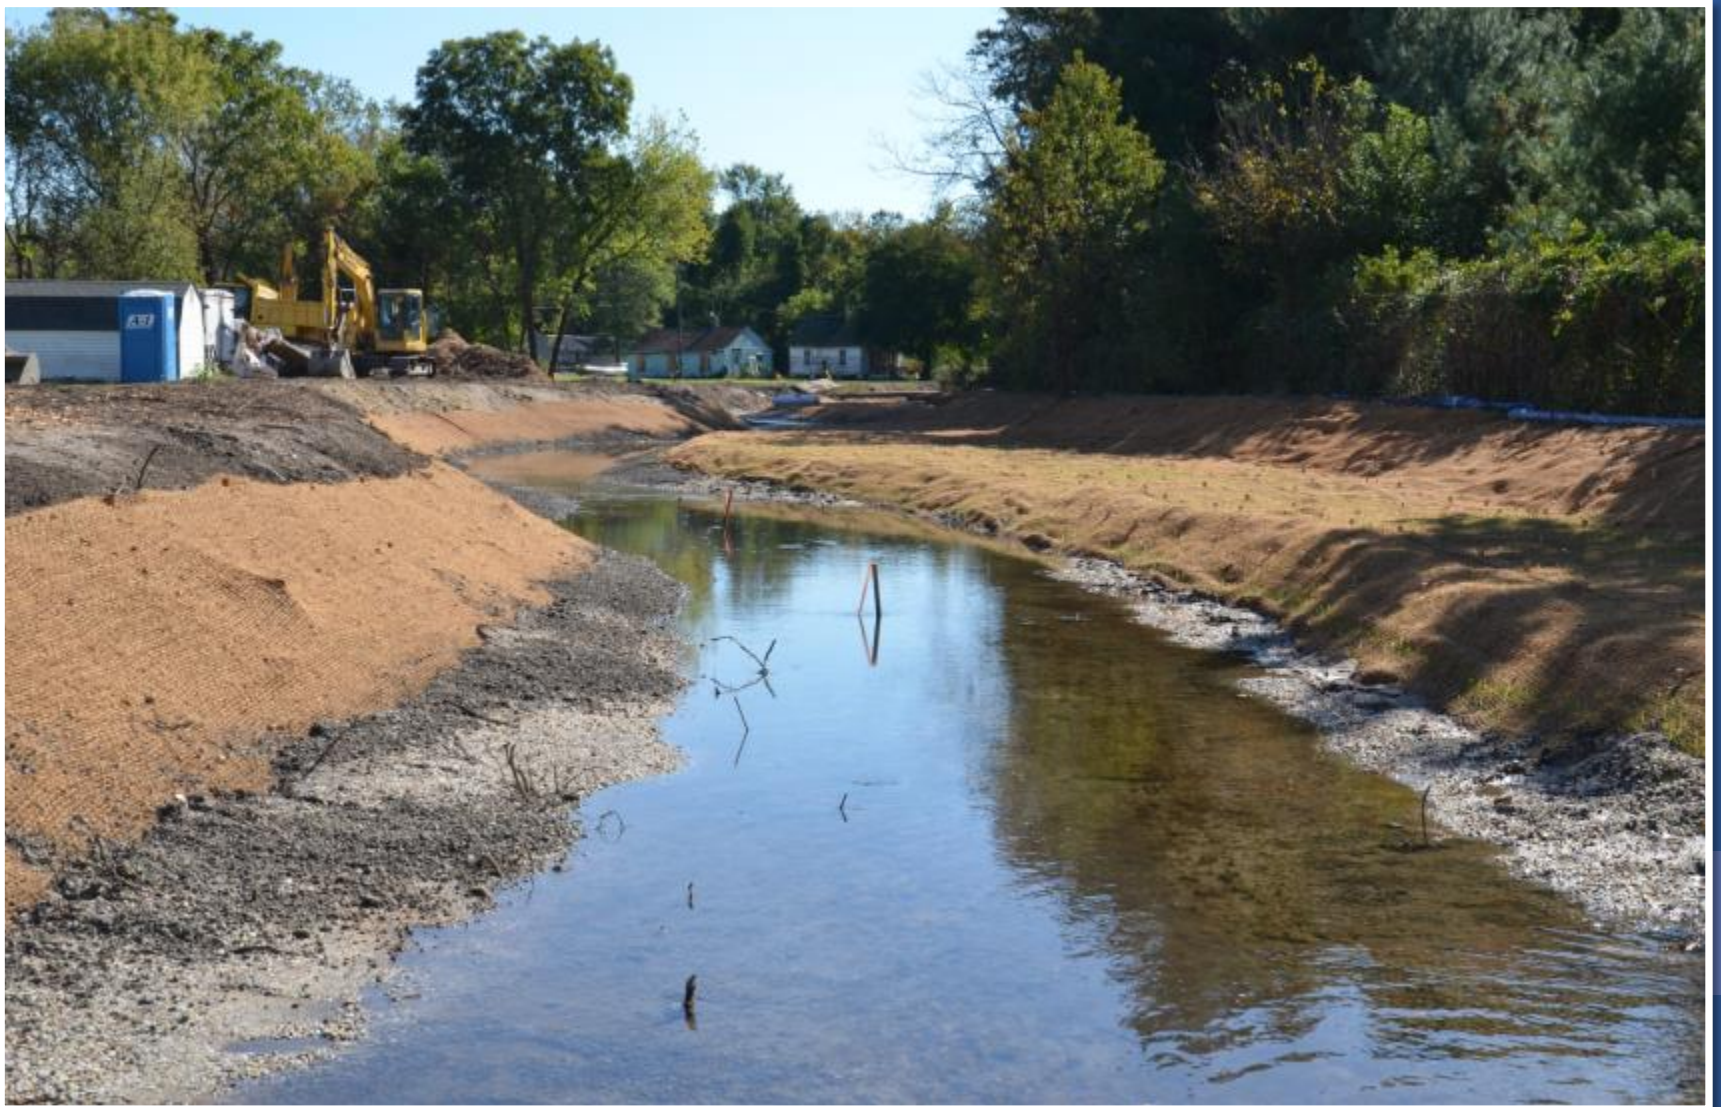
Bridgeville Branch Tax Ditch

During – Transformed Tax Ditch with Floodplain and Riffles/Pools
