Not Your Father's Tax Ditch

*Enhancing Delaware's Drainage Network Through the
Use of Natural Channel Design Techniques*

**Division of Watershed Stewardship
Drainage Program**

Presented at the National Conference on Ecological Restoration
April 21, 2016
Presented by: Brooks Cahall, Drainage Program Manager
Co-Authors: Matthew Grabowski, Sara Esposito P.E.

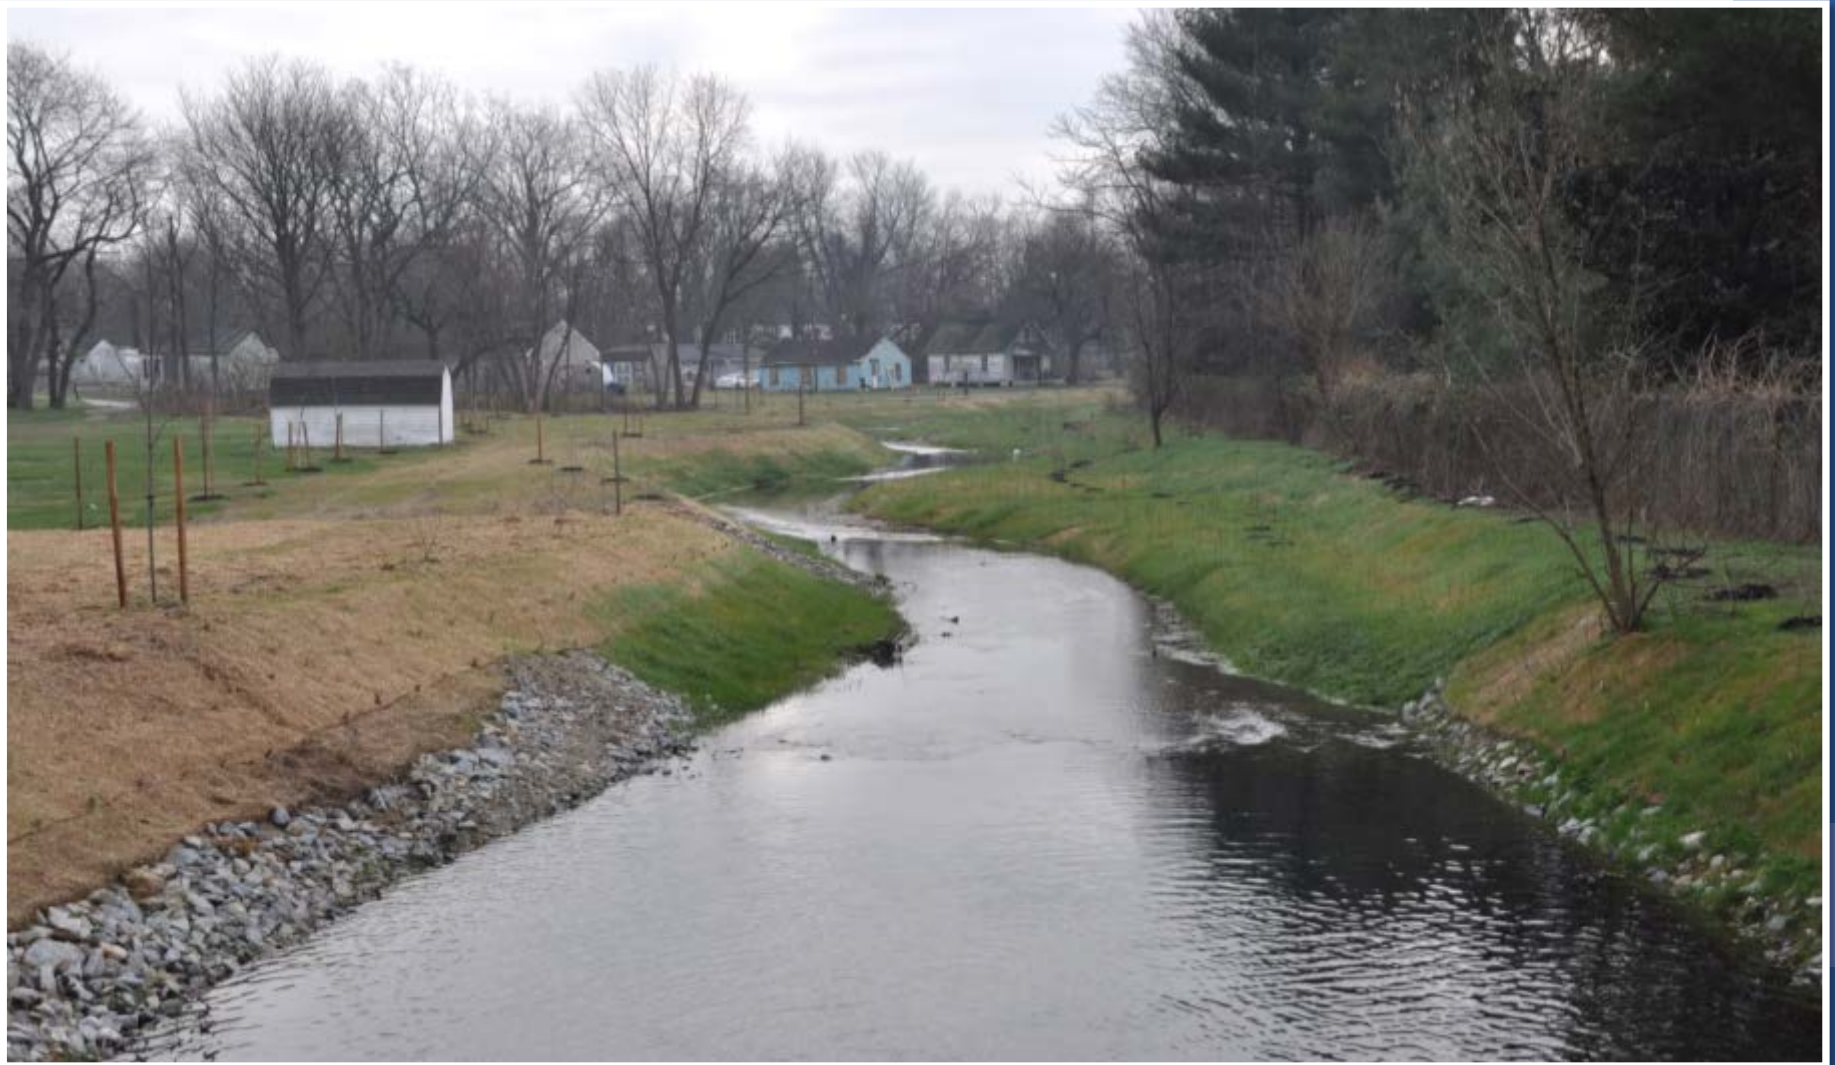
Bridgeville Branch Tax Ditch

After – Transformed Tax Ditch with Floodplain and Riffles/Pools

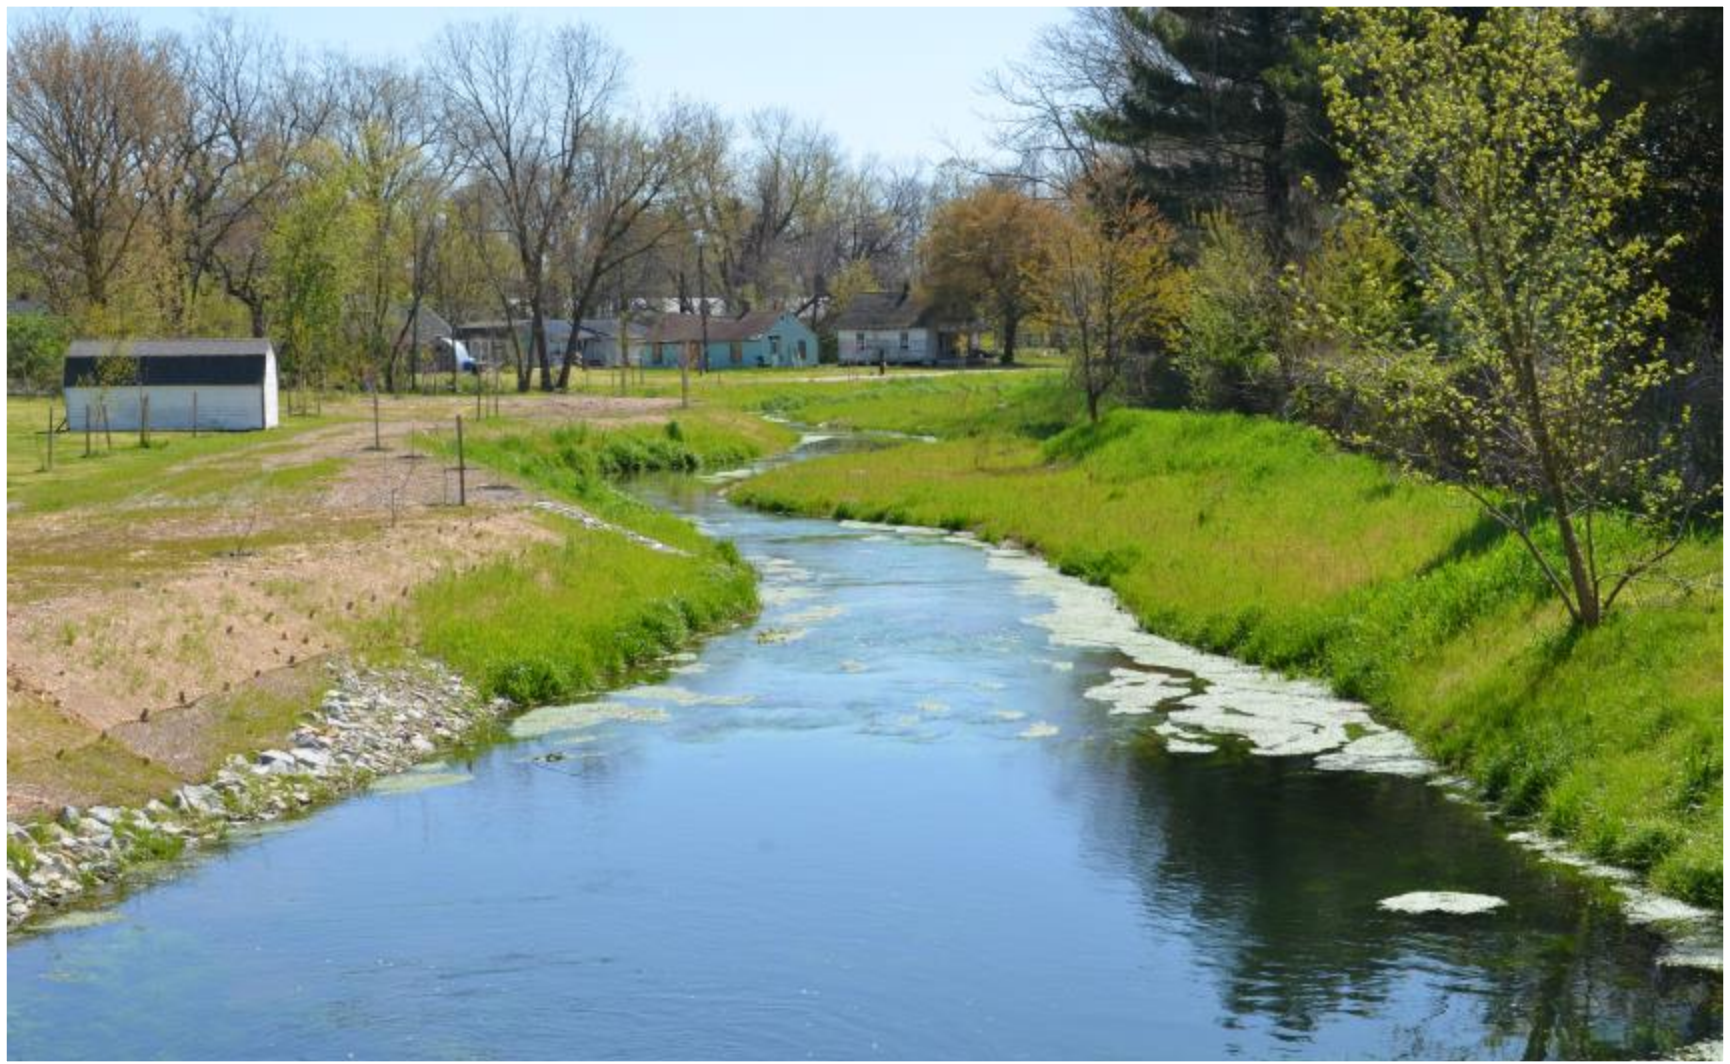
Bridgeville Branch Tax Ditch

After – Transformed Tax Ditch with Floodplain and Riffles/Pools

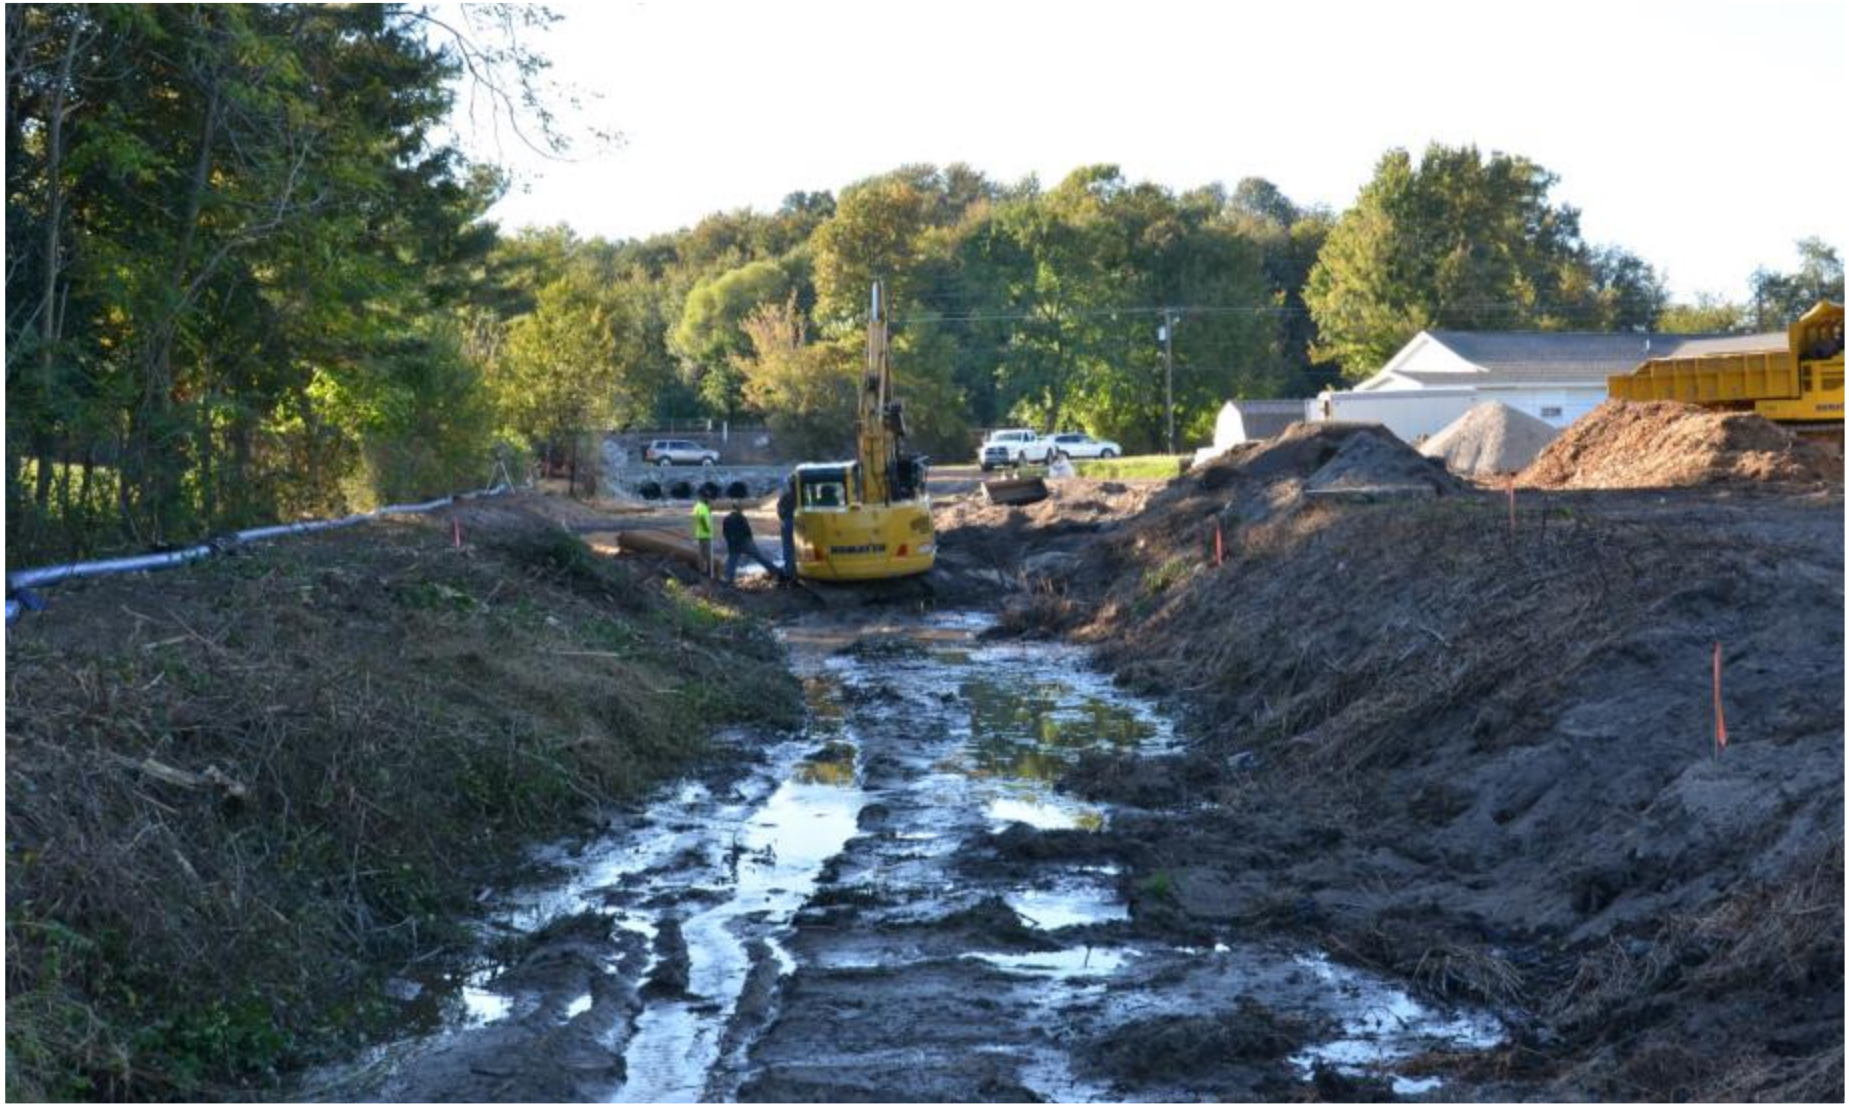
Bridgeville Branch Tax Ditch

Before – Traditional “Ditch” with 1:1 side slopes

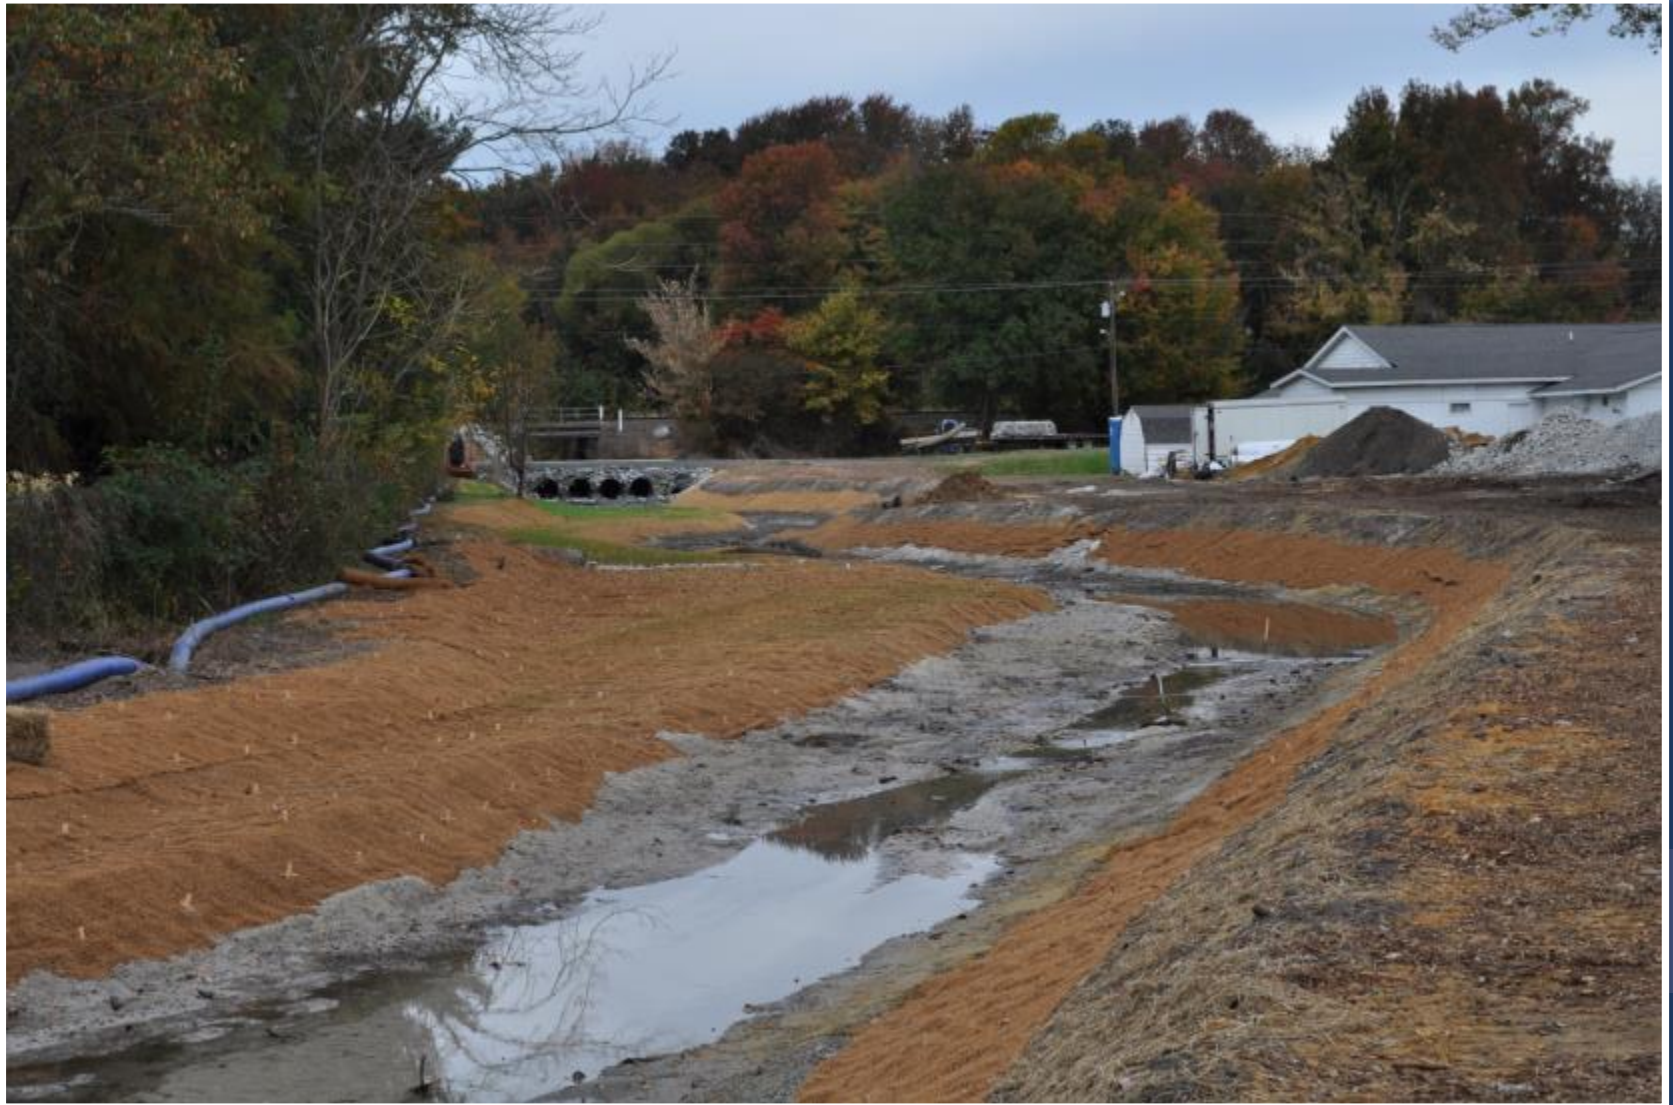
Bridgeville Branch Tax Ditch

During – Transformed Tax Ditch with Floodplain and Riffles/Pools

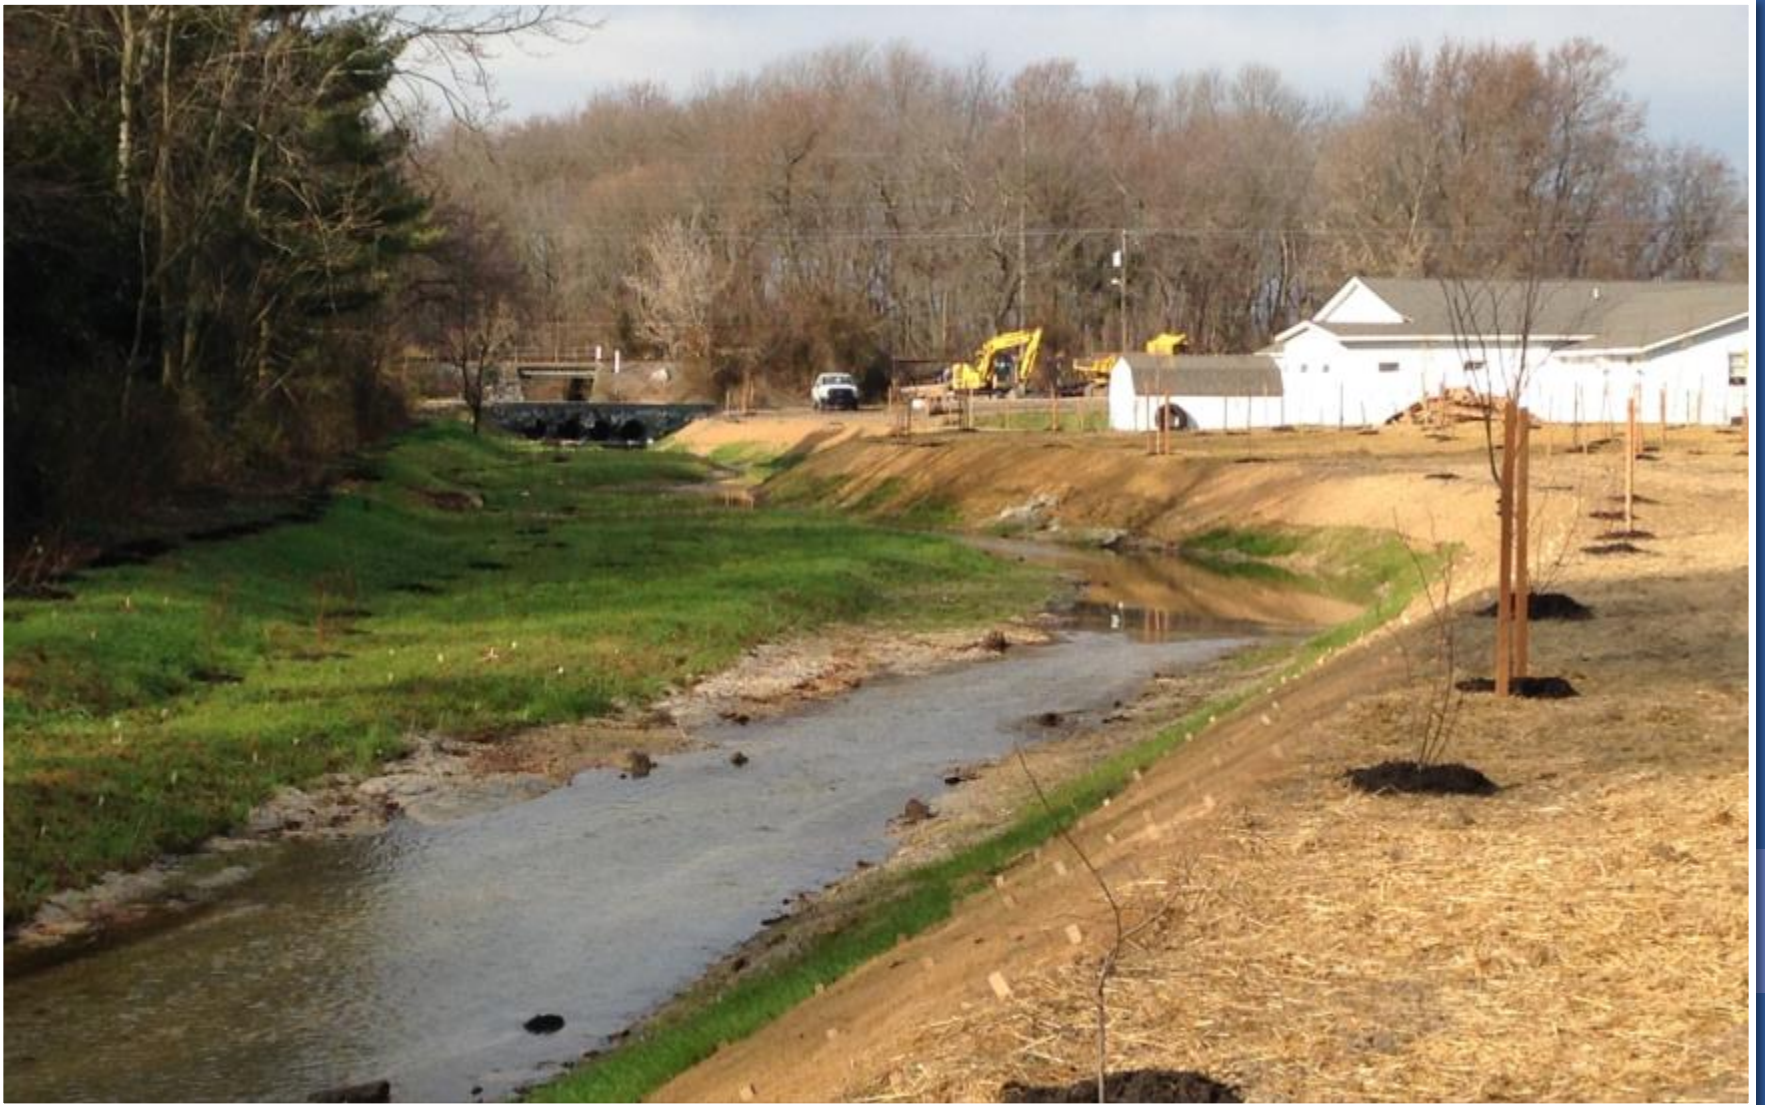
Bridgeville Branch Tax Ditch

After – Transformed Tax Ditch with Floodplain and Riffles/Pools

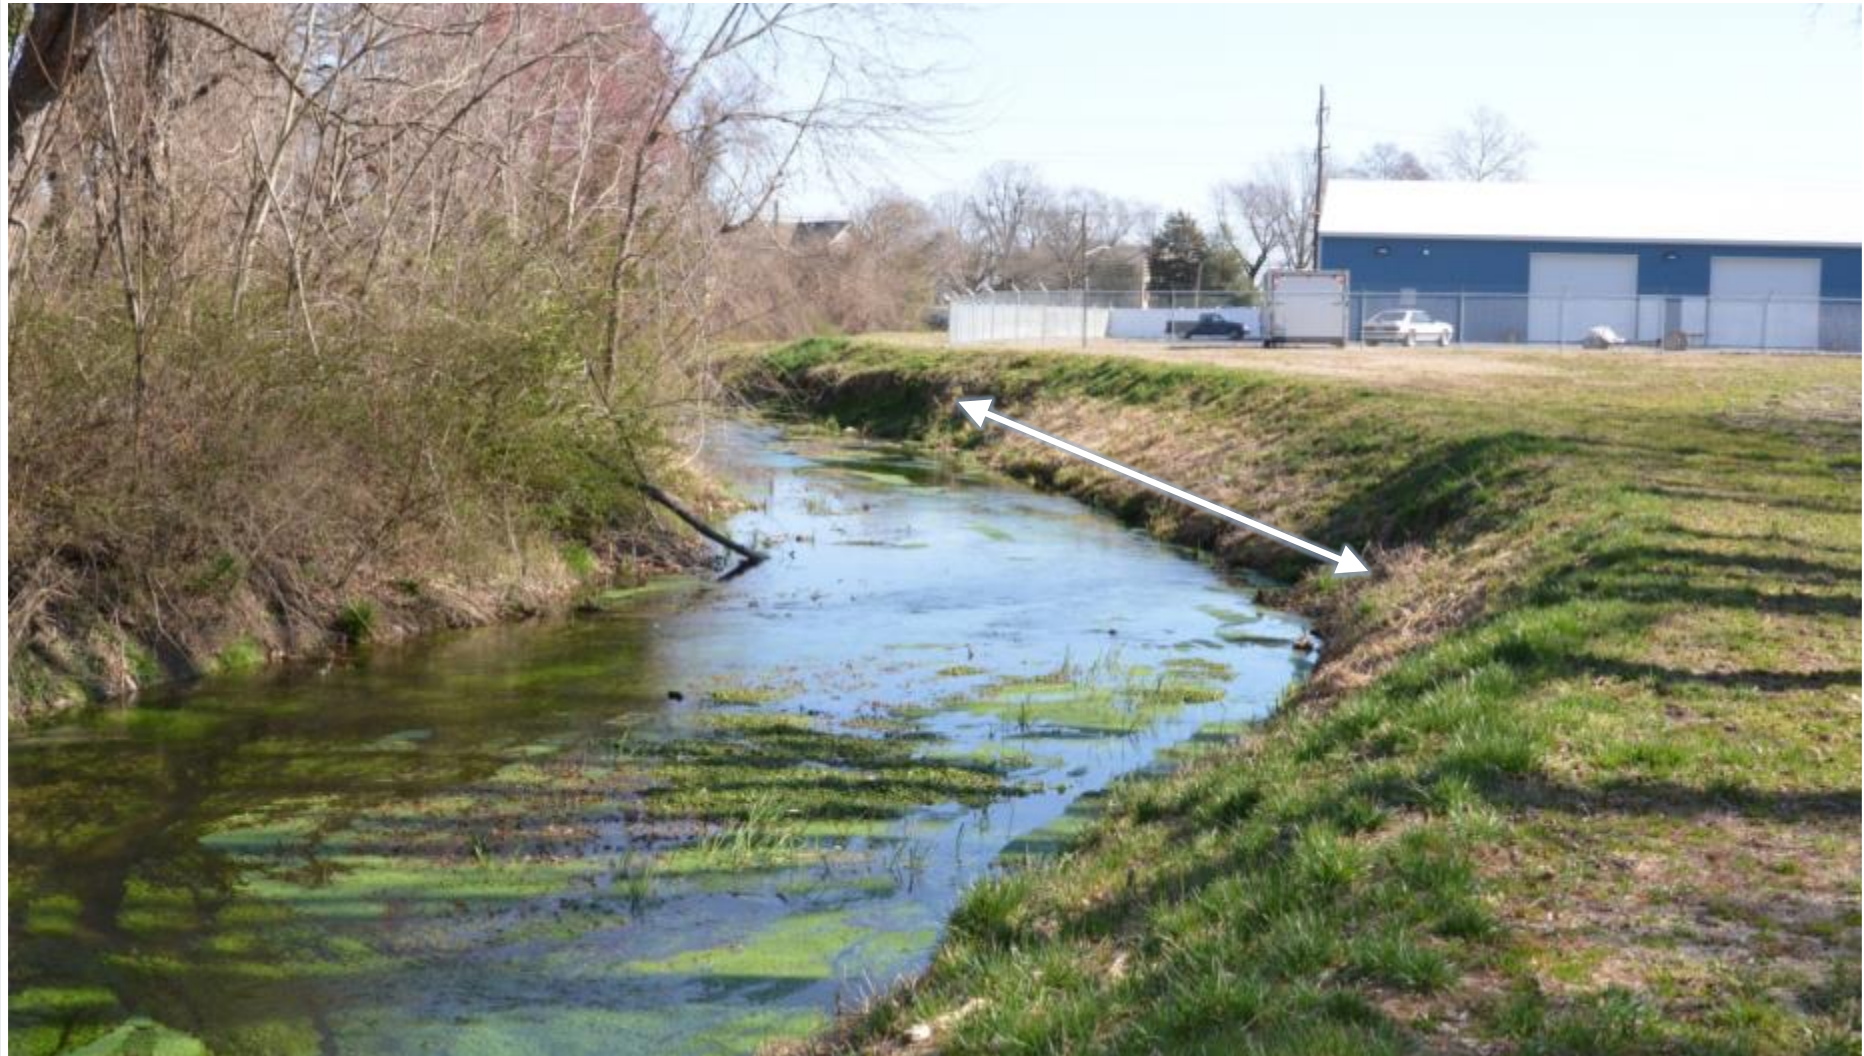
Bridgeville Branch Tax Ditch

Before – Scour Around Bend Jeopardizing Sewer Main

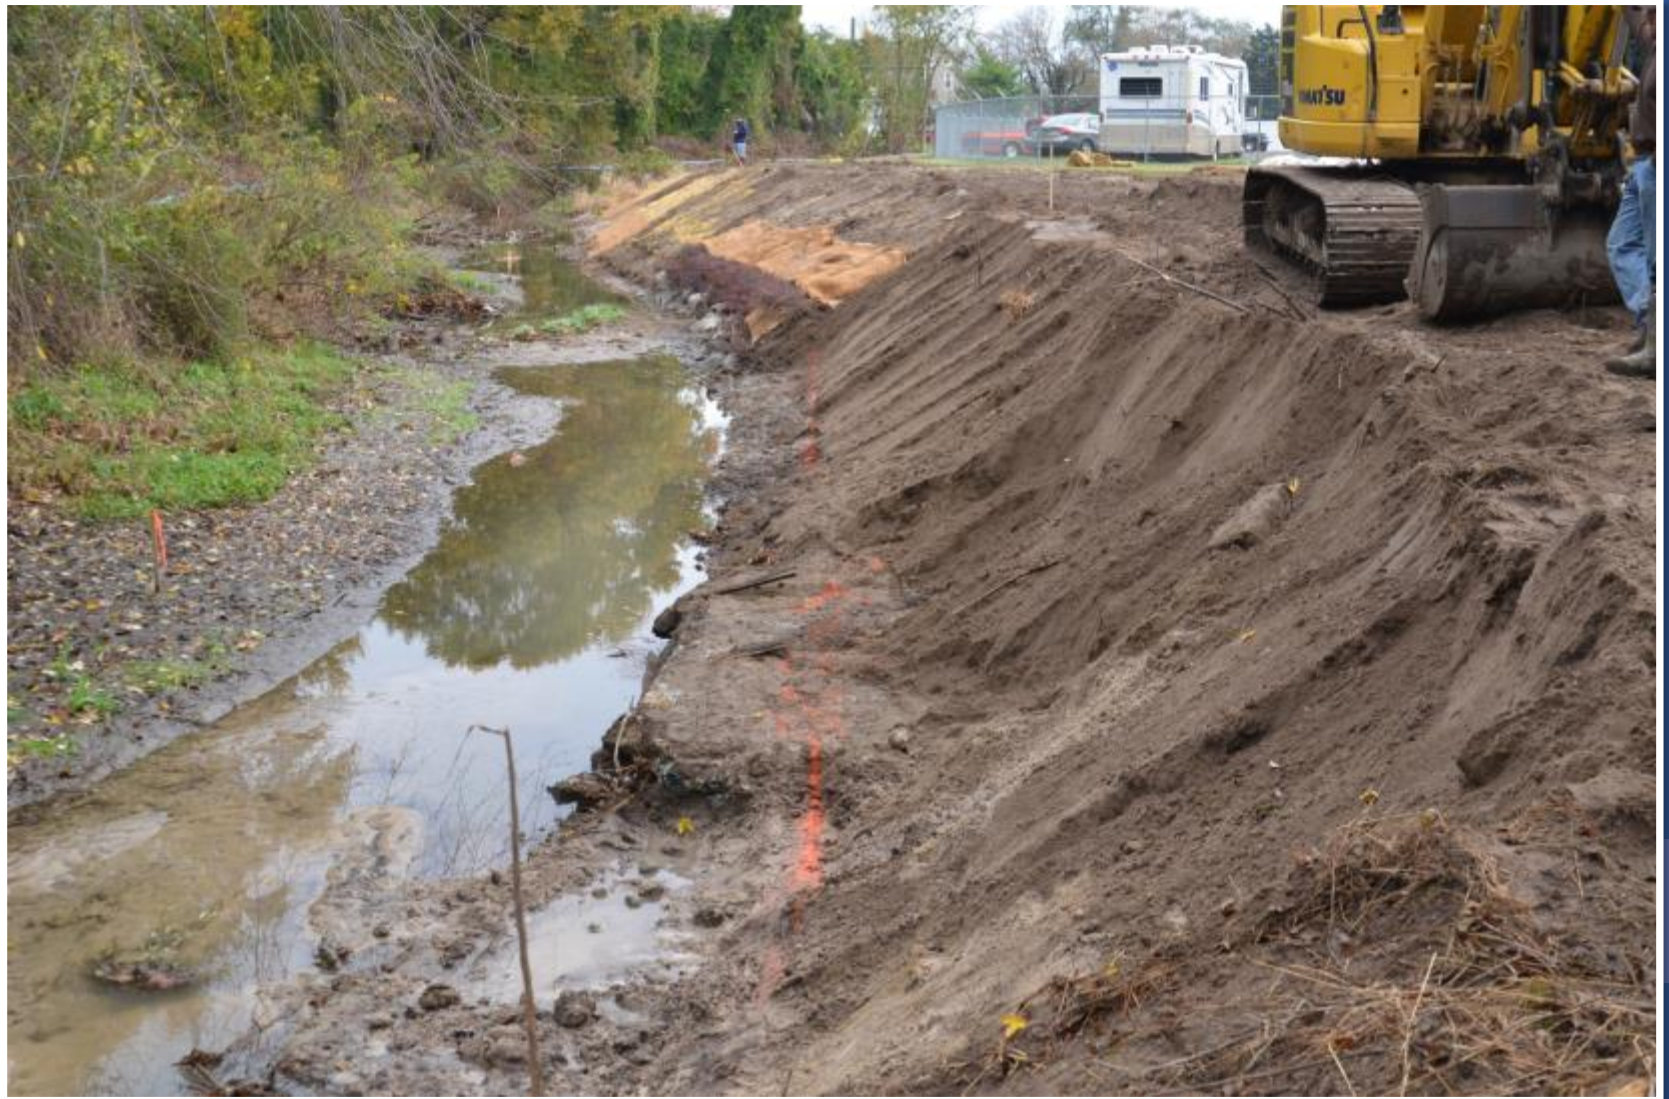
Bridgeville Branch Tax Ditch

During – Soil Lift and Live Layering

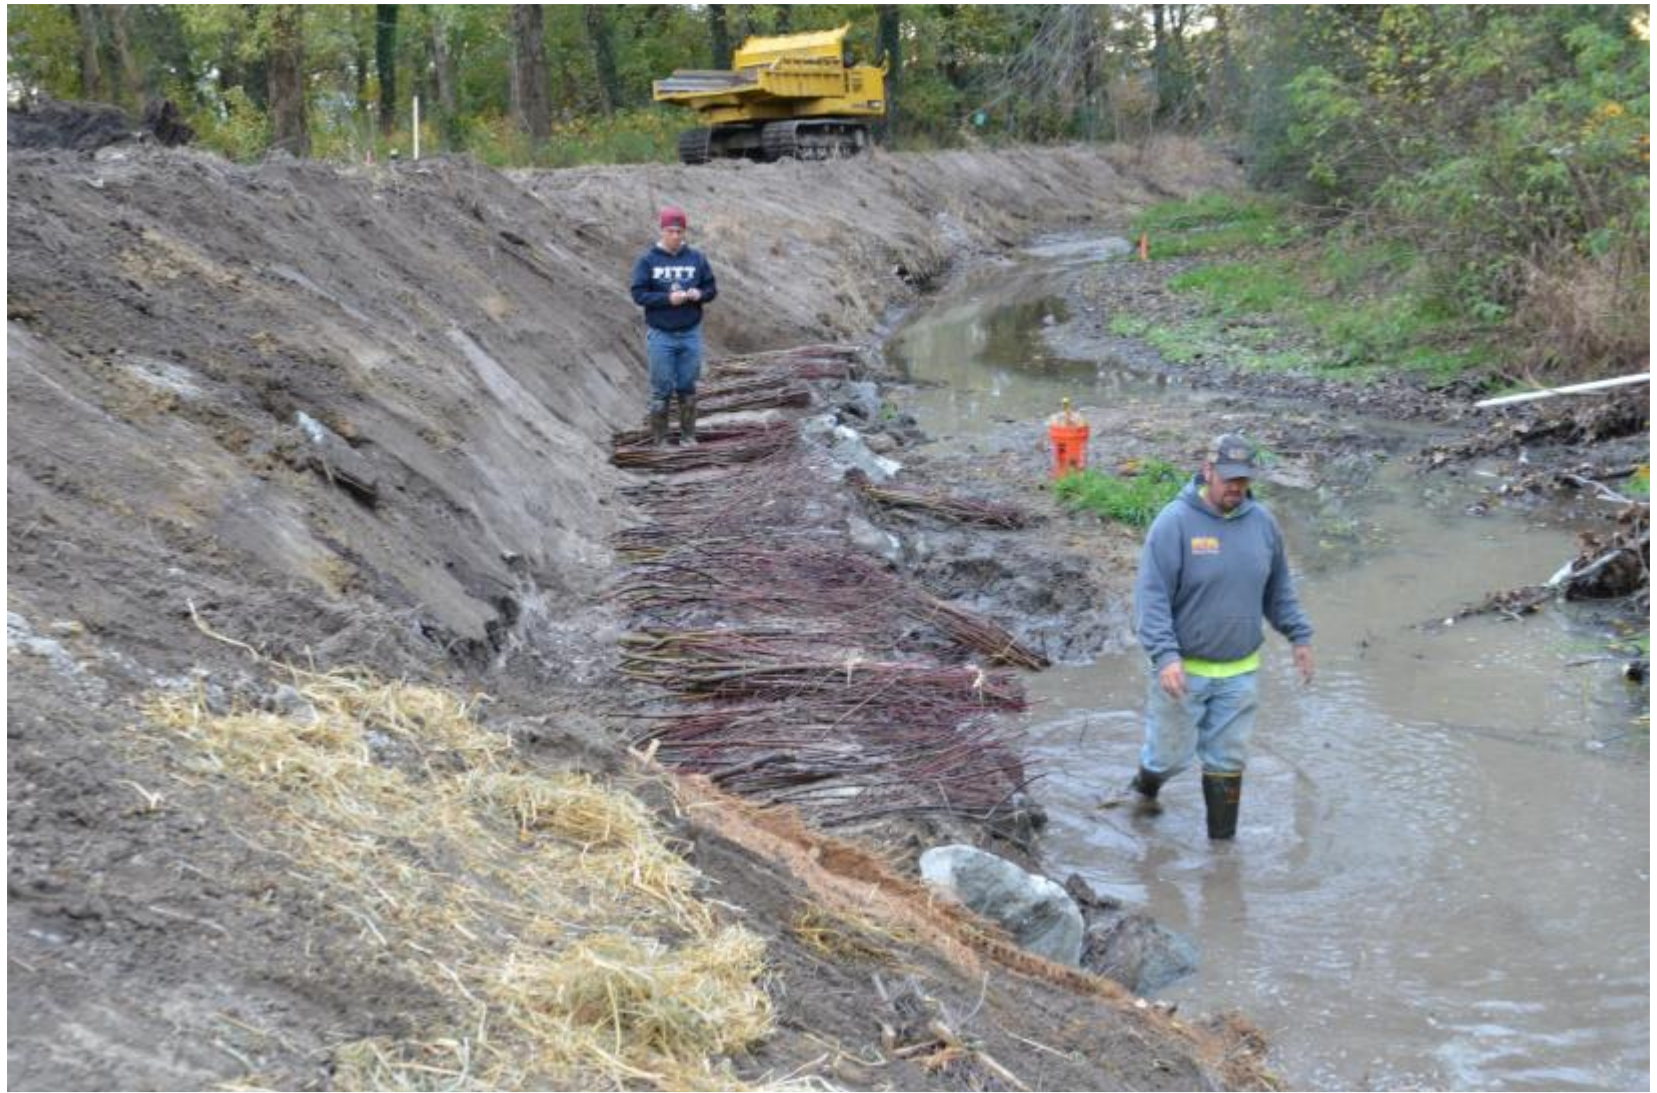
Bridgeville Branch Tax Ditch

During – Soil Lift and Live Layering

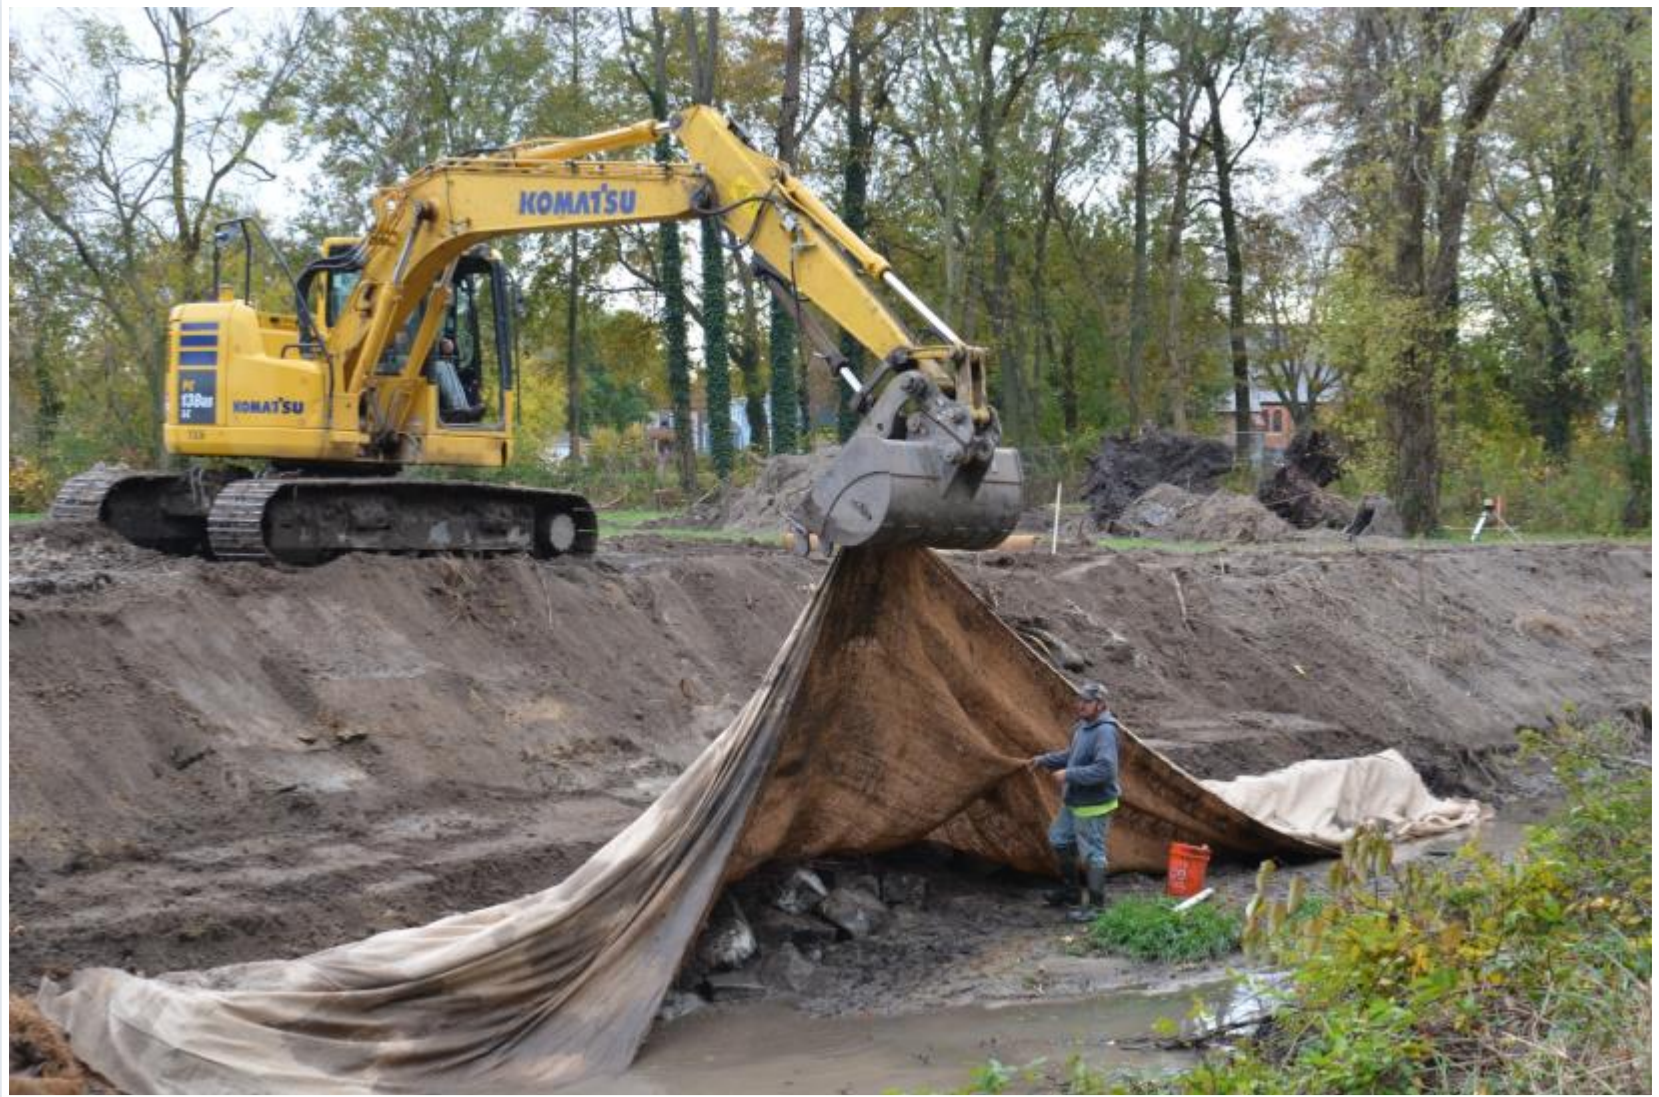
Bridgeville Branch Tax Ditch

During – Soil Lift and Live Layering

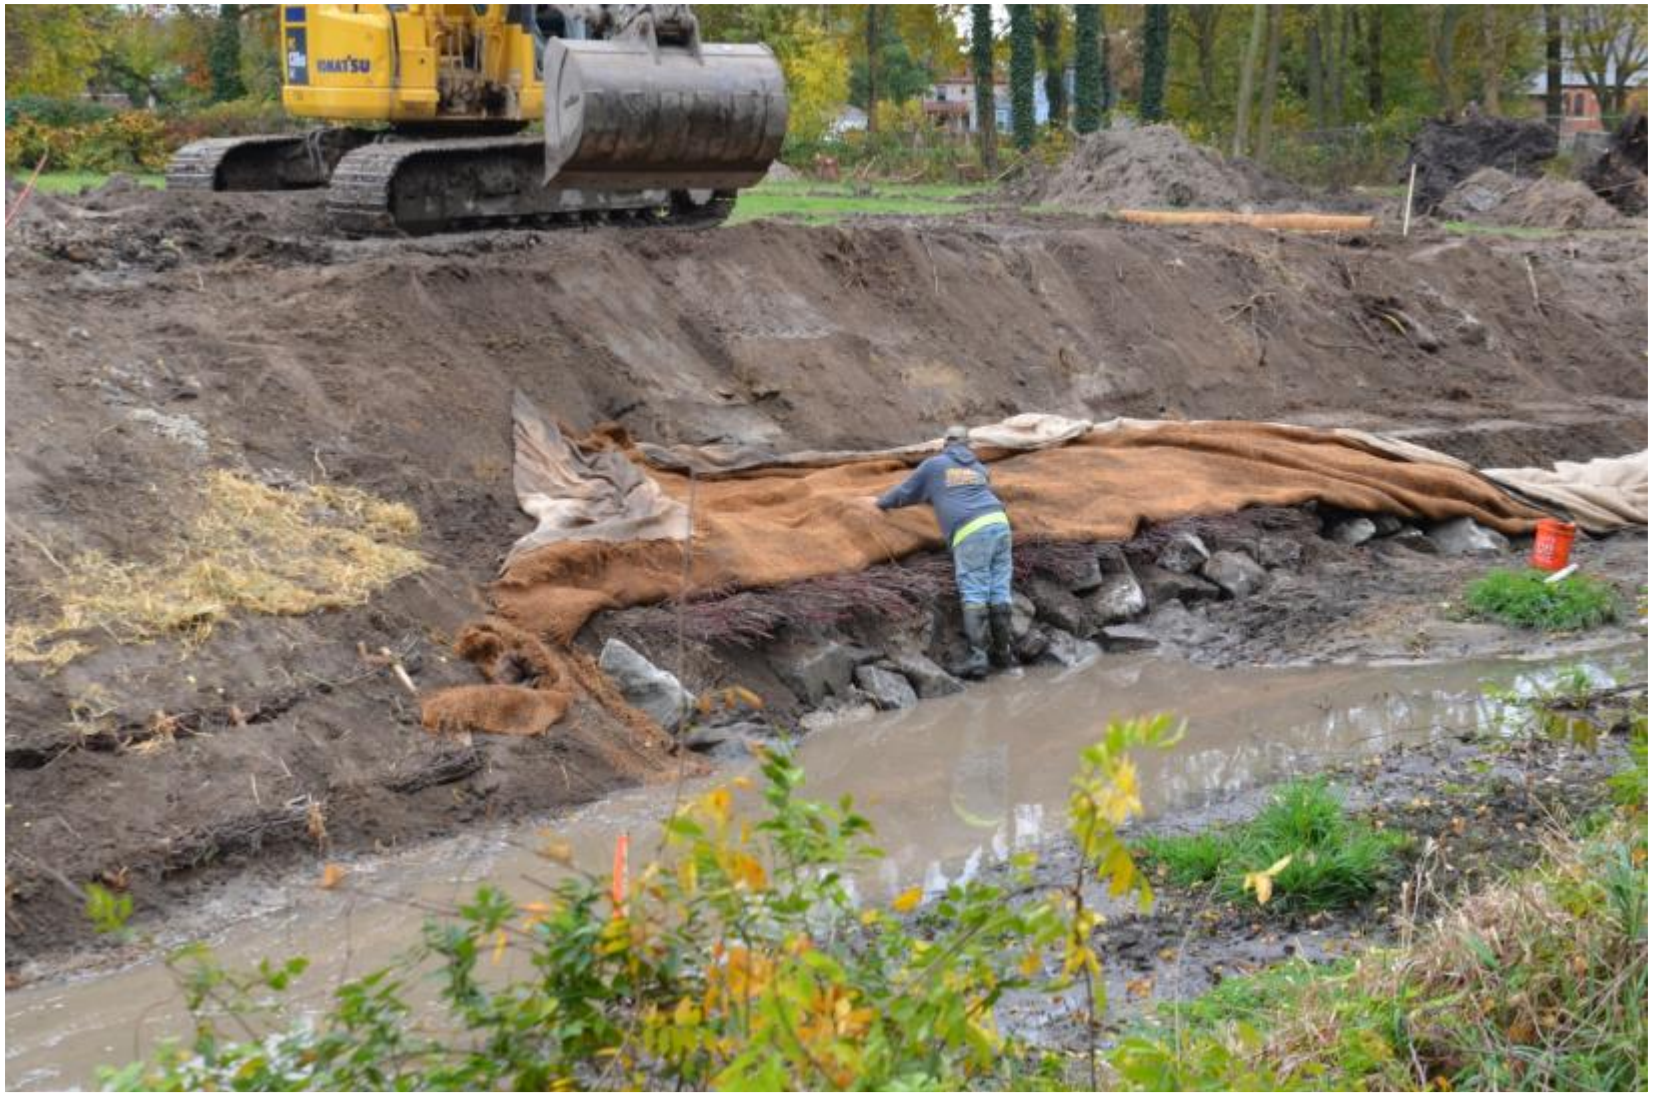
Bridgeville Branch Tax Ditch

During – Soil Lift and Live Layering

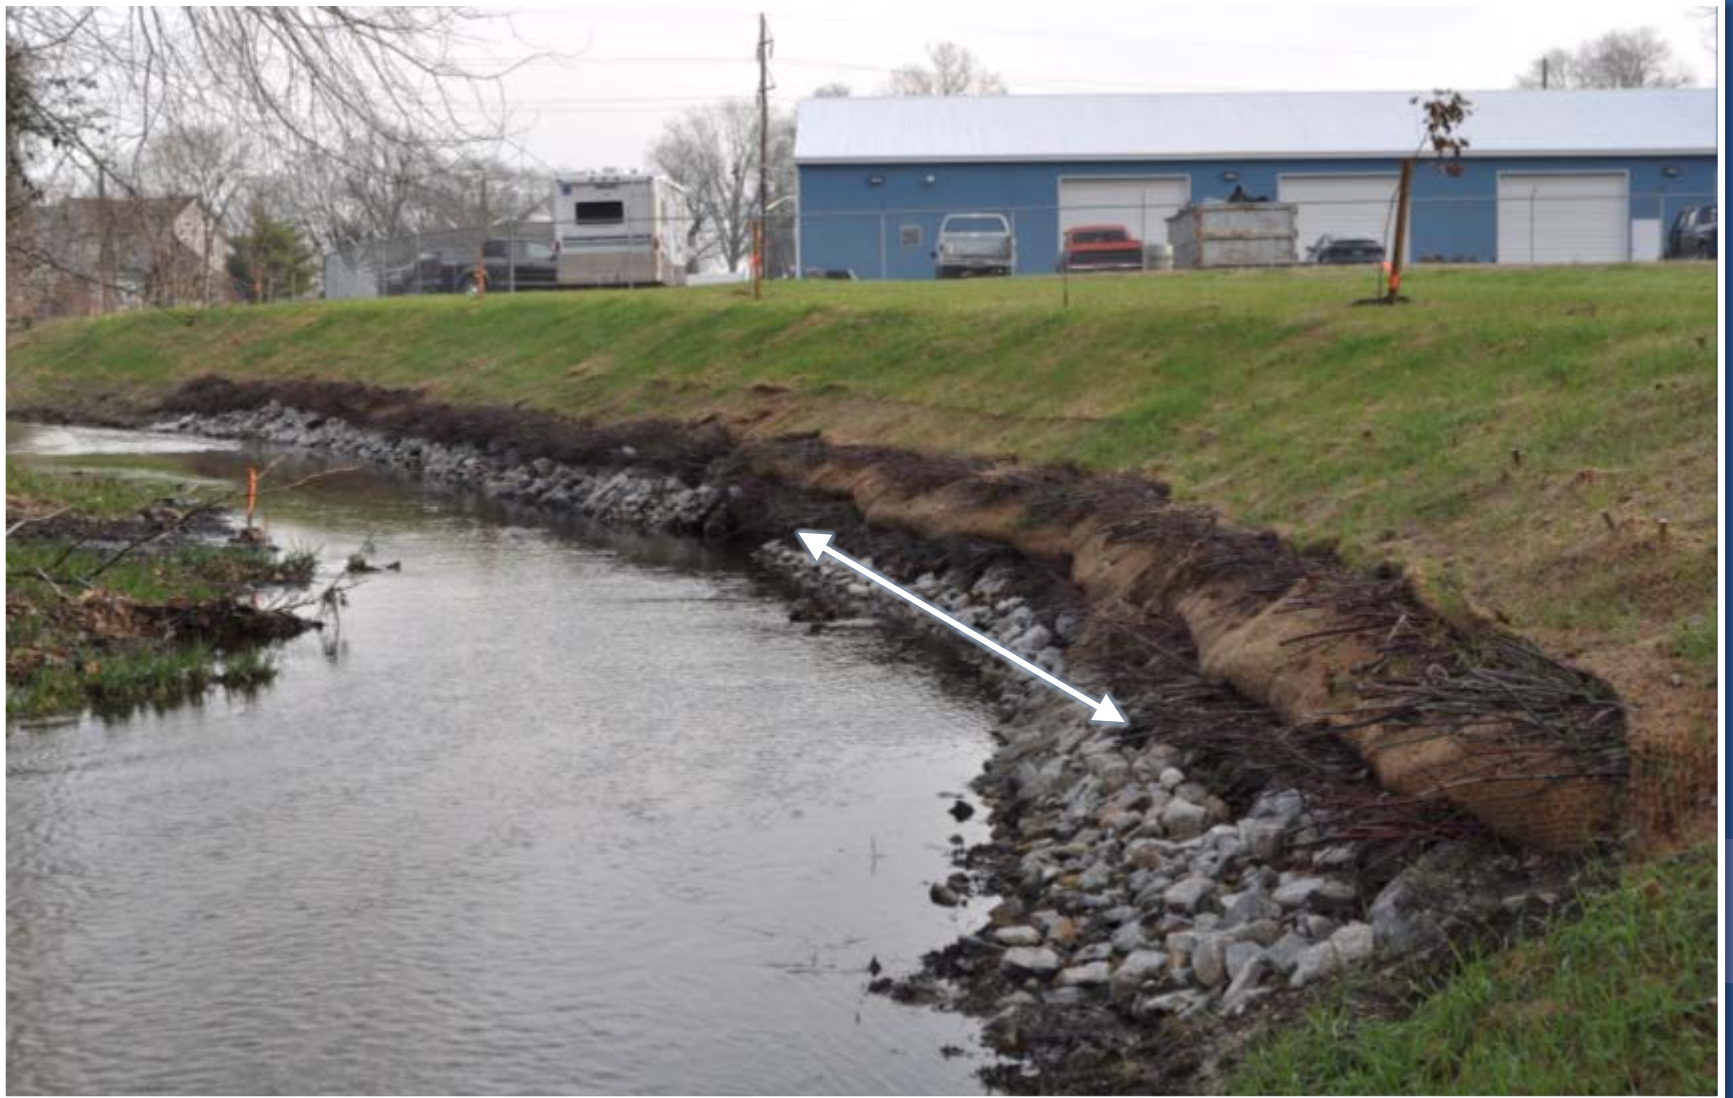
Bridgeville Branch Tax Ditch

After – Soil Lift and Live Layering

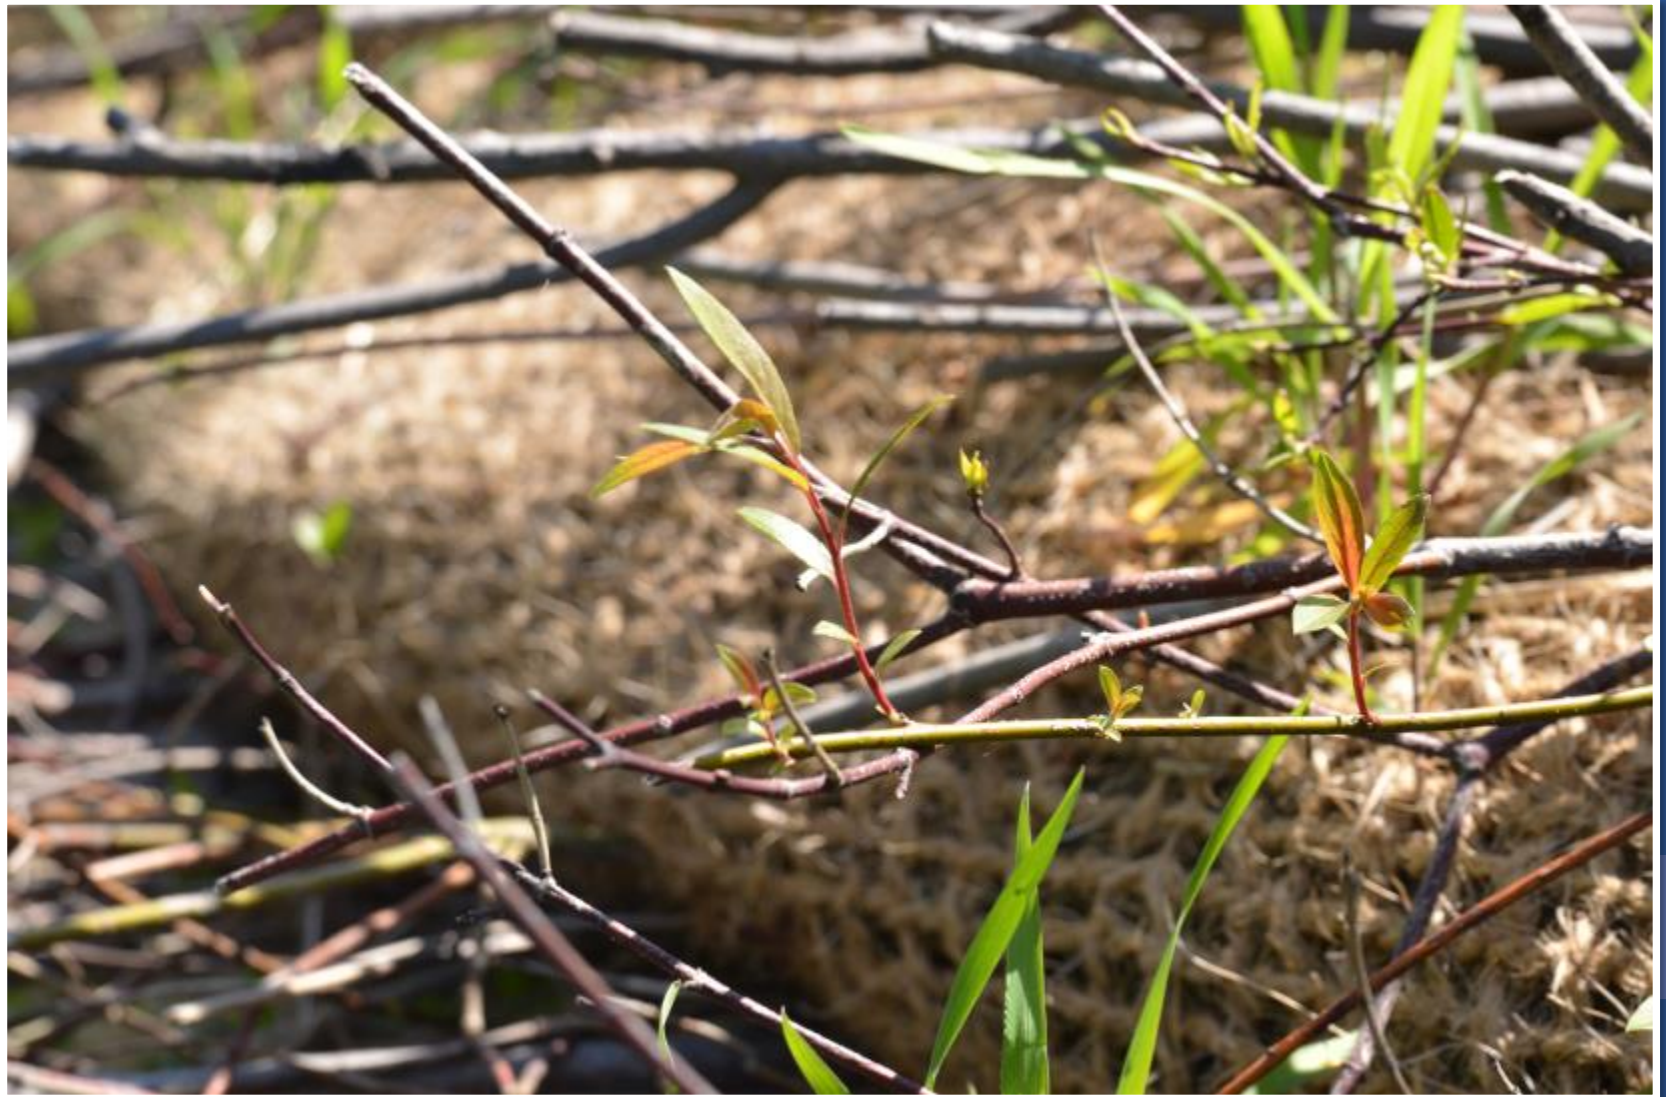
Bridgeville Branch Tax Ditch

After – Soil Lift and Live Layering
