Not Your Father's Tax Ditch

*Enhancing Delaware's Drainage Network Through the
Use of Natural Channel Design Techniques*

**Division of Watershed Stewardship
Drainage Program**

Presented at the National Conference on Ecological Restoration
April 21, 2016
Presented by: Brooks Cahall, Drainage Program Manager
Co-Authors: Matthew Grabowski, Sara Esposito P.E.

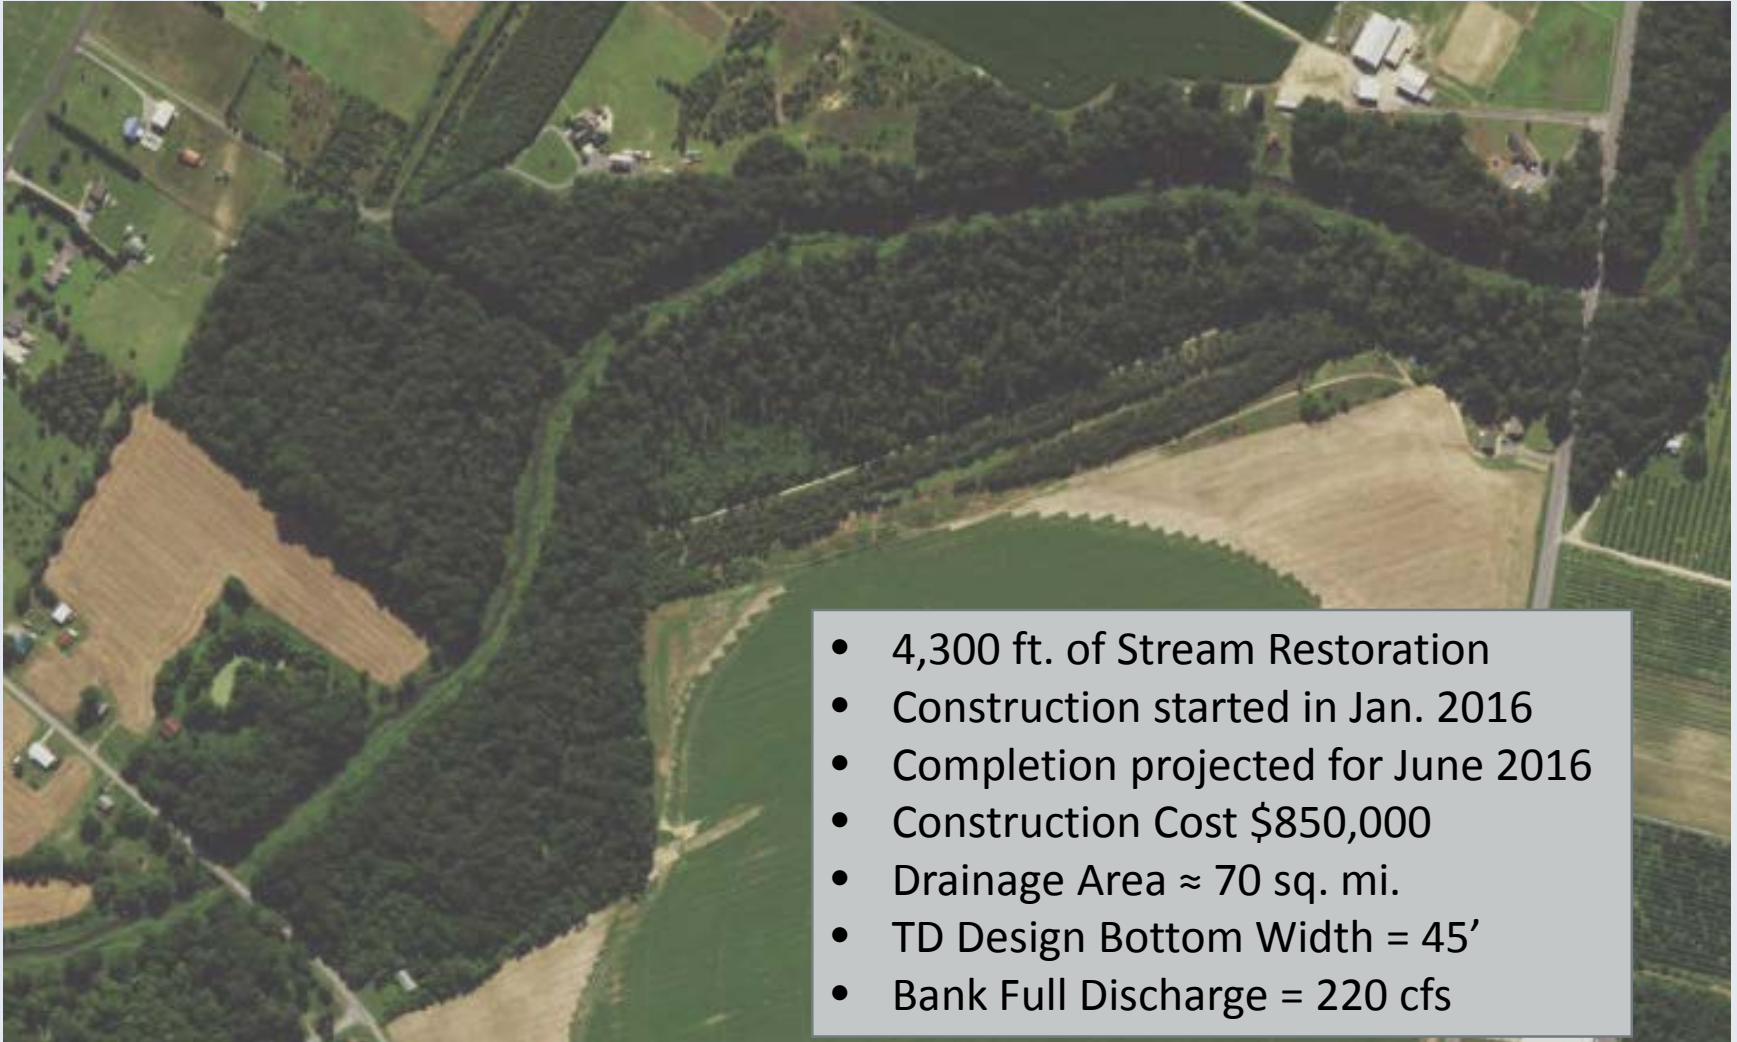
Nanticoke River Tax Ditch

Stream Restoration Project

- 4,300 ft. of Stream Restoration
- Construction started in Jan. 2016
- Completion projected for June 2016
- Construction Cost \$850,000
- Drainage Area \approx 70 sq. mi.
- TD Design Bottom Width = 45'
- Bank Full Discharge = 220 cfs

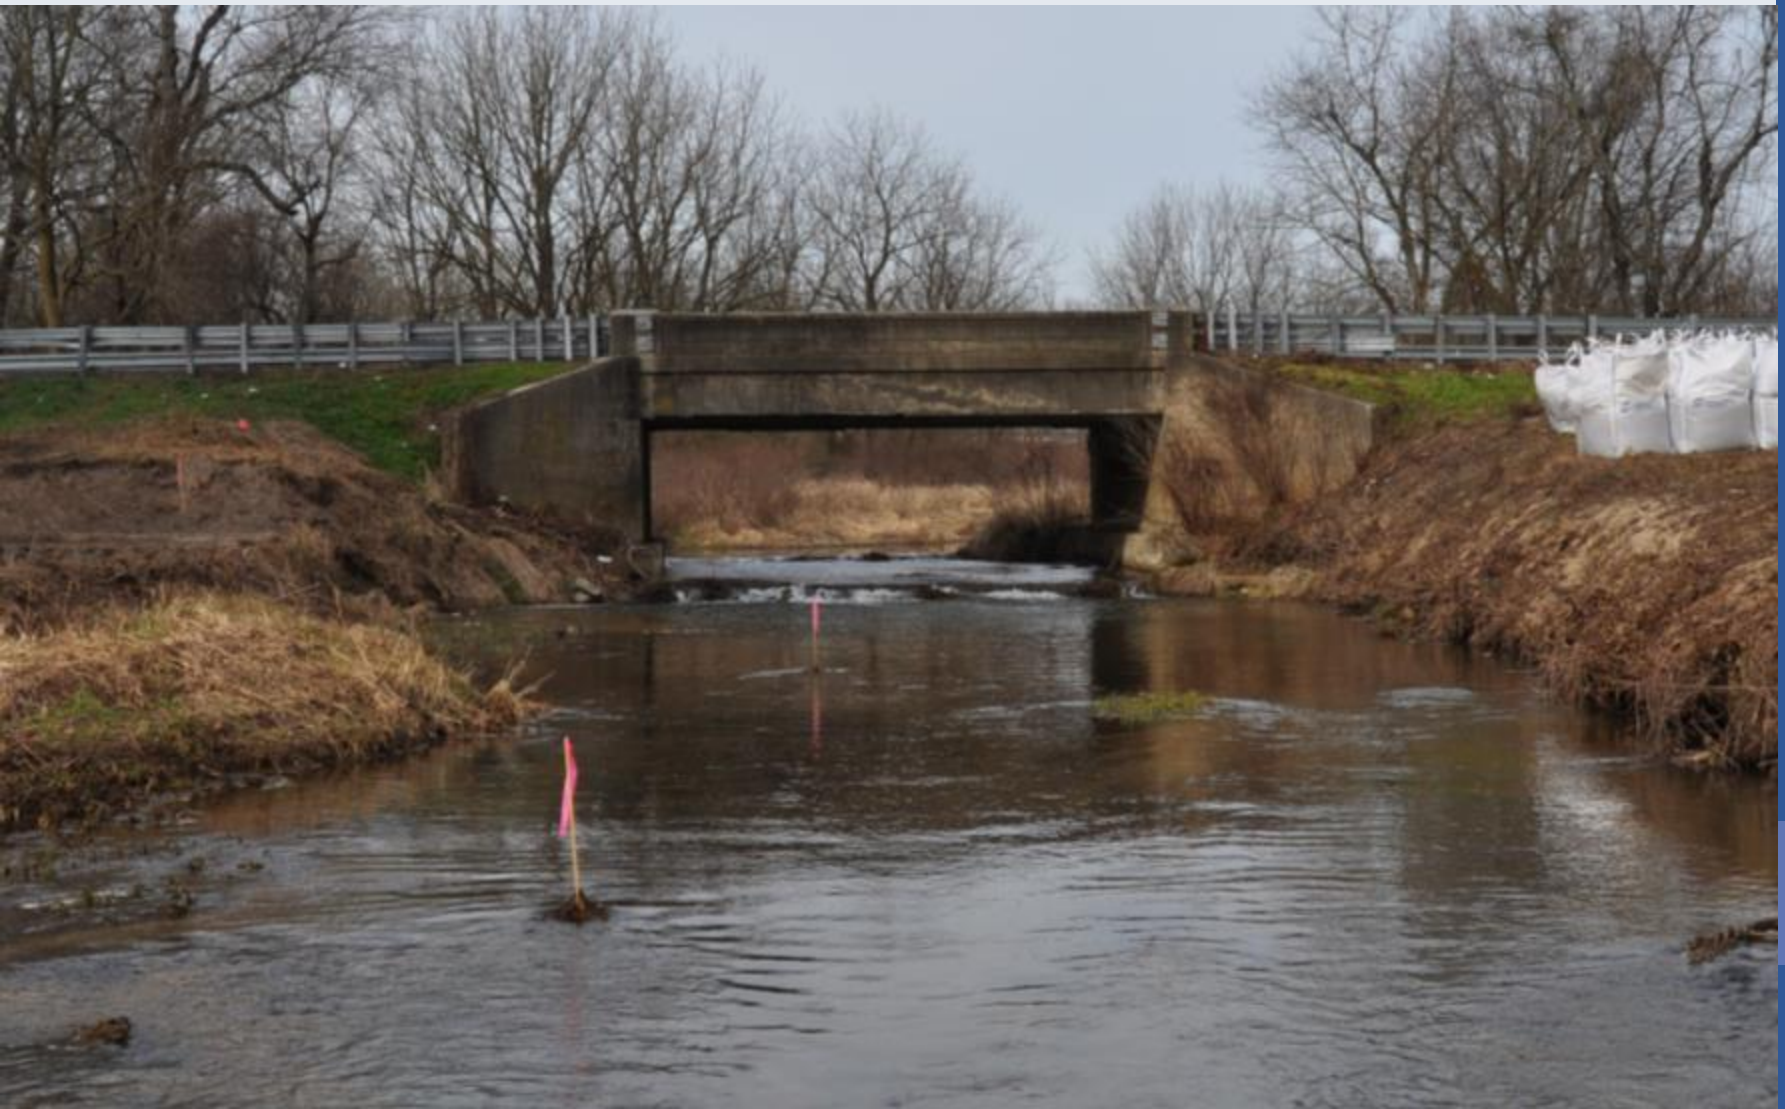
Nanticoke River Tax Ditch

Grade Control

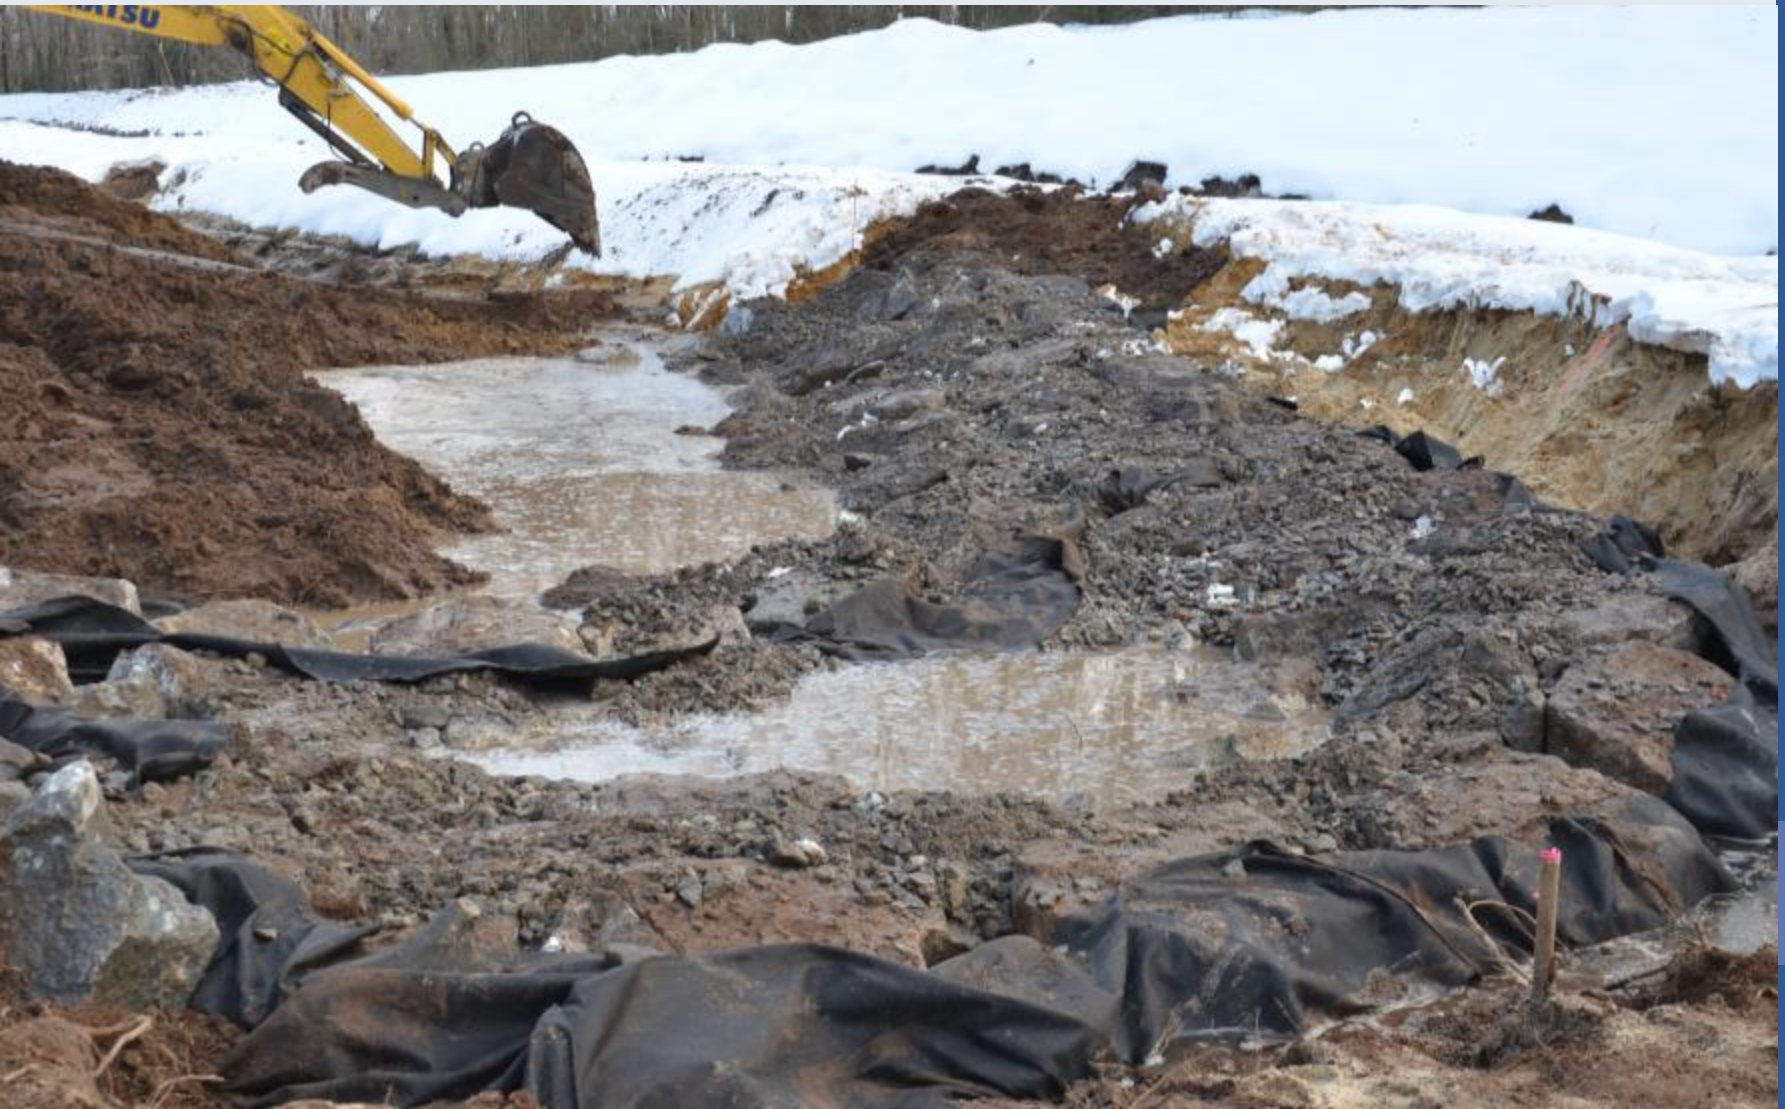
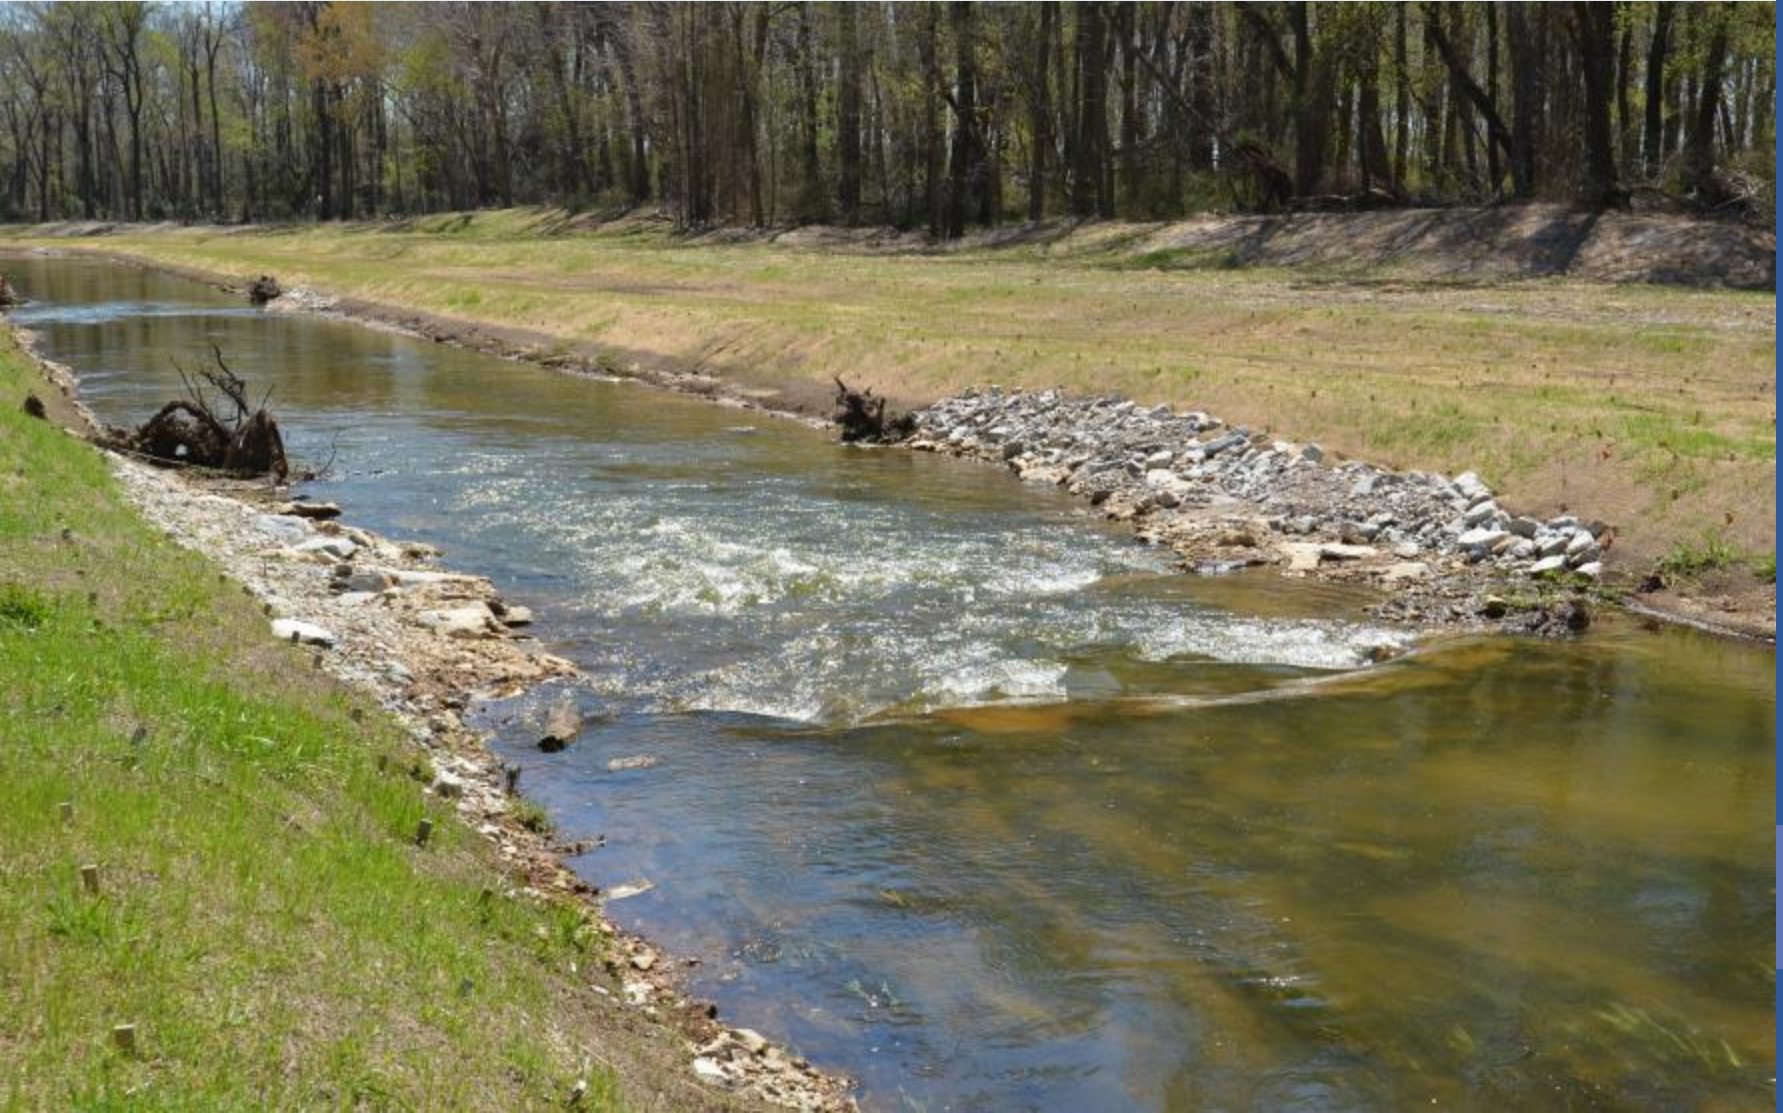
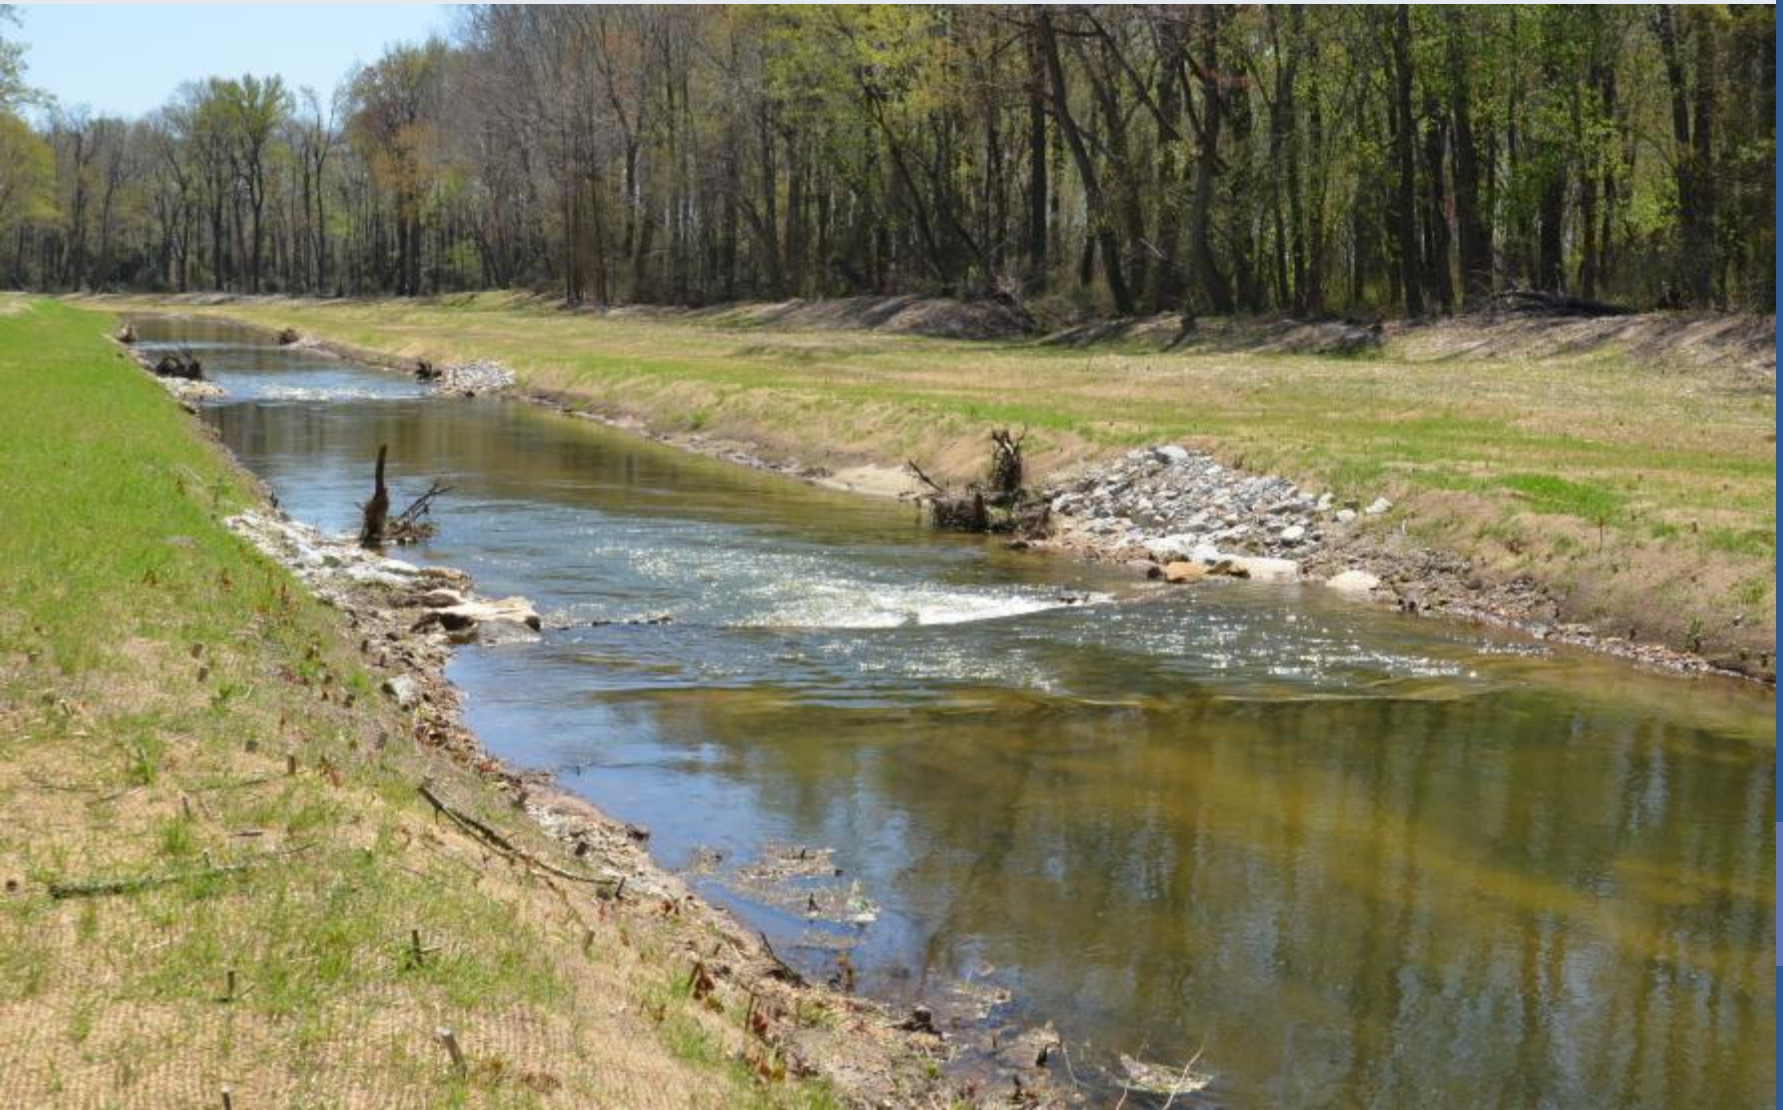
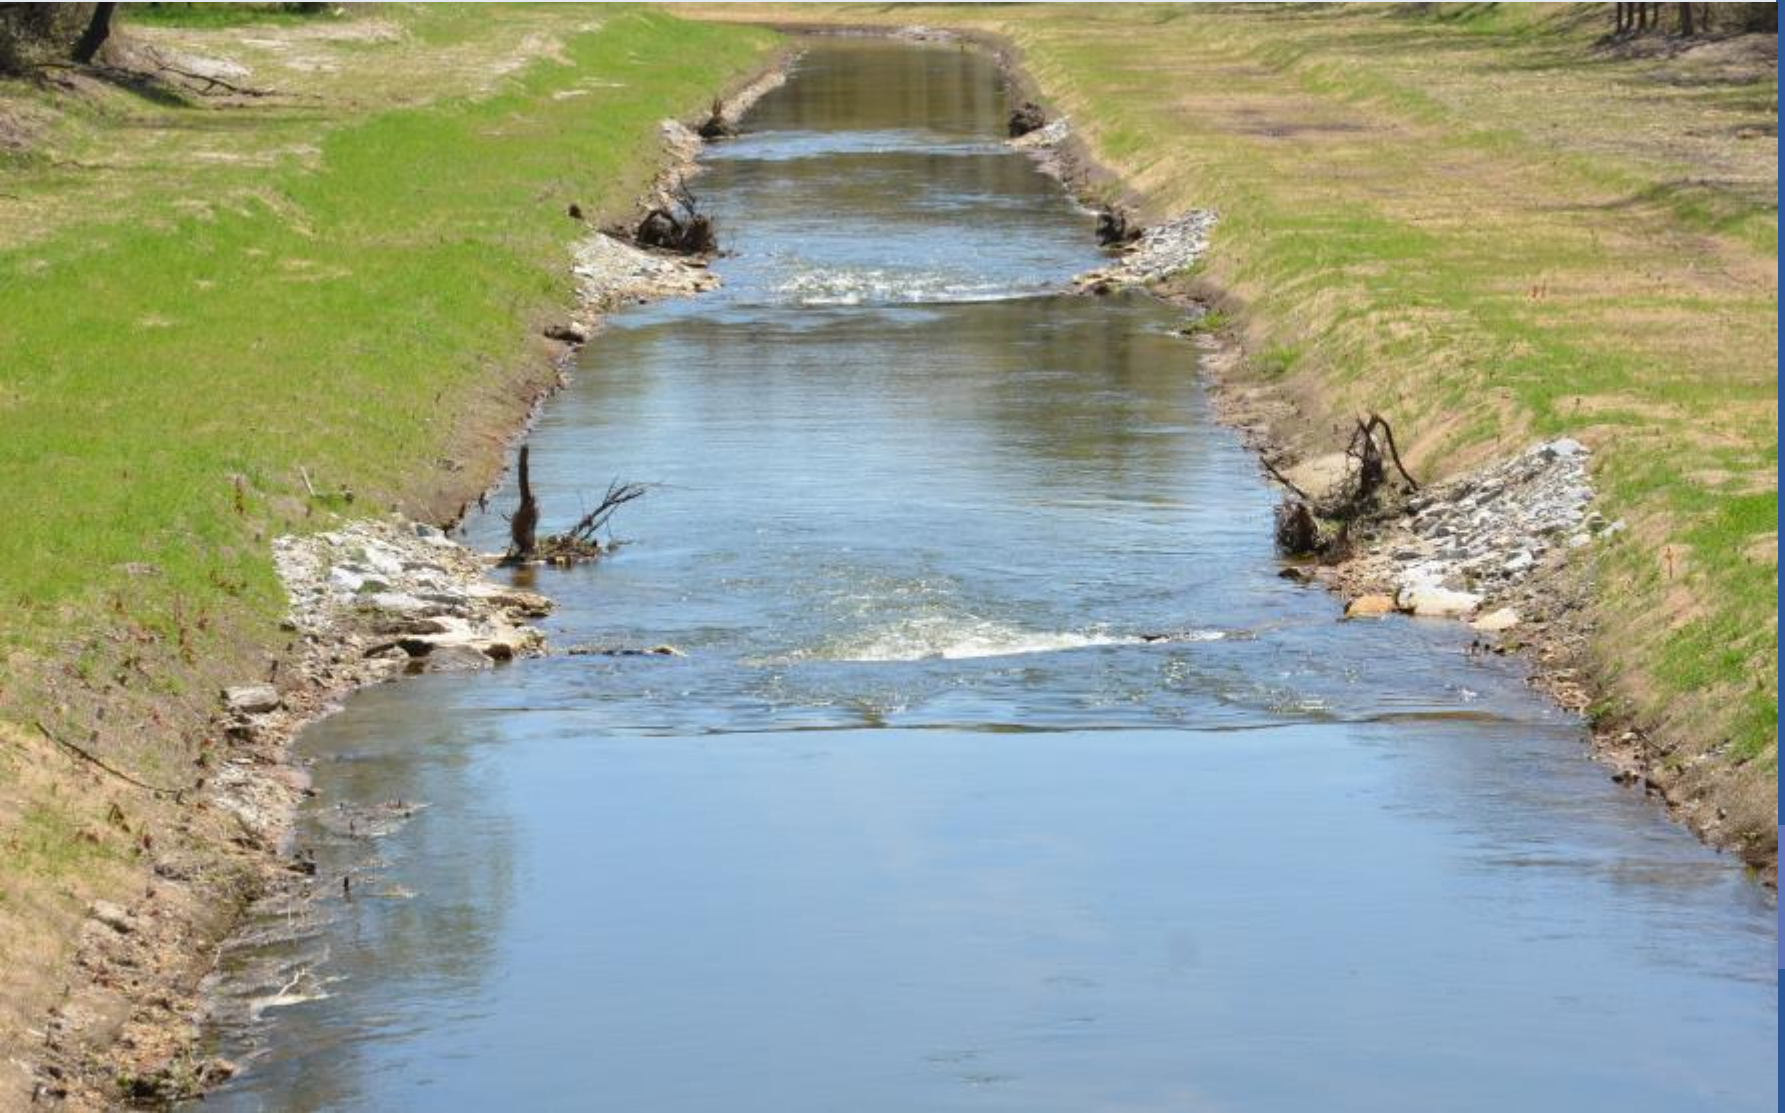
Rock Cross Vane with Step

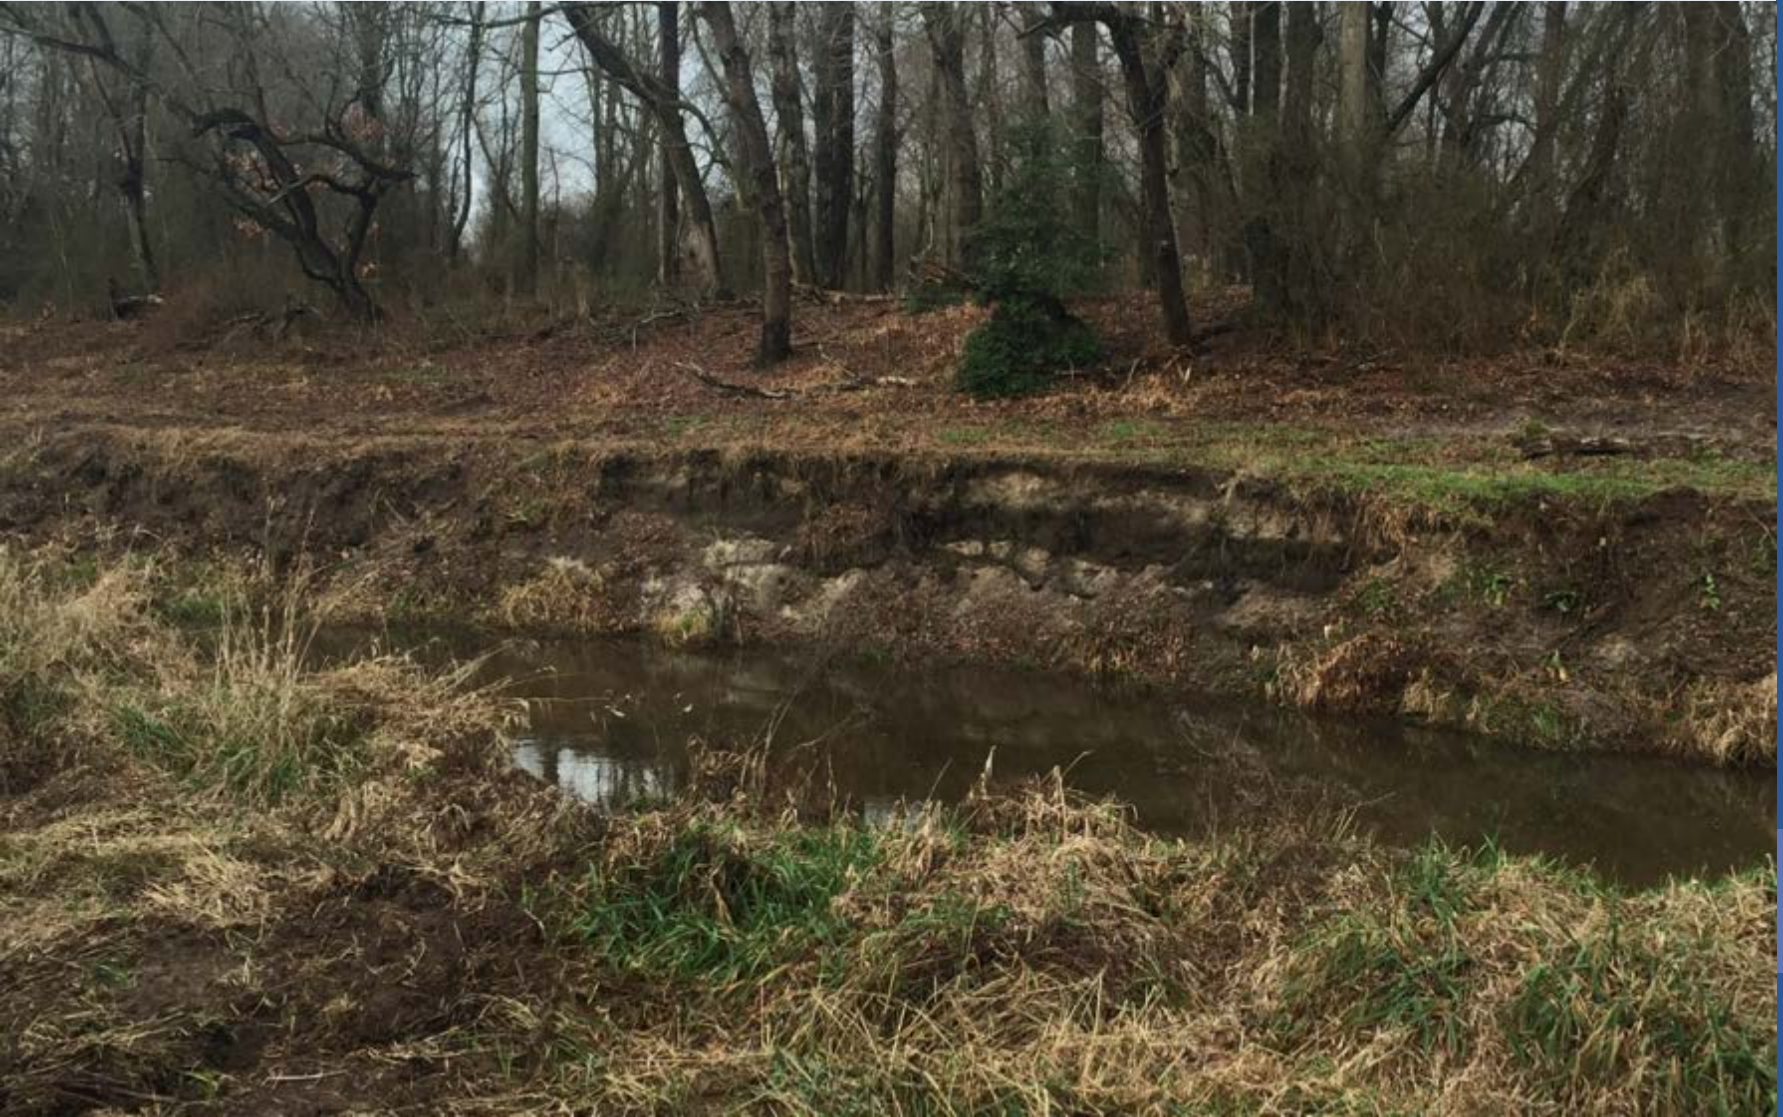
Nanticoke River Tax Ditch

Severely Eroded Banks

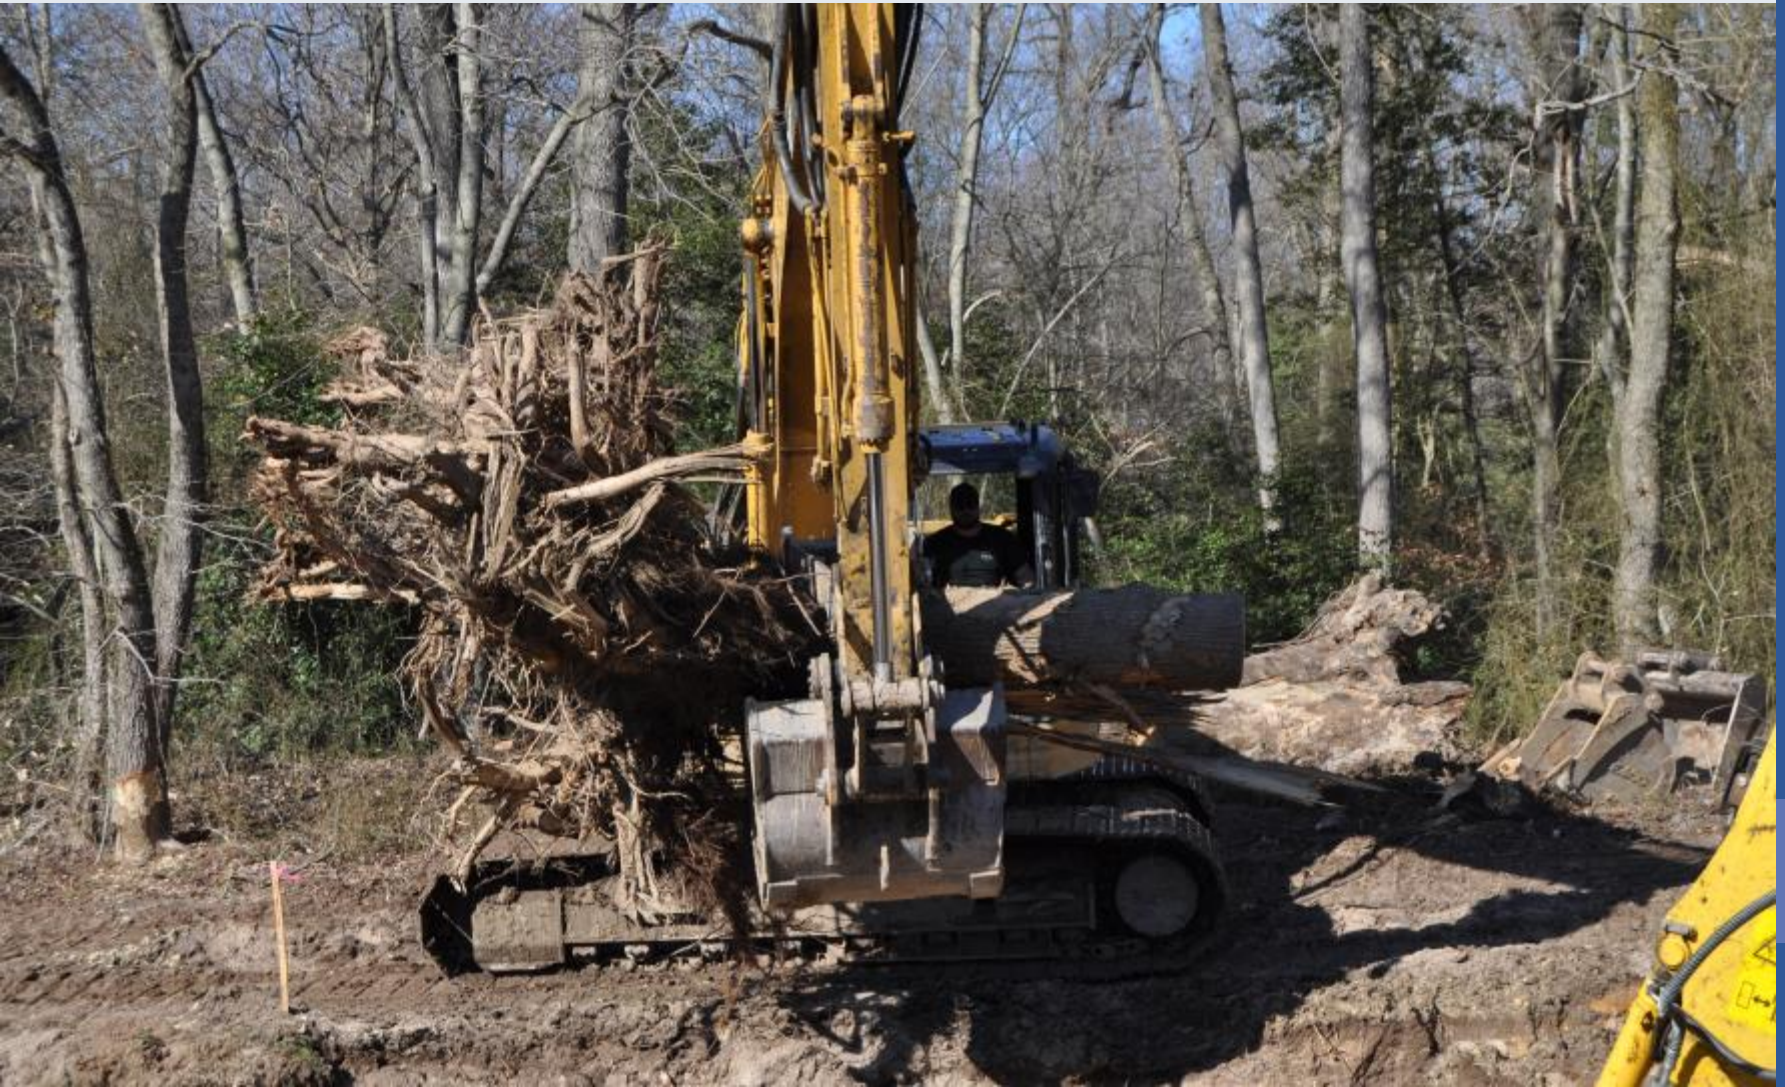
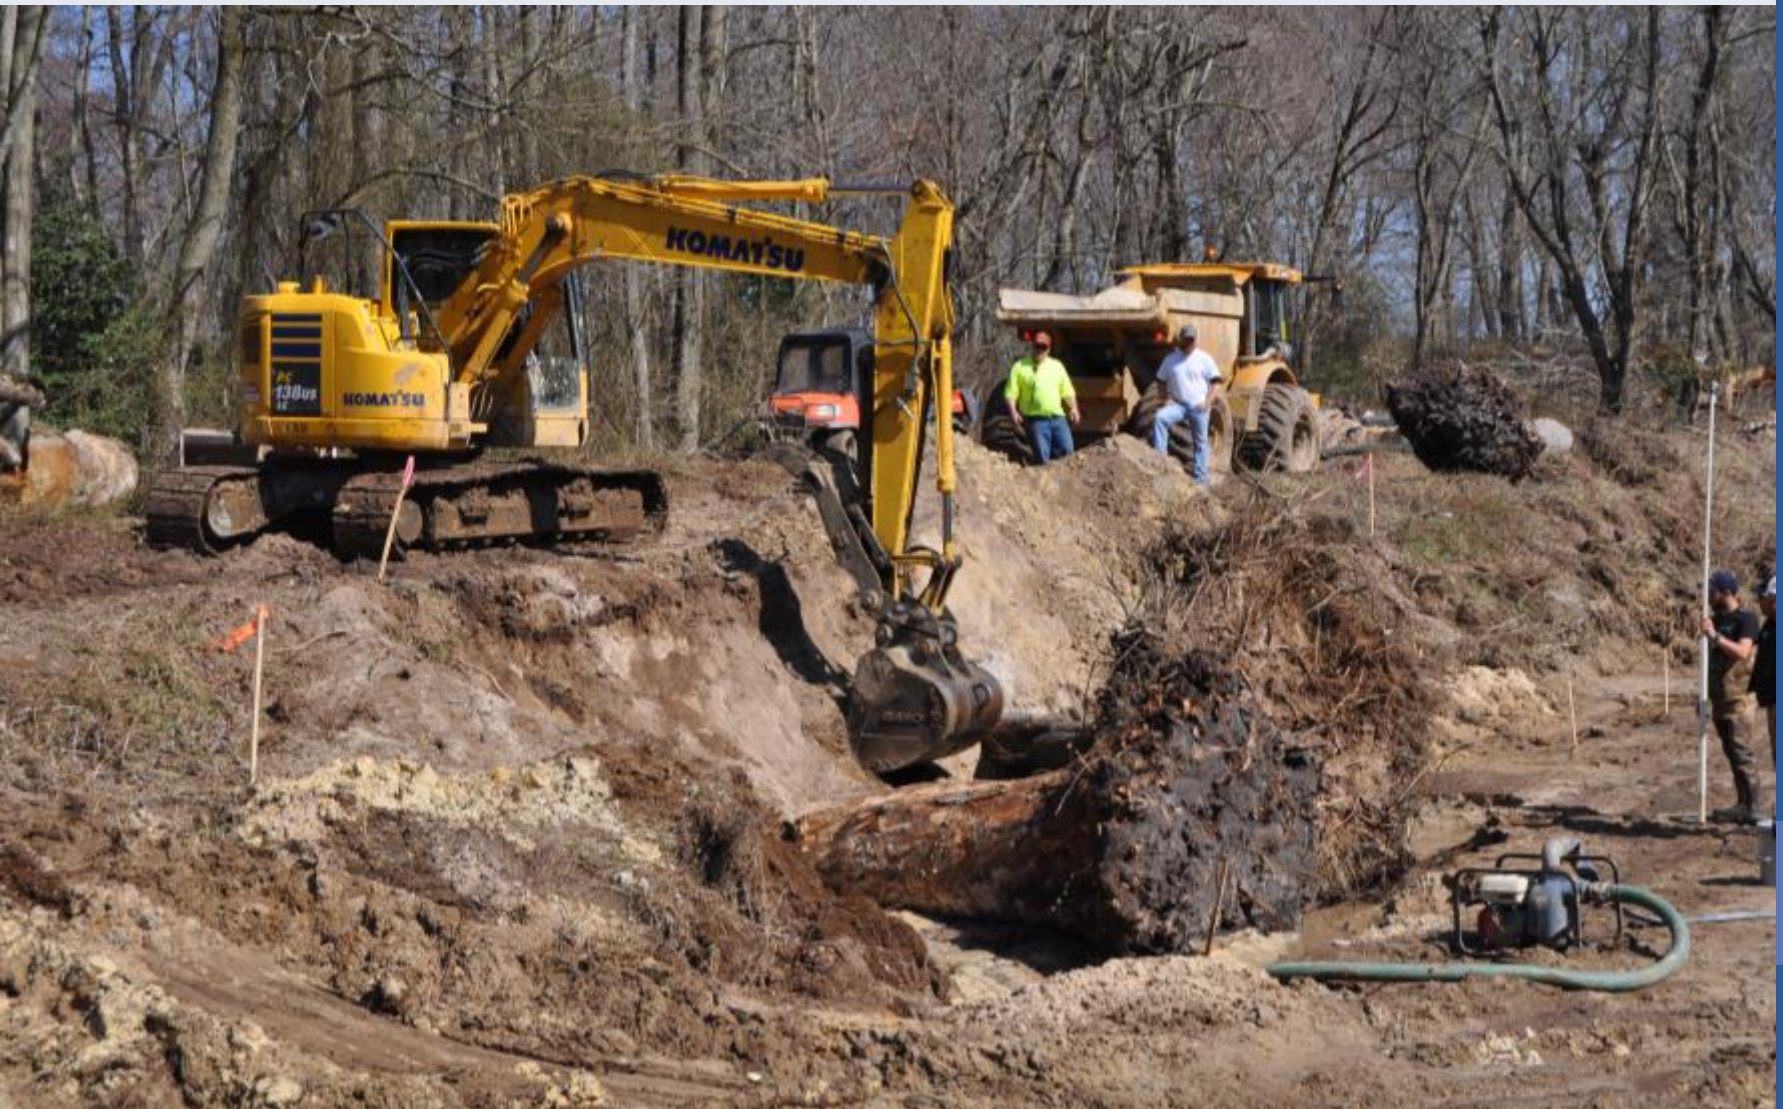
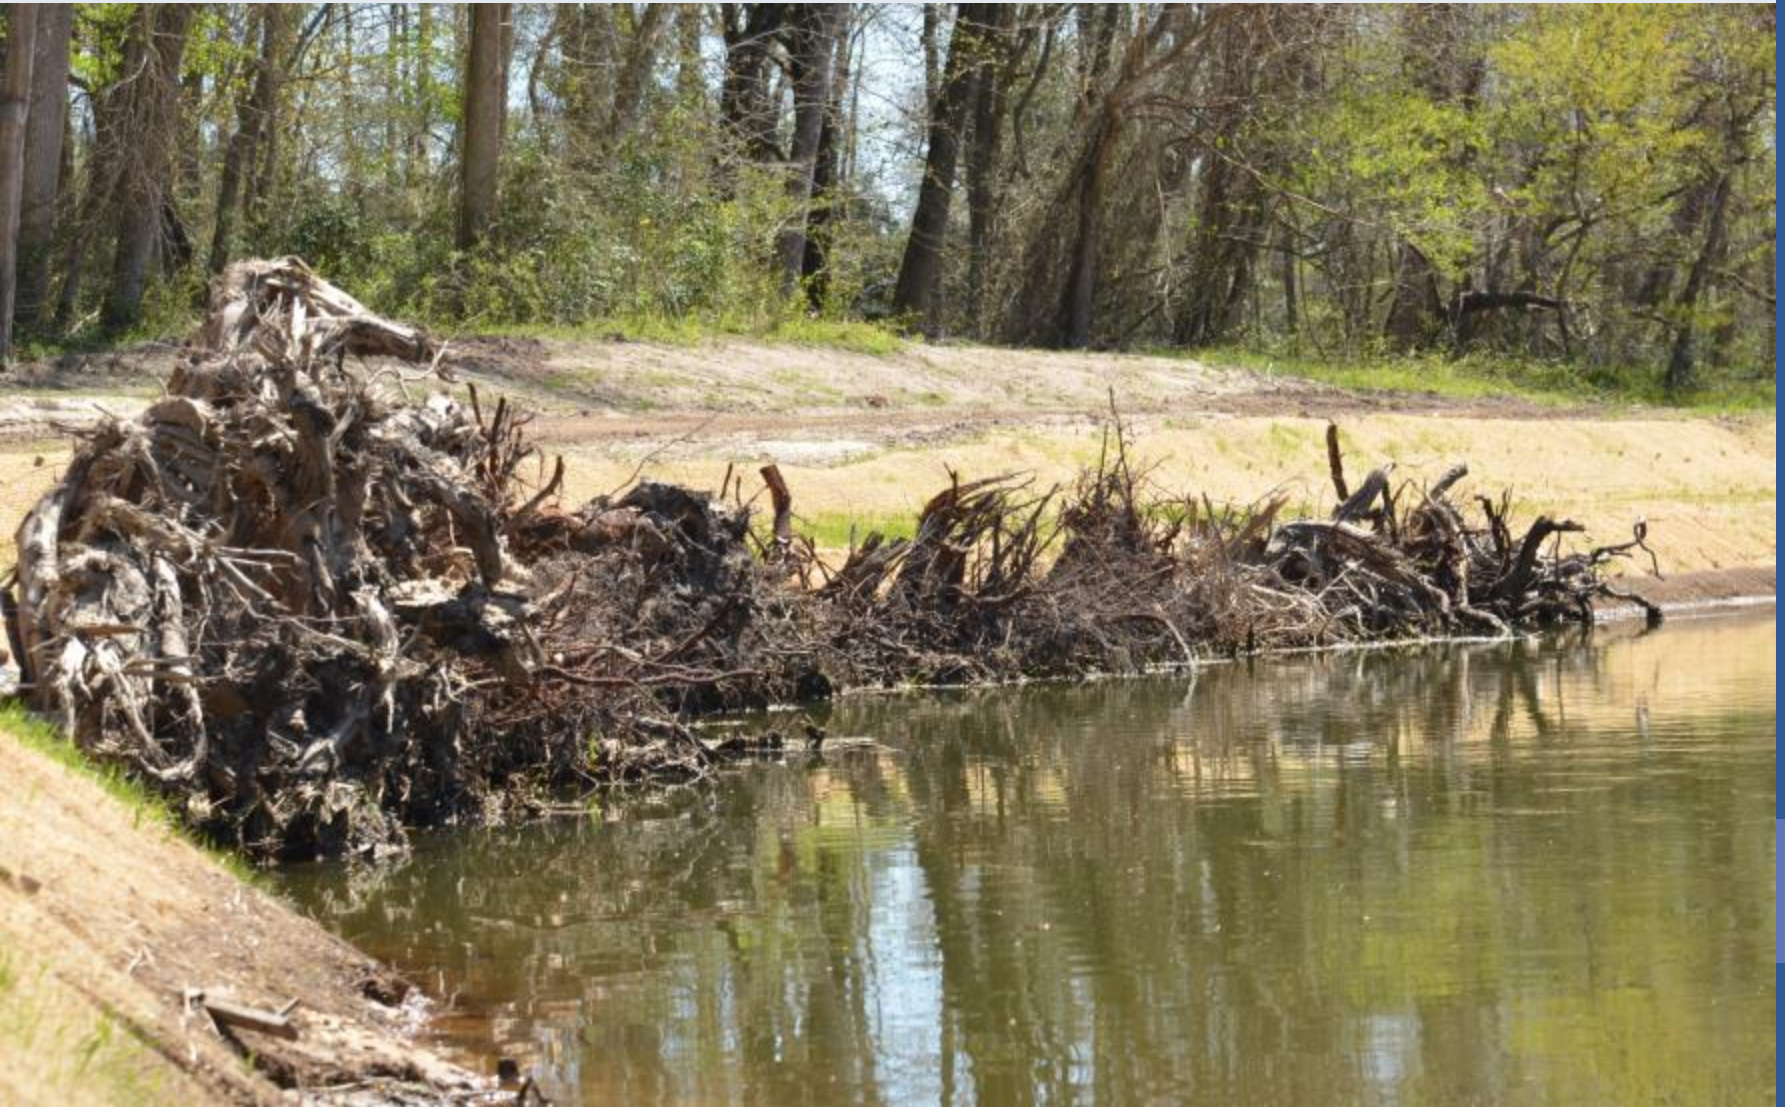
Toe Wood

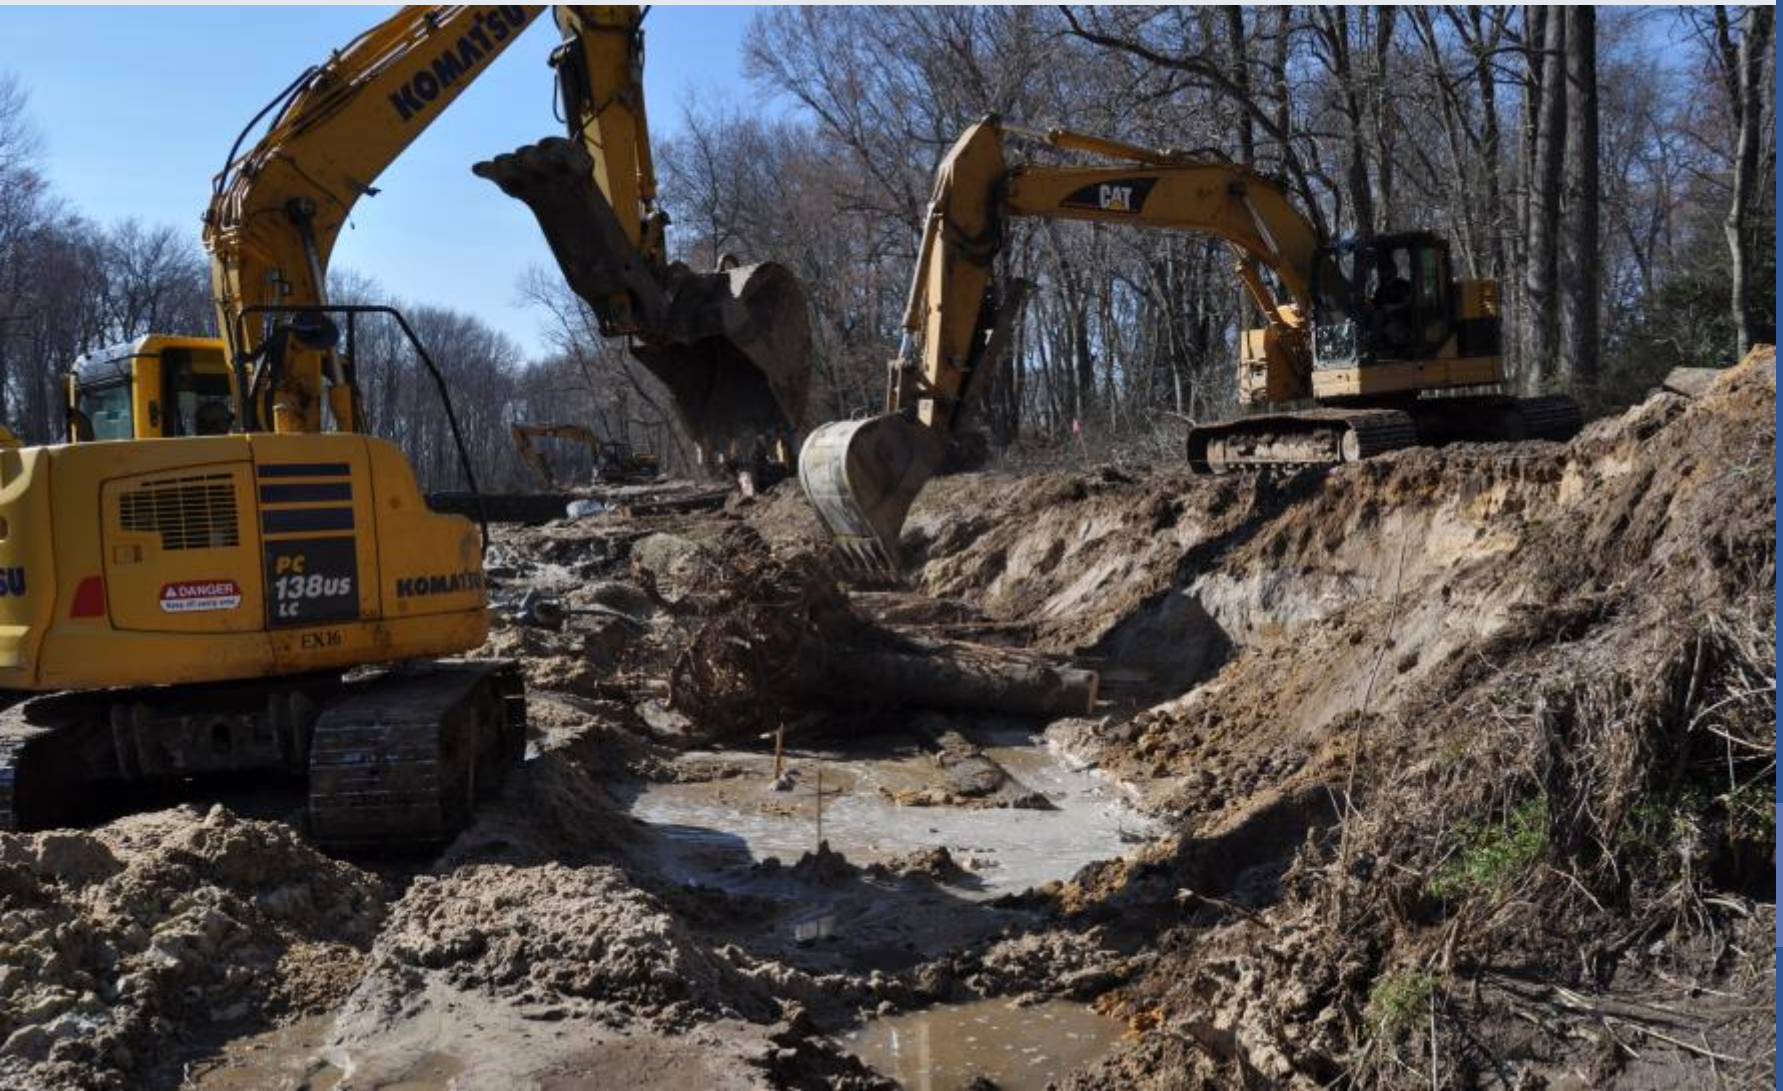
Nanticoke River Tax Ditch

Severely Eroded Banks
