Not Your Father's Tax Ditch

*Enhancing Delaware's Drainage Network Through the
Use of Natural Channel Design Techniques*

**Division of Watershed Stewardship
Drainage Program**

Presented at the National Conference on Ecological Restoration
April 21, 2016
Presented by: Brooks Cahall, Drainage Program Manager
Co-Authors: Matthew Grabowski, Sara Esposito P.E.

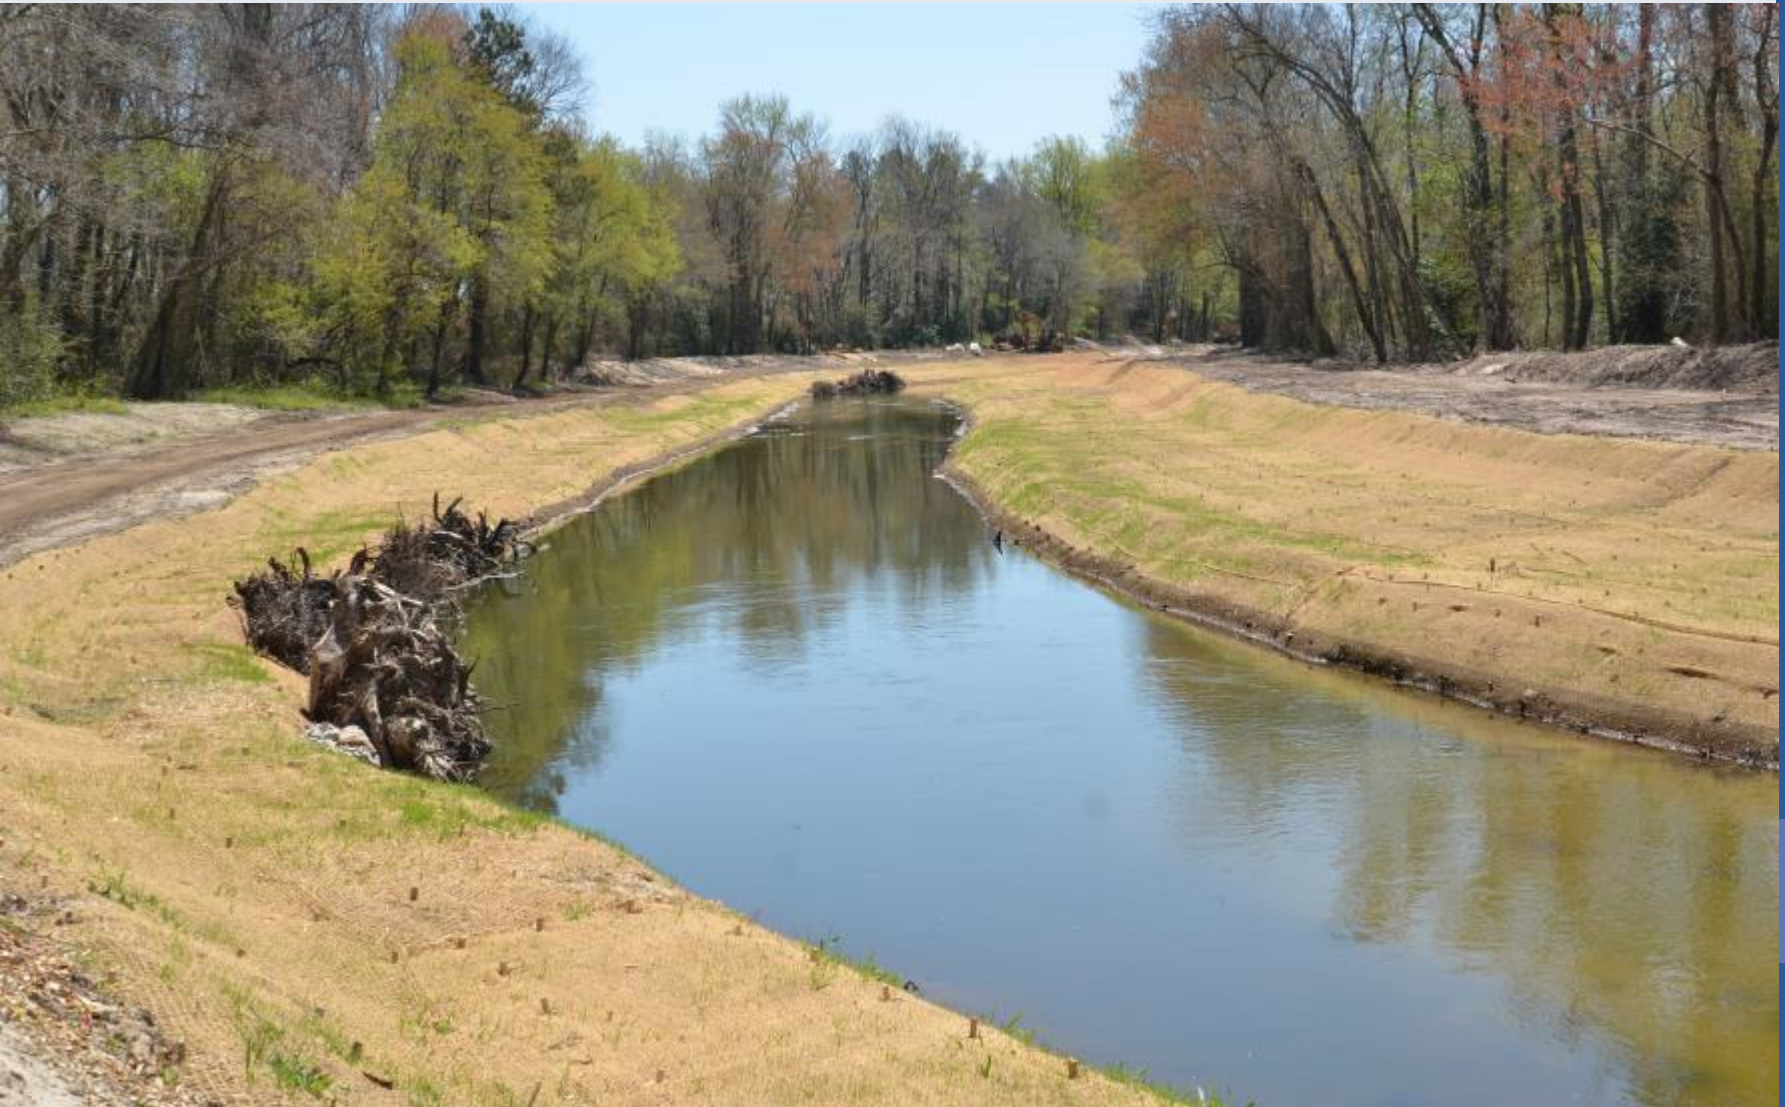
Nanticoke River Tax Ditch

Severely Eroded Banks
