# History of Restoration Along the Middle Rio Grande

Richard A. Valdez, Linnea Spears-Lebrun, and Sarah Griffin  
SWCA Environmental Consultants

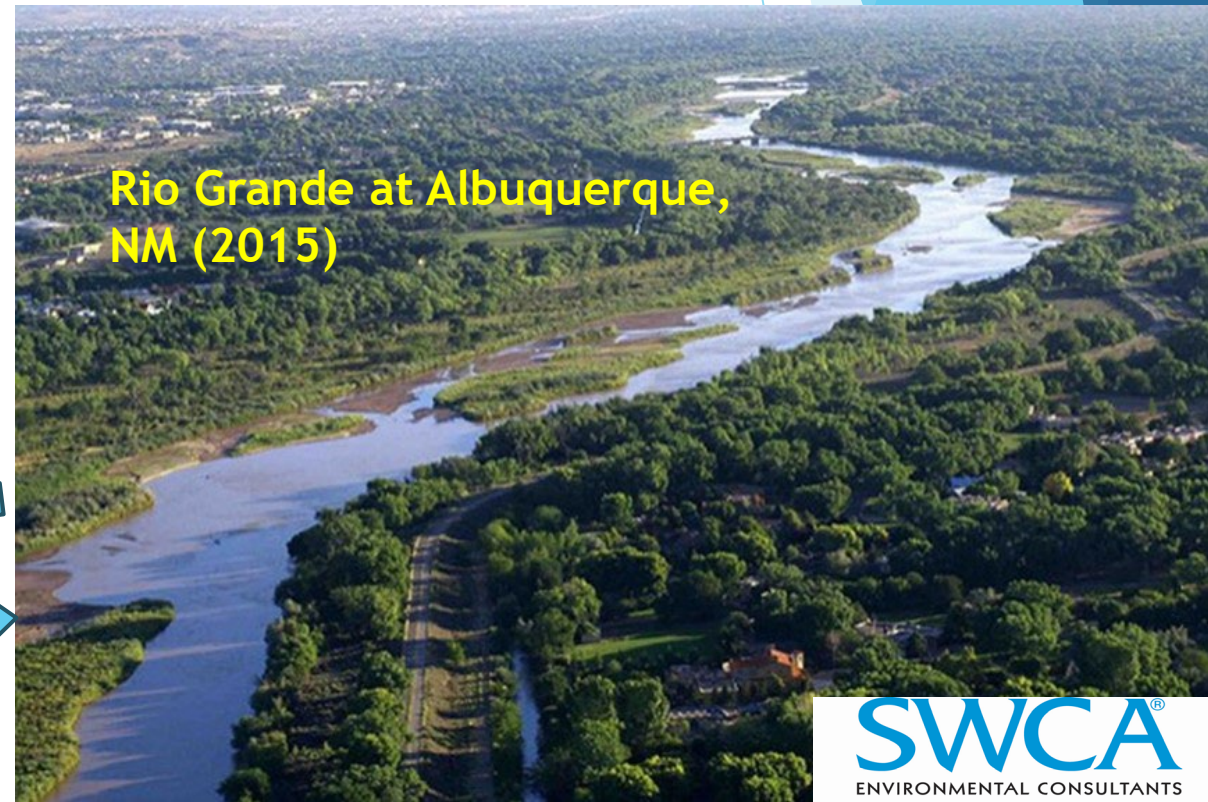
Historically, the Middle Rio Grande often flooded laterally with snow-melt runoff and inundated nearby communities like the City of Albuquerque.

Extensive water use, threats of floods and a desire to gain more control of river flows prompted the construction of hundreds of miles of levees in the 1930s, 40s, and 50s and installation of jetty jacks that confined the river channel, effectively delinking the river from its historic floodplain.

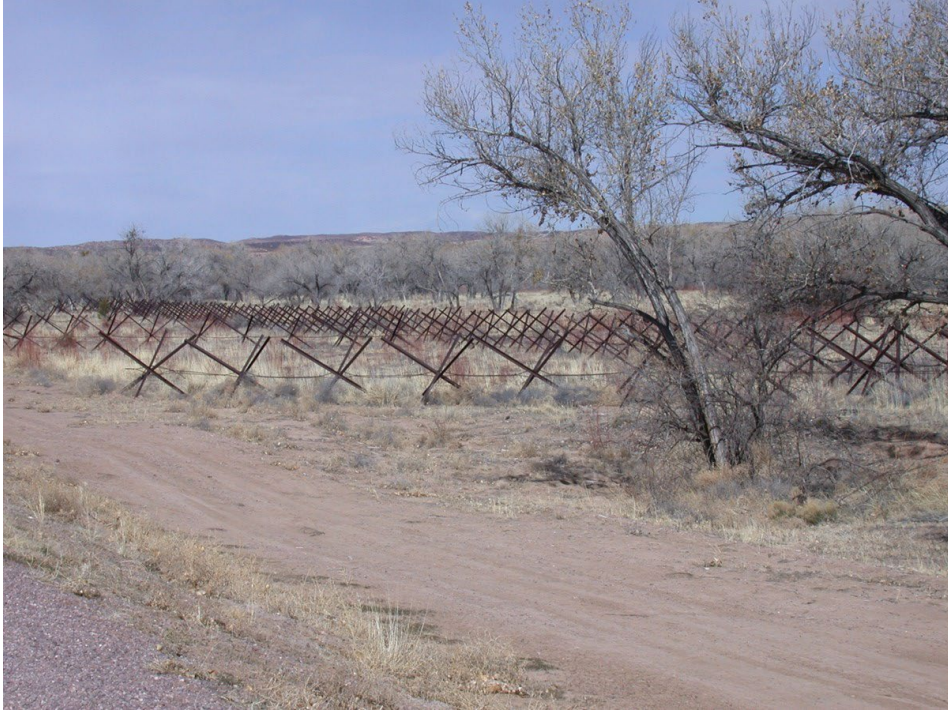
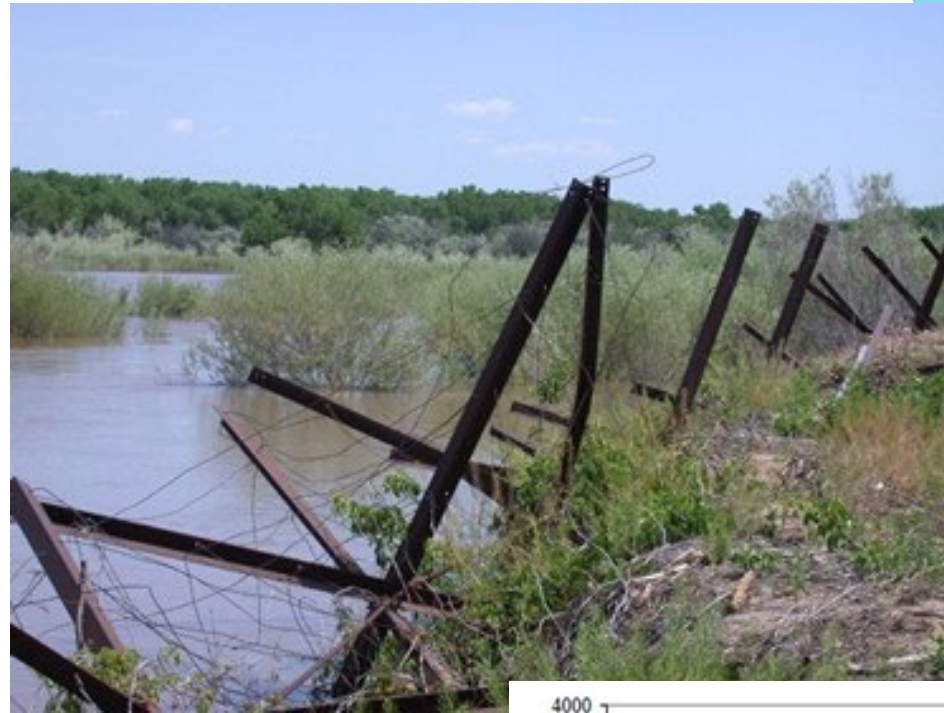
# Kellner Jetty Jacks

- Under the Middle Rio Grande Project, over 100,000 steel jetty jacks were installed in the 1950s and 1960s to protect the levees and trap sediment and debris and further narrow the channel, causing downcutting and further floodplain disconnection.
- Maximum channel width decreased by ~82% from 1918 to 2001 (Holmquist-Johnson 2004).

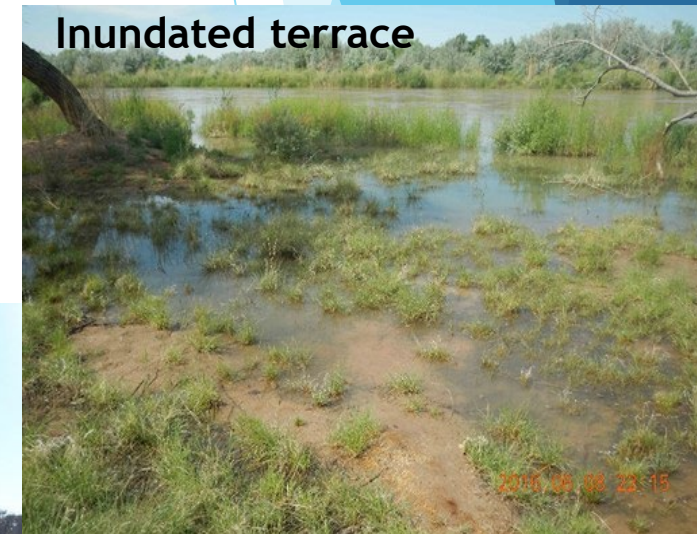
NDC-5i embayment after construction

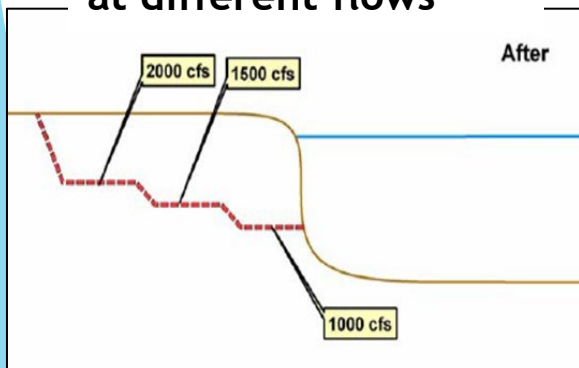
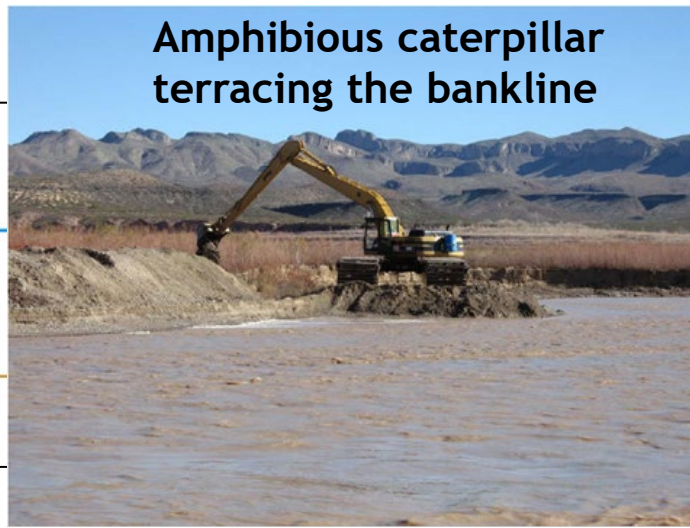
Terracing to inundate at different flows

Amphibious caterpillar terracing the bankline

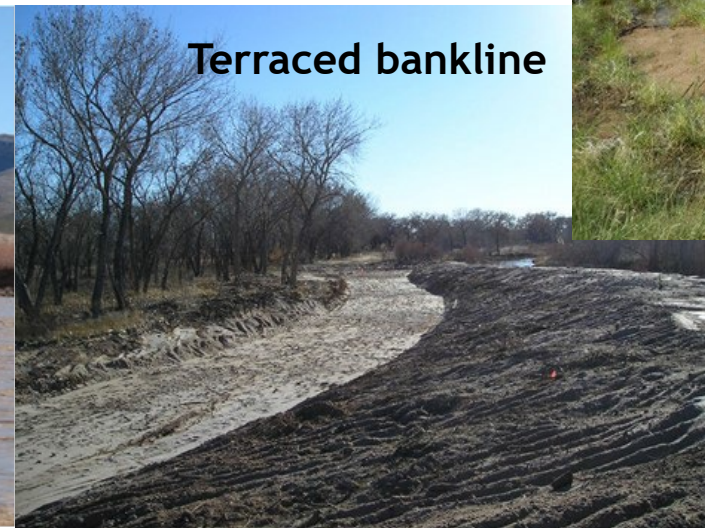
Terraced bankline
