Synergistic D/B/M
Team:
Foundation to
Transformative
Restoration

BRANCH AVE PARK STREAM RESTORATION

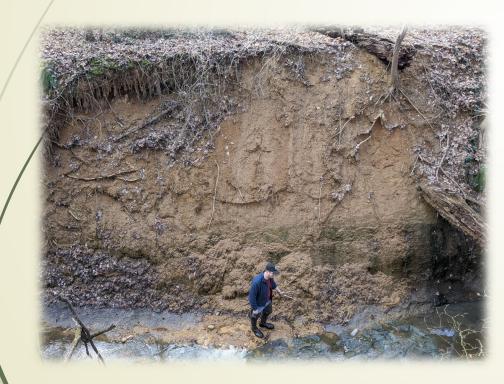
16-ft V shaped channel

The
"canyon"
and the
gully

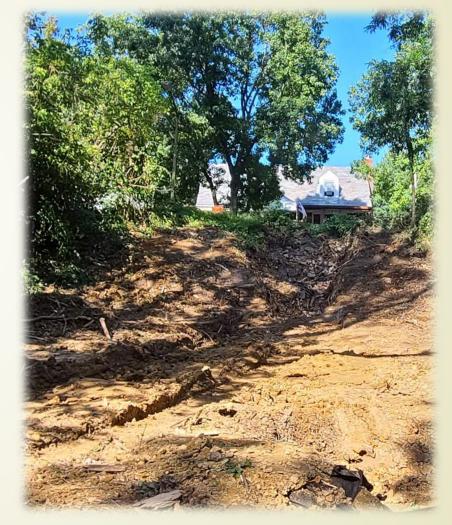
Actively eroding gully

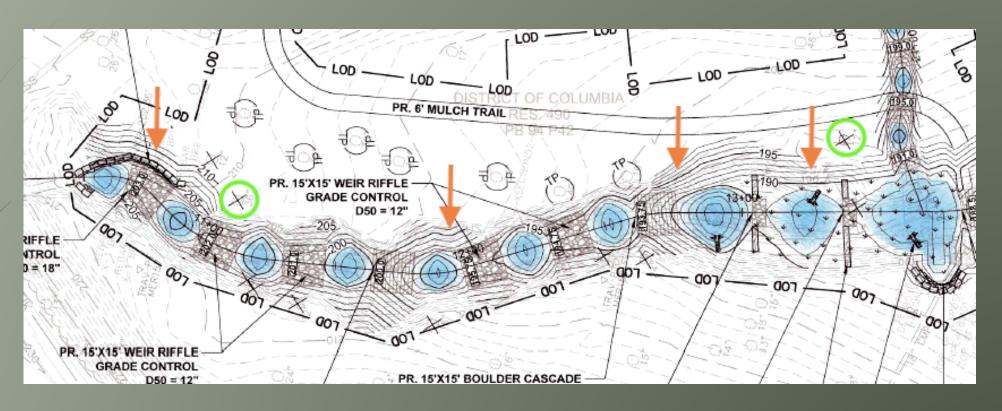
- Trail alignment used as access road to minimize tree removal.
- Strategic access to stream to save trees permitted for removal (5).
- Protect soils, avoid compaction
