# Hurricane Irma Impact on South Florida Water Management System and Storm Surge

*Wossenu Abtew*

GEER 2019

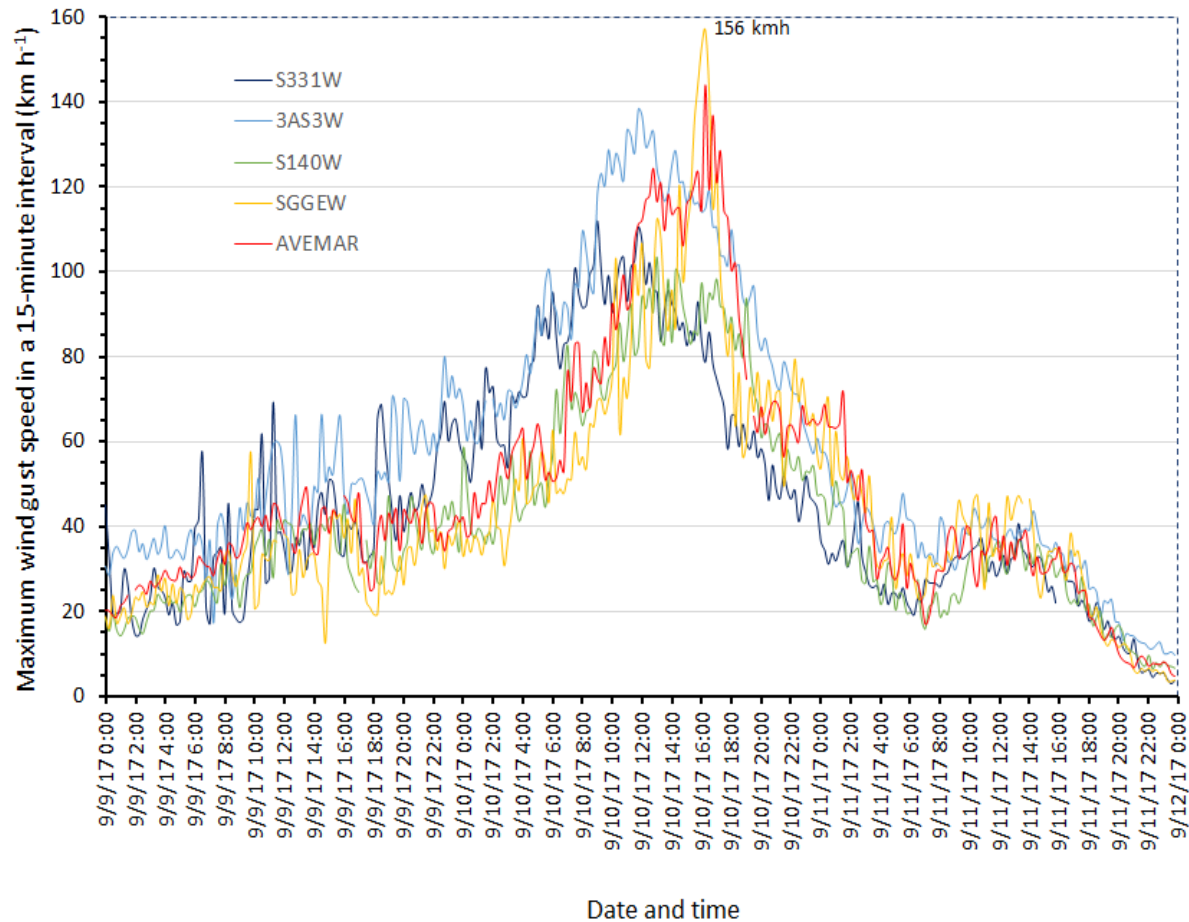
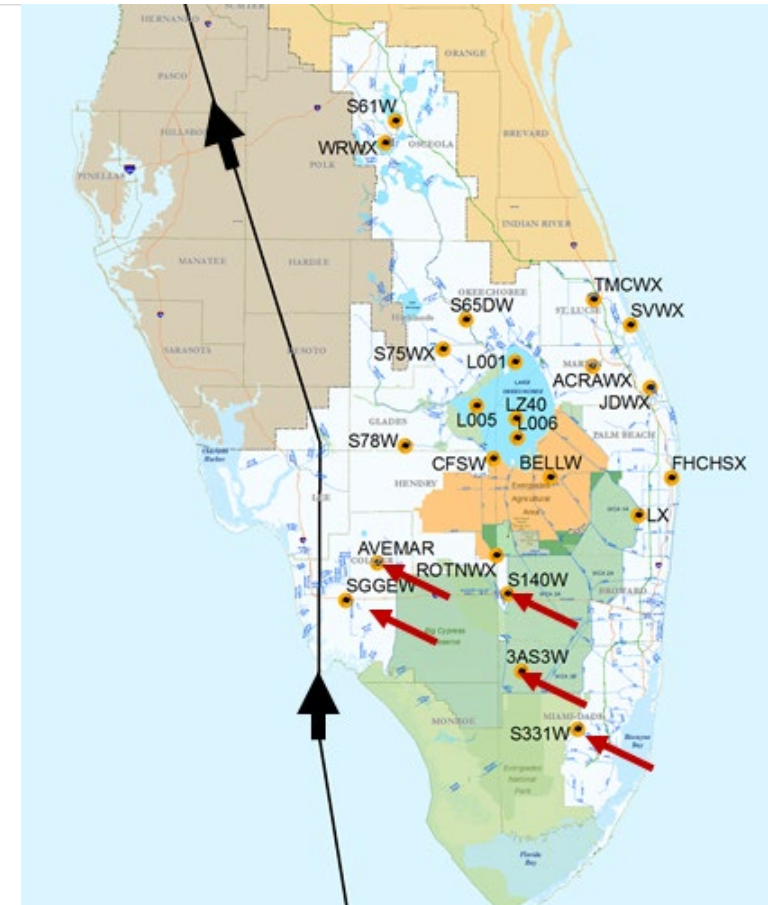
- 1) Wind sensor height, location clearance, calibration and maintenance
  - 2) Frequency at which wind gust is measured, averaged and reported
  - 3) Sensor malfunction
- .

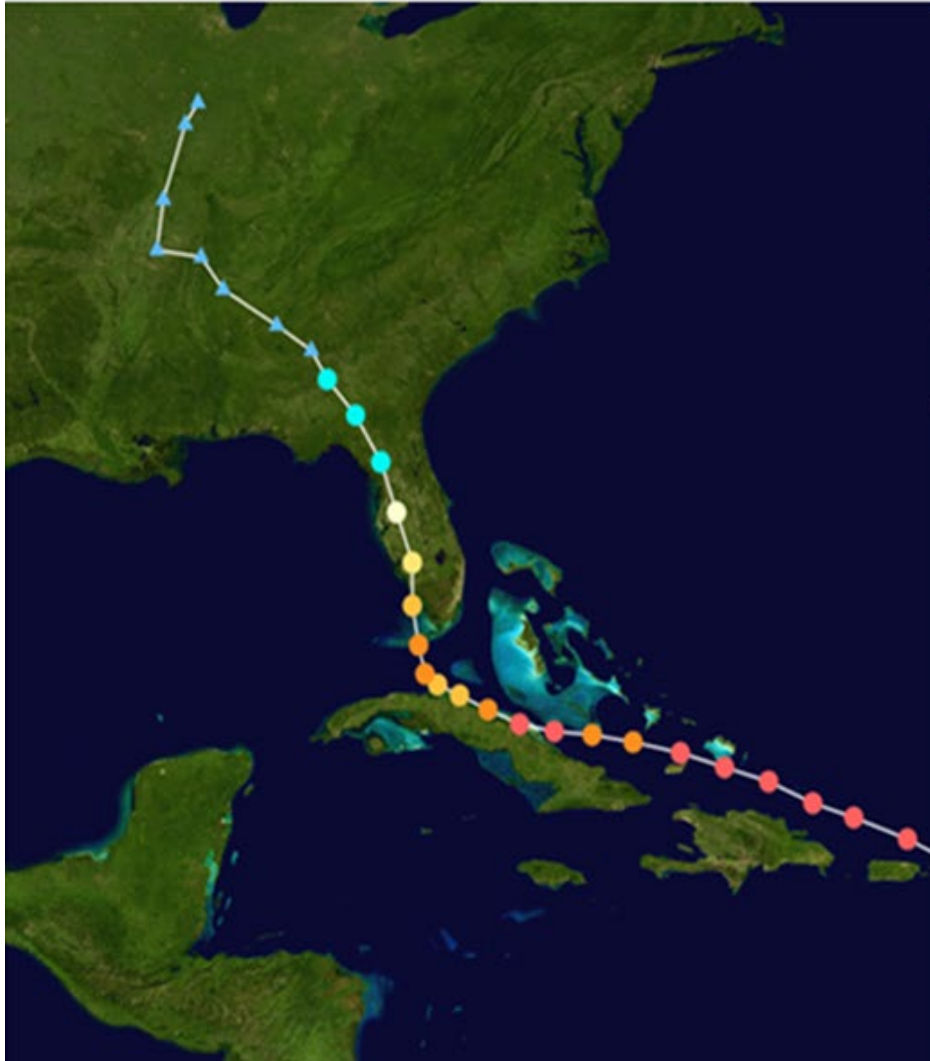
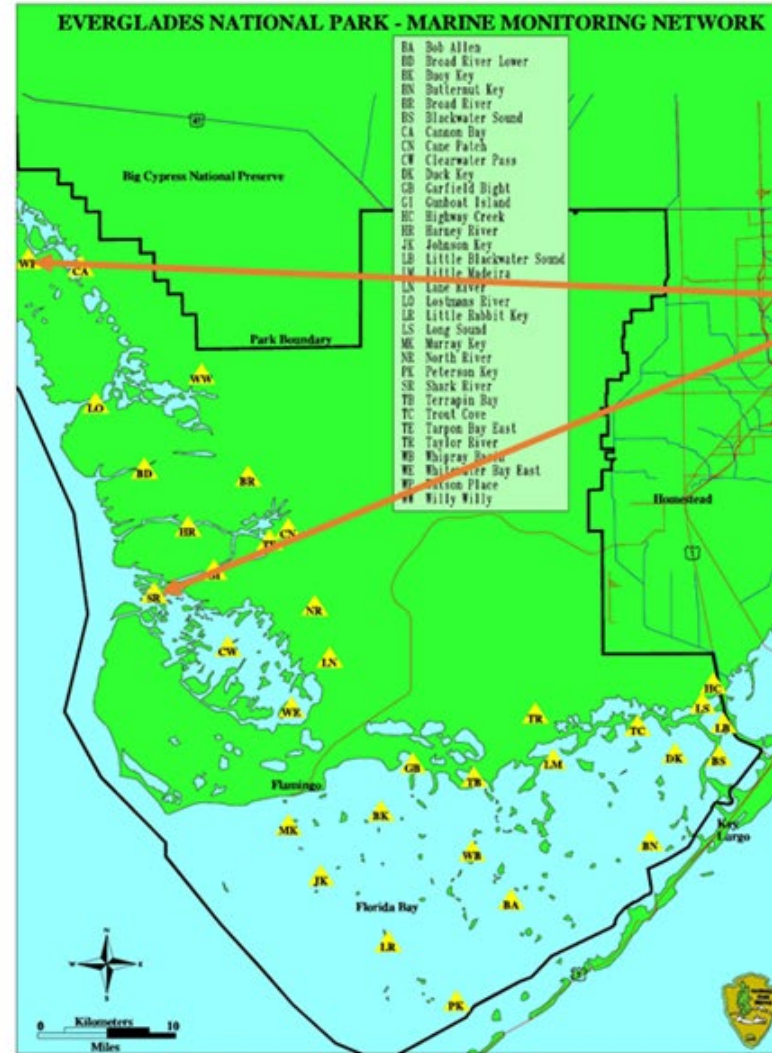
## Maximum Storm Surge (several malfunctioned)

1.85 to  
2.15 m  
Highest  
storm  
surge

- ENP marine monitoring network gauges need higher reading capacity at each gauge to correctly record storm surge
- Storm surge appears lower in the southeast with the highest along the path of the hurricane in the southwest
- Rainfall over the SFWMD region was 21 cm with site measurements of as high as 55 cm in ENP
- Wind gust speed of  $\approx 200 \text{ km h}^{-1}$  was observed on land at the southwest
- Damages occurred to water management facilities and constructed wetlands
- Lake Okeechobee experienced wind setup of close to 2 m

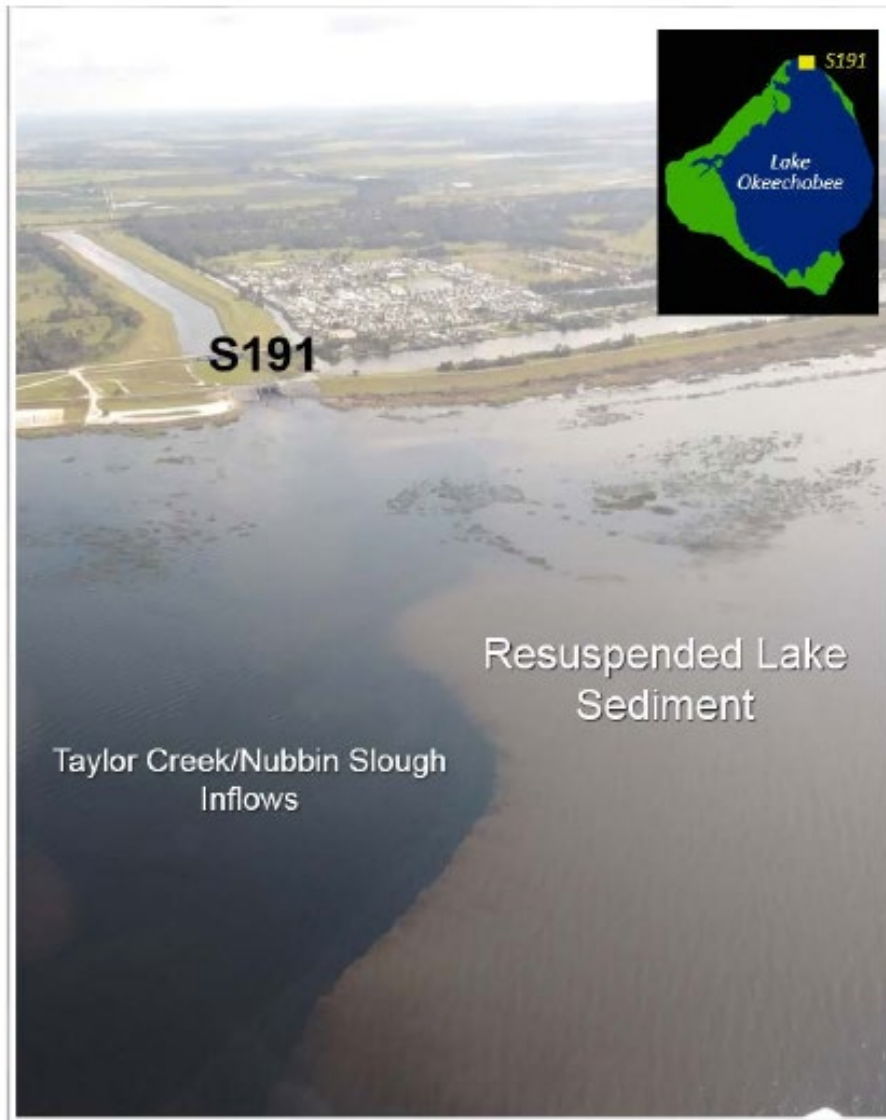
High TP load from high runoff

High TP concentration from sediment resuspension
