Kinnickinnic River: Rehabilitation in an Urban Watershed

Stuart C. Trabant, Michael D. Harvey, Robert A. Mussetter (Tetra Tech, Inc.),
David Fowler (Milwaukee Metropolitan Sewerage District)

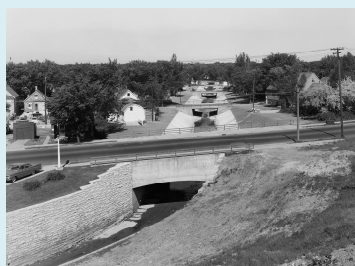
Figure 2. 1961 photograph of the recently lined KKR.

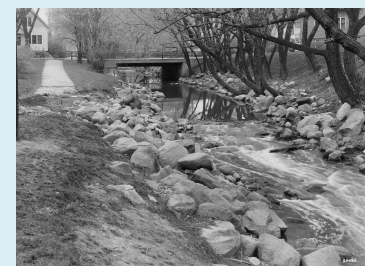
Figure 3. 1960 photograph of a riprap along the KKR.

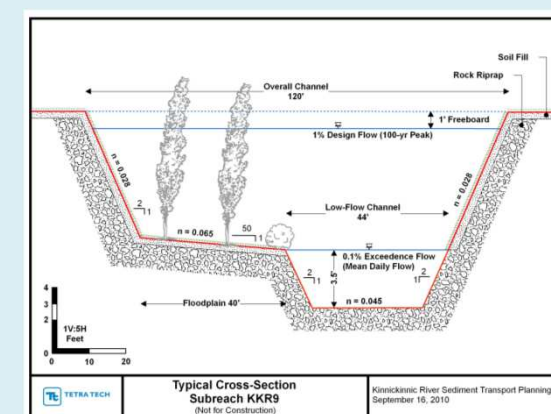
- Problem:** Lack of hydraulic capacity (<100-year peak flow), primarily in the concrete-lined subreaches of the KKR between South 43rd Street and South 6th Avenue.
- Rehabilitation Opportunity:** Replacement of the existing, concrete-lined channel with a larger channel geometry to provide increased flood conveyance. Successful replacement could be achieved with a compound channel, sized to convey the 100-yr RI design flow without eroding, including a low-flow, rock-lined channel sized to convey about the 0.1-percent mean daily exceedence flow (Figures 10 and 11). Appropriate vertical and lateral variability could be incorporated to provide fish passage and resting areas.

Figure 10. Conceptual design for the replaced channel in the Kinnickinnic River.

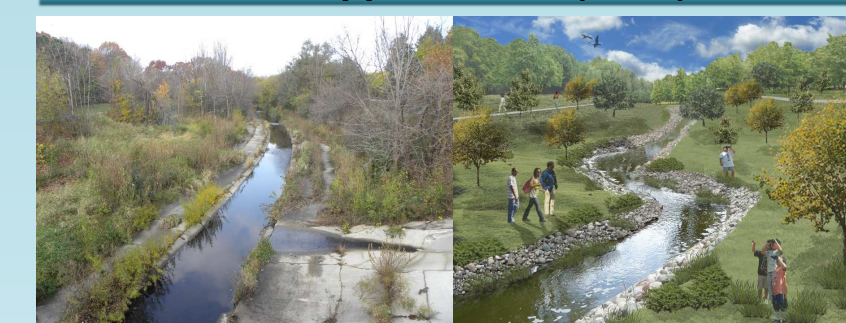
Figure 11. Photograph of the existing KKR and conceptual rendering of the rehabilitated channel.

- Problem:** Failed and poor-condition, open-channel concrete lining, primarily in the KKR that was constructed in the early 1960s and is coincident with the impaired hydraulic capacity.

- Rehabilitation Opportunity:** Given the coincidence between the poor state of the concrete and the impaired hydraulic capacity, the compound channel identified to mitigate problems with channel capacity would also remedy the problems with the concrete lining.

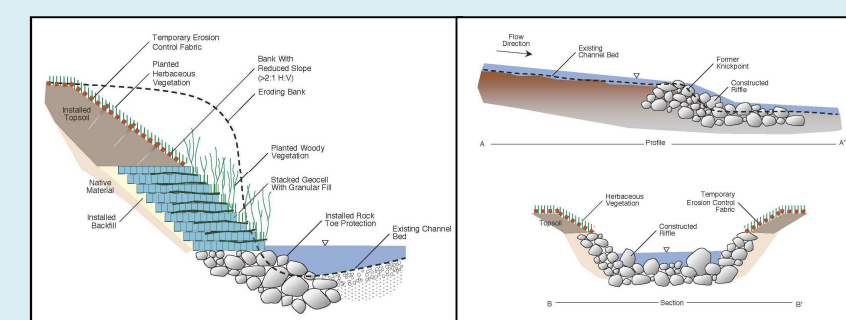
- Problem:** Eroding unlined channel segments in the KKR and tributaries that both threaten streamside infrastructure and supply sediment to the downstream estuary of the KKR where it is deposited.

Figure 12. Conceptual design of combination rock-toe and bio-engineered bank stabilization.

- Rehabilitation Opportunity:** Stabilization of the eroding banks that are currently threatening infrastructure could be achieved by installing a rock toe designed to withstand movement at the 100-yr RI flow with bio-engineered upper banks (Figure 12). Rock riffle grade control structures will be necessary in areas of downcutting, and will also enhance habitat (Figure 13).

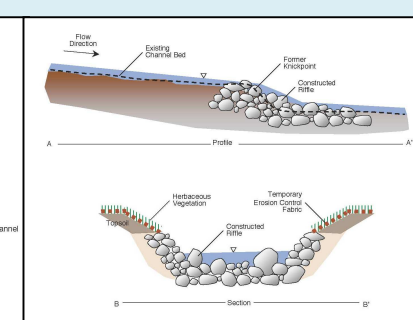
Figure 13. Conceptual design of rock riffle grade control structure.
