# Monitoring Restoration and Recovery of Impounded Mangroves at Oleta River State Park

Savanna Hearne<sup>1</sup>, Heather A. Stewart<sup>1,2</sup>, Casey Craig<sup>1</sup>, Olivia Schlei<sup>1</sup>, Nicole Silverman<sup>1</sup>, Kara R. Radabaugh<sup>1</sup>

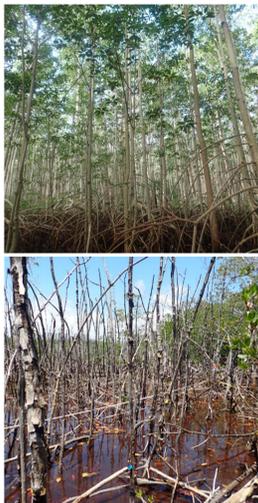
**Figure 1.** Examples of control (top) and stressed (bottom) mangrove areas at ORSP. Photos taken pre-restoration, in 2023.

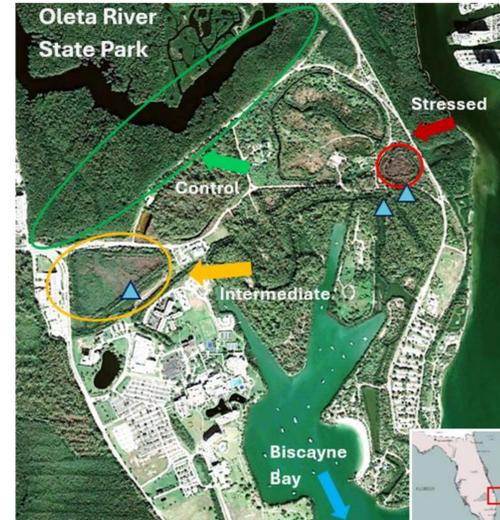
**Figure 2.** The control, intermediate stress, and stressed sites at ORSP. Biscayne Bay was used as a reference for water quality pre- and post-restoration. Blue triangles mark culvert locations.

Three 5x5-m plots were established in three sites classified as control, intermediate stress, and stressed, based on visual indicators such as mangrove mortality (Figure 2). Canopy cover was measured at each plot corner using a convex spherical densiometer. Soil cores were collected outside each plot using a "Russian-type" split-barrel peat corer to quantify percent organic matter via loss-on-ignition. Salinity was measured at multiple locations throughout ORSP using a handheld multi-parameter meter and surface water samples were collected using a peristaltic pump. One unfiltered sample was collected for Total Organic Carbon (TOC) measurement, and a second sample was filtered through pre-combusted glass microfiber filters for Dissolved Organic Carbon (DOC) analysis. Monitoring was completed approximately every six months for two years pre- and post-restoration.

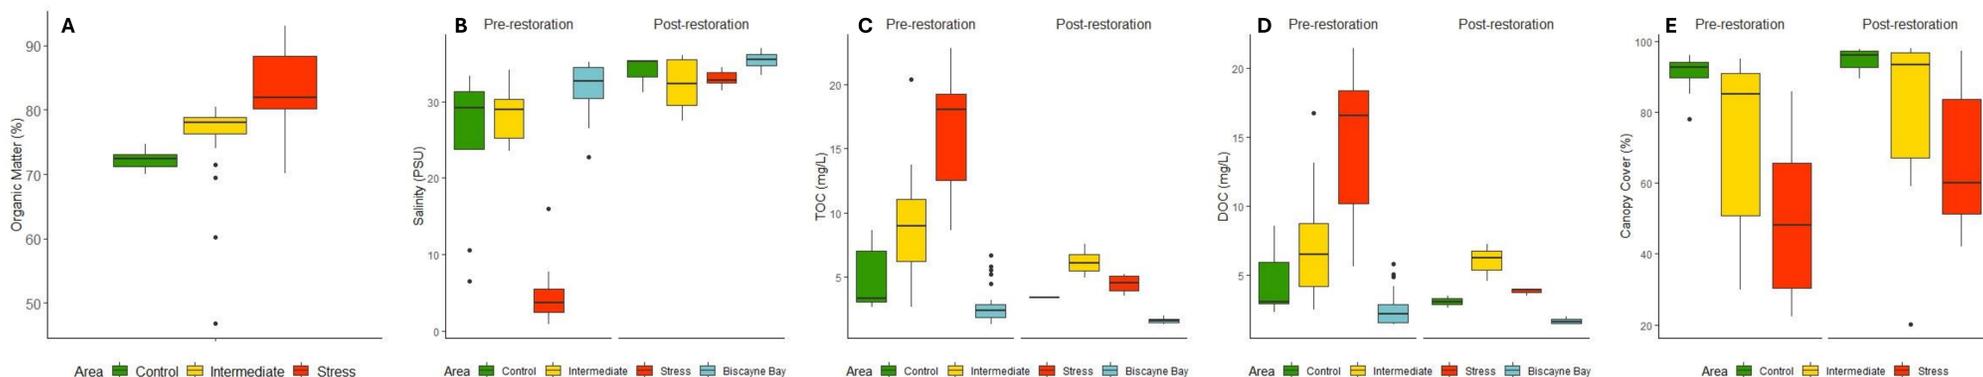
**Figure 3.** (A) Pre-restoration percent organic matter in soil (0–10 cm depth) across sites, (B) Salinity of surface water across sites, grouped by restoration period, (C) Total Organic Carbon in surface water across sites, grouped by restoration period, (D) Dissolved Organic Carbon in surface water across sites, grouped by restoration period, and (E) percent canopy cover across sites, grouped by restoration period.

The control site contained significantly less organic matter in soil (0–10 cm depth) than the intermediate site ( $p < 0.001$ ; Figure 3A), which in turn contained significantly less organic matter than the stressed site ( $p < 0.001$ ).

The salinity of surface water was significantly lower pre-restoration compared to post-restoration at all sites ( $p < 0.05$ ; Figure 3B). Salinity was significantly lower in the stressed site compared to all other sites pre-restoration ( $p < 0.005$ ), but no significant differences were found among sites post-restoration.

TOC in surface water was significantly higher pre-restoration compared to post-restoration in the stressed site ( $p = 0.002$ ; Figure 3C). TOC was significantly higher in the stressed site compared to all other sites pre-restoration (all  $p$ -values  $< 0.001$ ), but no significant differences were found among sites post-restoration.

DOC in surface water was significantly higher pre-restoration compared to post-restoration in the stressed site ( $p = 0.006$ ; Figure 3D). DOC was significantly higher in the stressed site compared to all other sites pre-restoration (all  $p$ -values  $< 0.001$ ), but no significant differences were found among sites post-restoration.

Canopy cover did not differ significantly between pre- and post-restoration periods at any site (Figure 3E). Pre-restoration, the stressed site had significantly lower canopy cover than all other sites ( $p < 0.005$ ), but no significant differences were found among sites post-restoration.

**A. Soil Organic Matter Content:** Organic matter content in intermediate stress and stressed forest soils was likely higher than in the control site, as assessed pre-restoration, due to a lack of allochthonous sediment deposition, which typically has a higher inorganic composition. The intermediate stress and stressed sites were surrounded by roads, likely minimizing tidal flow and sediment import.

**B. Salinity:** The significantly lower salinity in the stressed forest pre-restoration can be attributed to ponding of precipitation and a lack of tidal connectivity. Following culvert installation, salinity increased across all areas to near-reference conditions, suggesting the culverts successfully improved tidal flow.

**C & D. Total and Dissolved Organic Carbon:** High organic carbon in surface water can result from limited circulation, decomposing vegetation, and reduced microbial activity<sup>4</sup>. The significant decrease in TOC and DOC in the stressed forest post-restoration suggests that the culverts are improving water circulation, which could be reducing organic carbon accumulation in surface water.

**E. Canopy Cover:** The significant differences in canopy cover among sites pre-restoration can be attributed to mangrove mortality at the intermediate stress and stressed sites. Hydrologic improvements from culvert installation appear to be facilitating initial mangrove recovery and regrowth, though mangrove forests can take decades to fully mature and recover.

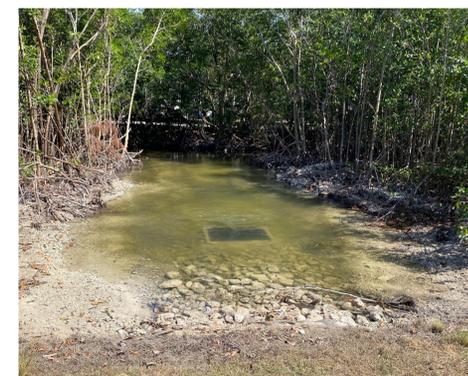
**Figure 4.** A culvert installed in the intermediate stress area in 2023.
