# Restoration Benefits Observed from the Biscayne Bay Coastal Wetlands Project Phase 1

Bahram Charkhian Lead Environmental Scientist Greater Everglades Ecosystem Restoration Coral Spring , Florida April 22-25, 2019

## Biscayne Bay Coastal Wetlands Restoration Project Goals

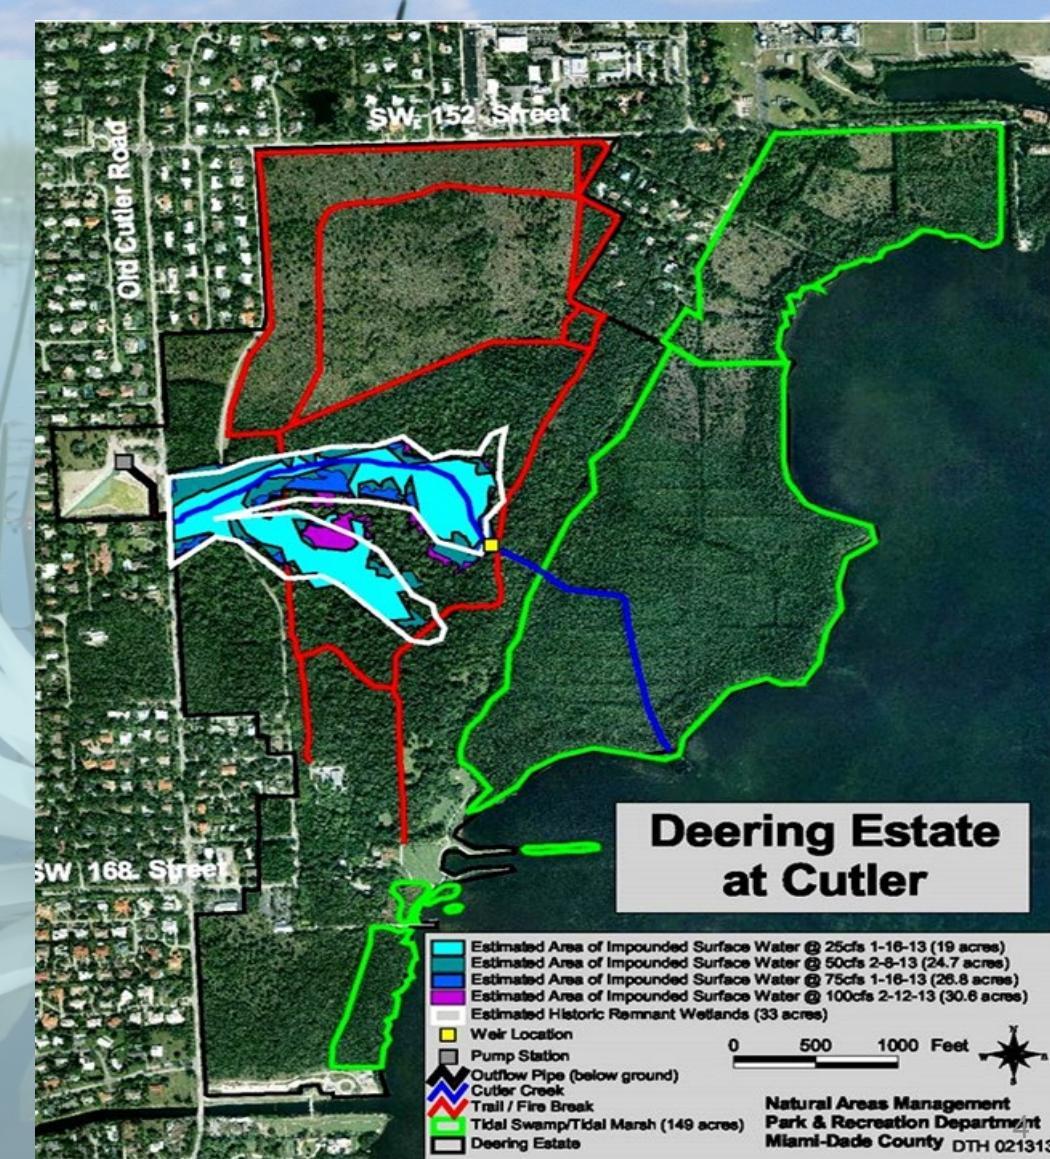
### Biscayne Bay Coastal Wetlands Restoration Deering Estate Hydrological Features

- Determined extent of inundation under various pumping rates
- Estimated acreage of impounded surface water under different pumping/flow rates within Deering Estate

Pumping Rate(cfs)	Duration of Testing	Estimated Acres of Impounded Surface Water	Percentage of Inundate Historic Remnant Wetlands
	(hours)		within Cutler Creek
0	5	0	0%
25	5	19	58%
50	5	25	76%
75	5	27	82%
100	5	31	94%

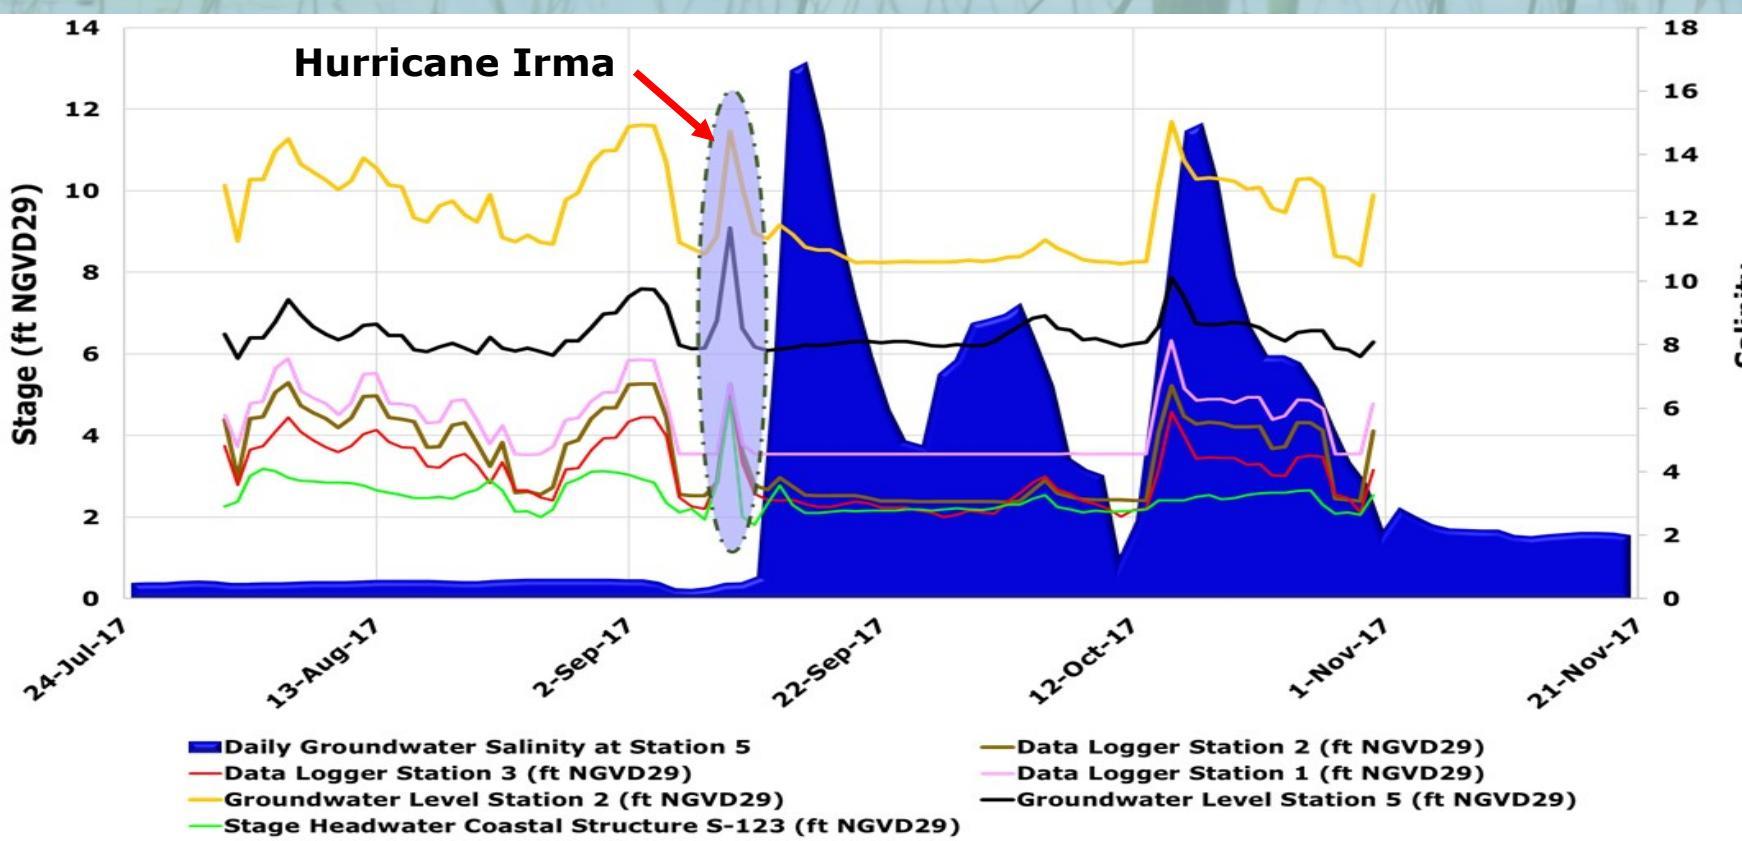
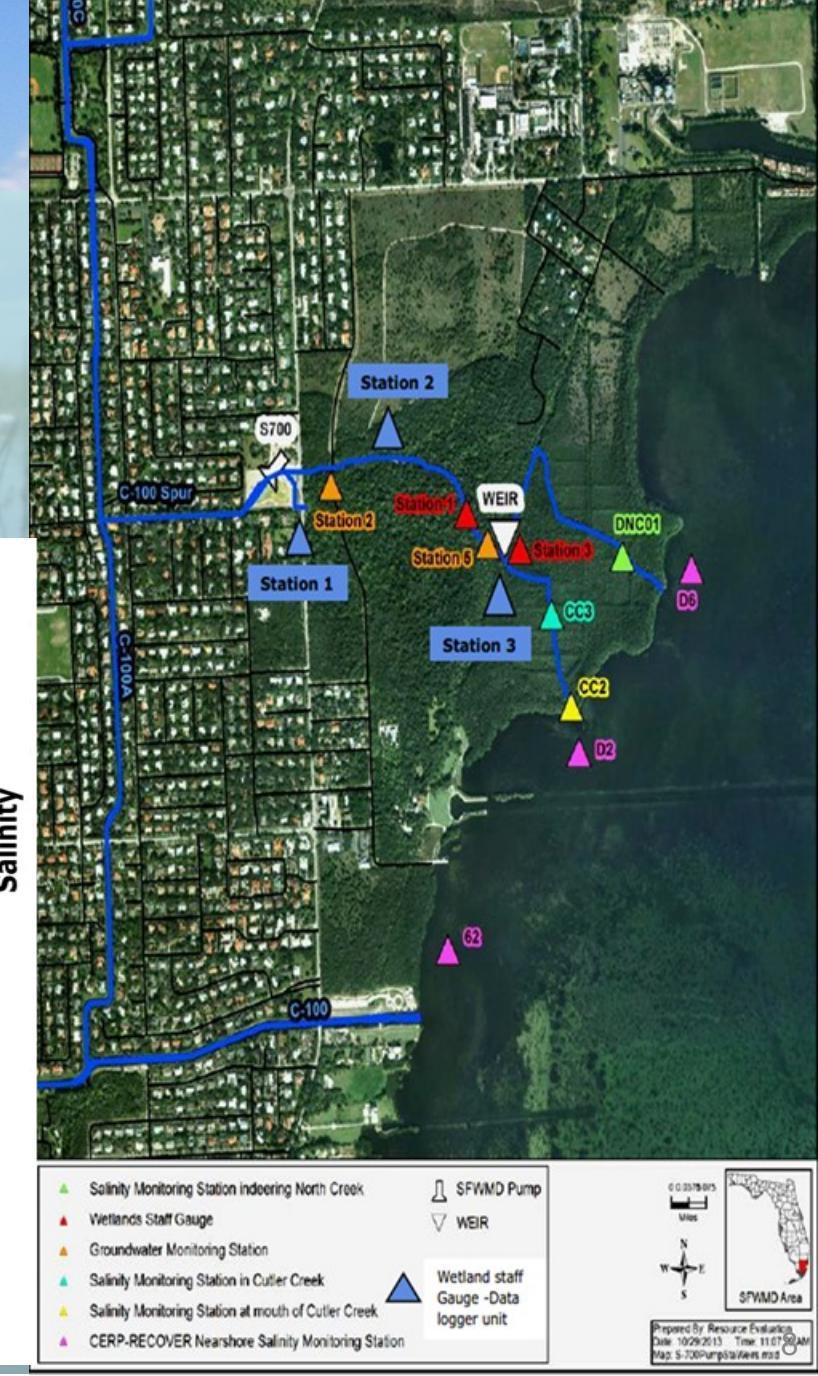
#### Biscayne Bay Coastal Wetlands Restoration Response to Hurricane Irma

- Comparison of salinity in nearshore groundwater versus wetland and groundwater stage during Hurricane Irma
- Comparison of salinity levels at groundwater monitoring stations and daily flow at the Deering Estate Pump Station

- Groundwater salinity also responded to the input of fresh water from Deering Estate pump station
- Groundwater salinity at a nearshore station rose above 17 during Hurricane Irma and was reduced to less than 2 after pump station resumed normal operation salinity
- Groundwater levels rose noticeably compared to baseline levels at groundwater monitoring stations

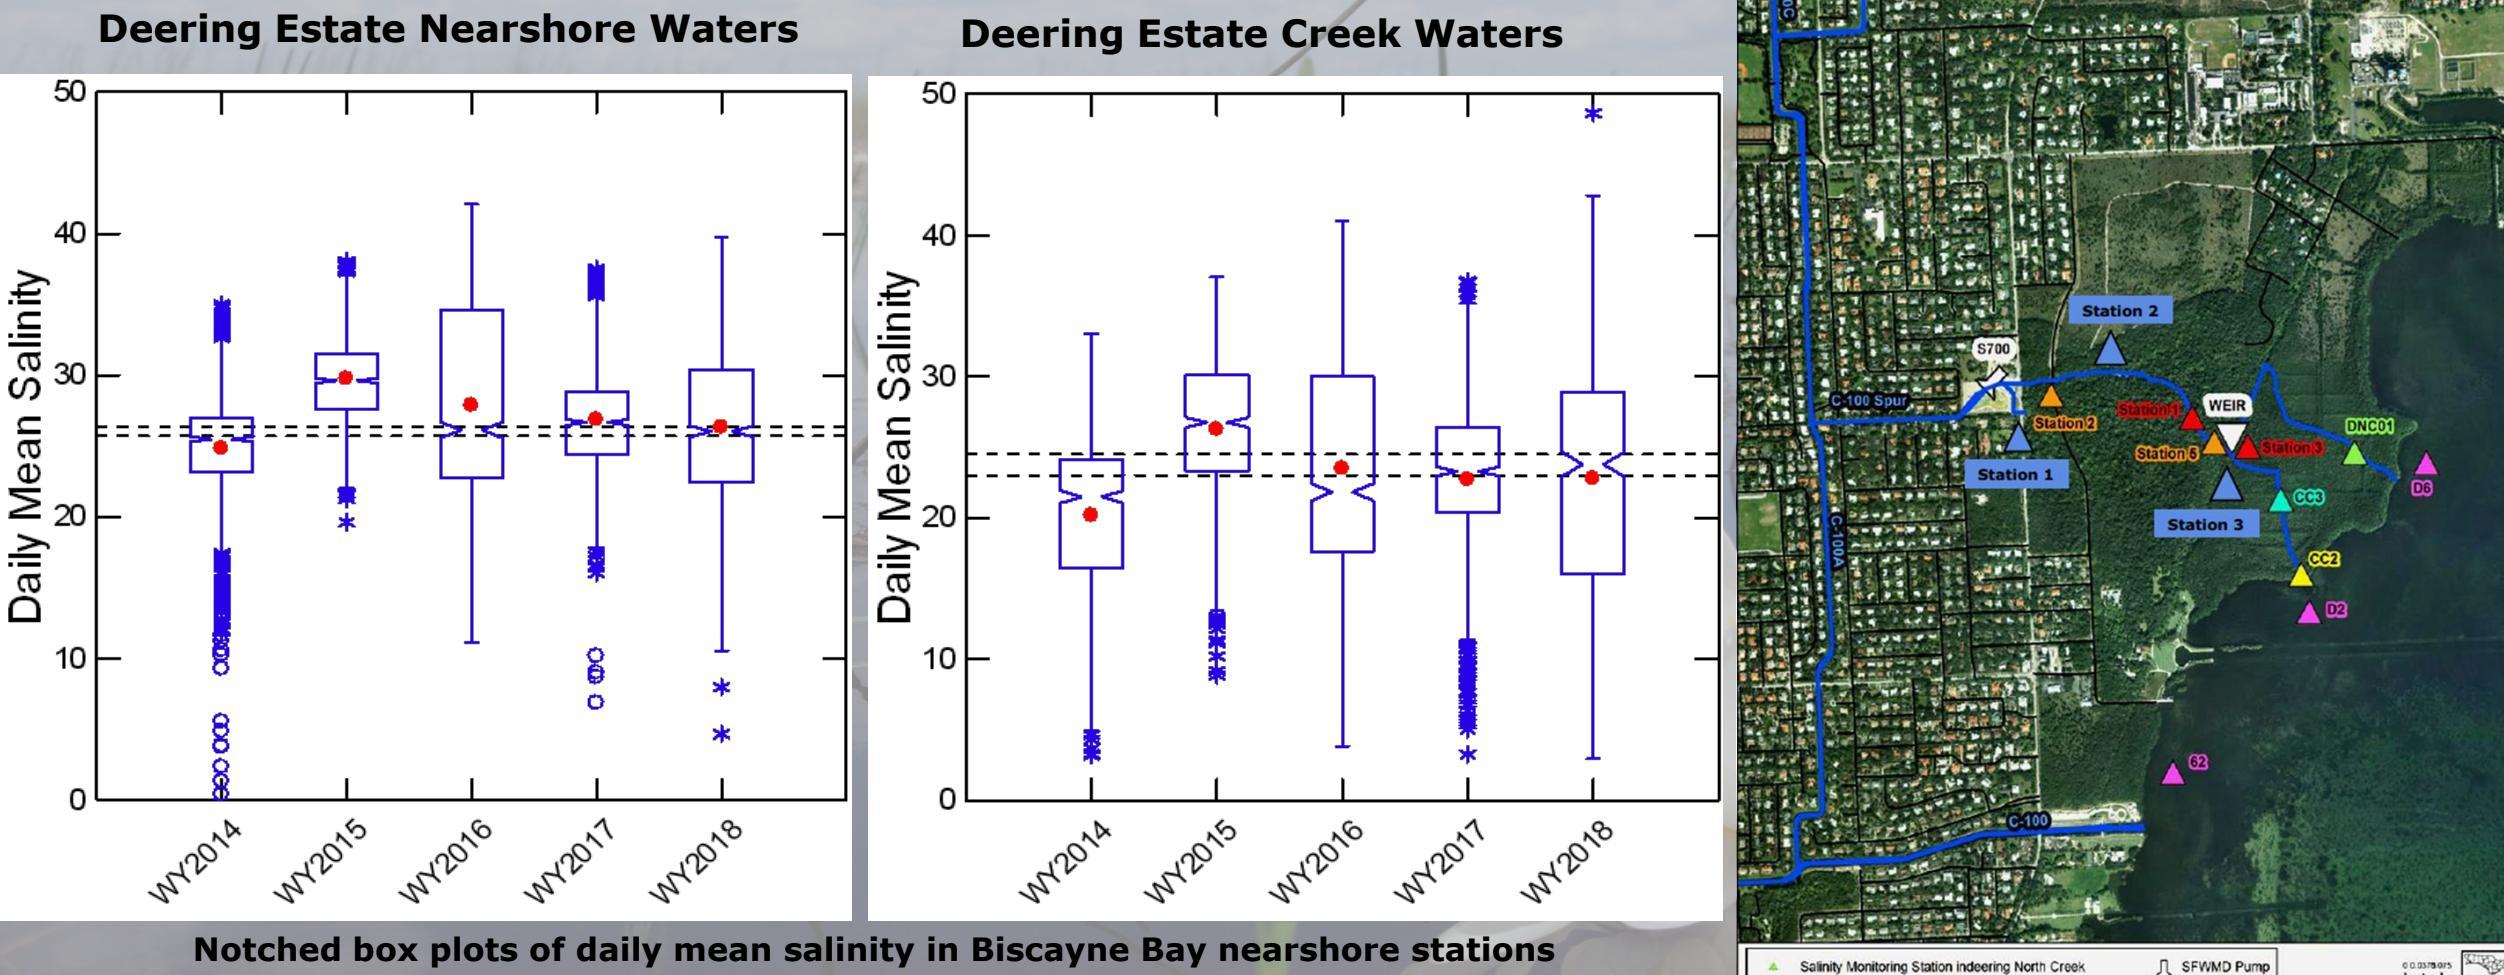
Notched box plots of daily mean salinity in Biscayne Bay nearshore stations (BISC62, BISCD2, and BISCD6) and Deering Estate creek stations (CC2, CC3, and DNC01) by water year (Note: The two black horizontal lines indicate the 95% confidence interval around the median daily salinity for WY2018.)

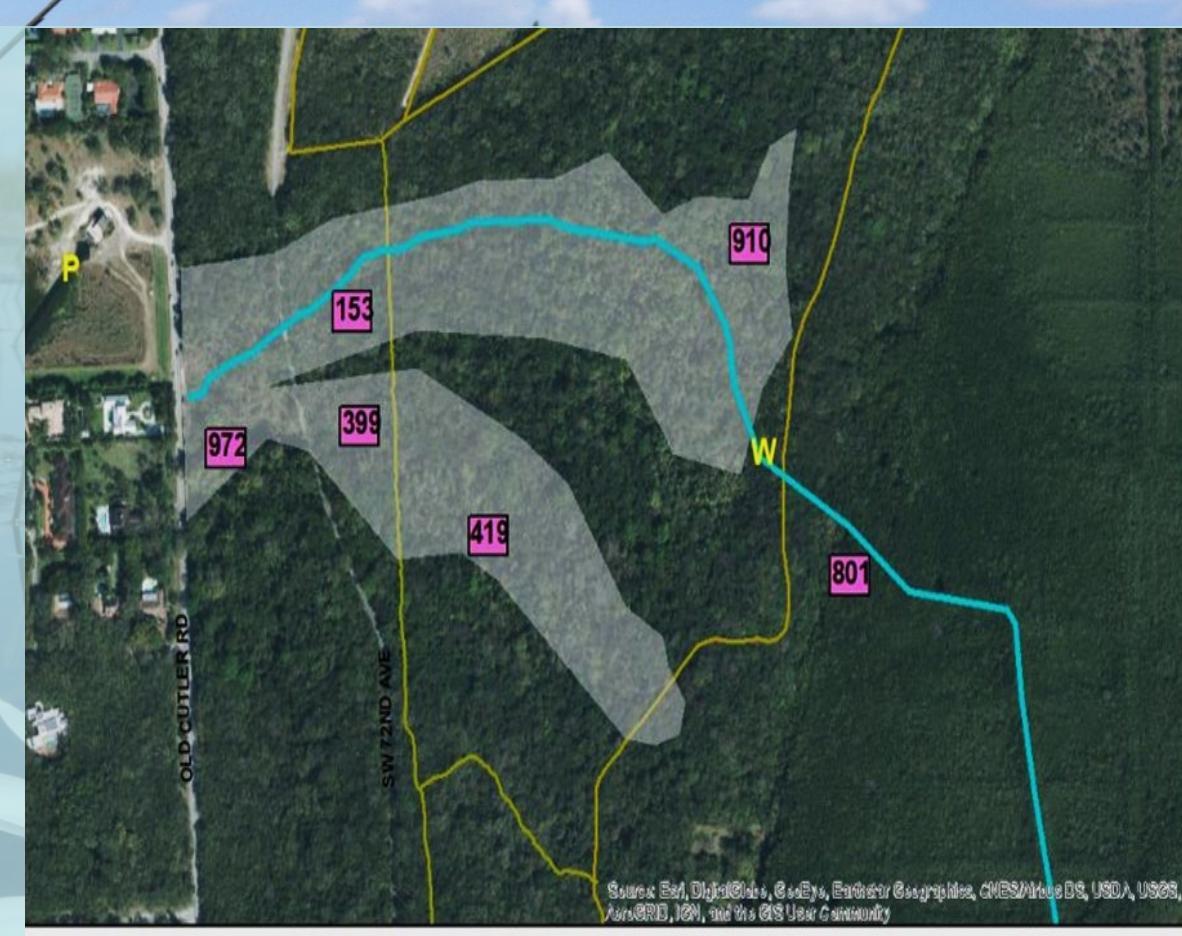
10x10m plots
Retention pond & pump
W Weir Historical sloughCutler Creek

- Sawgrass has begun to establish naturally in the slough
- The abundance of woody seedlings decreased from WY2017 to WY2018 across all plots
- ✓ Hurricane Irma caused significant canopy loss
- State-endangered ferns increased in abundance in both hammock plots

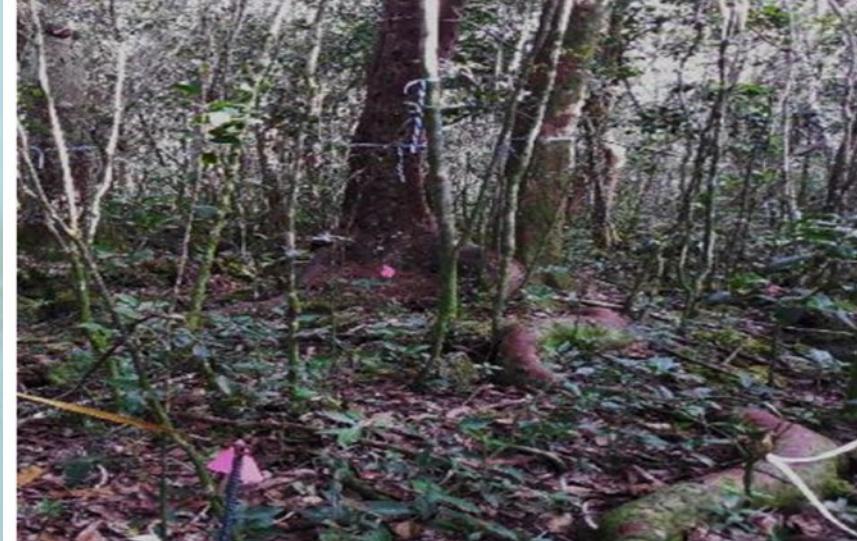
November 2016

BBCW Deering
Estate component
Vegetation
Changes

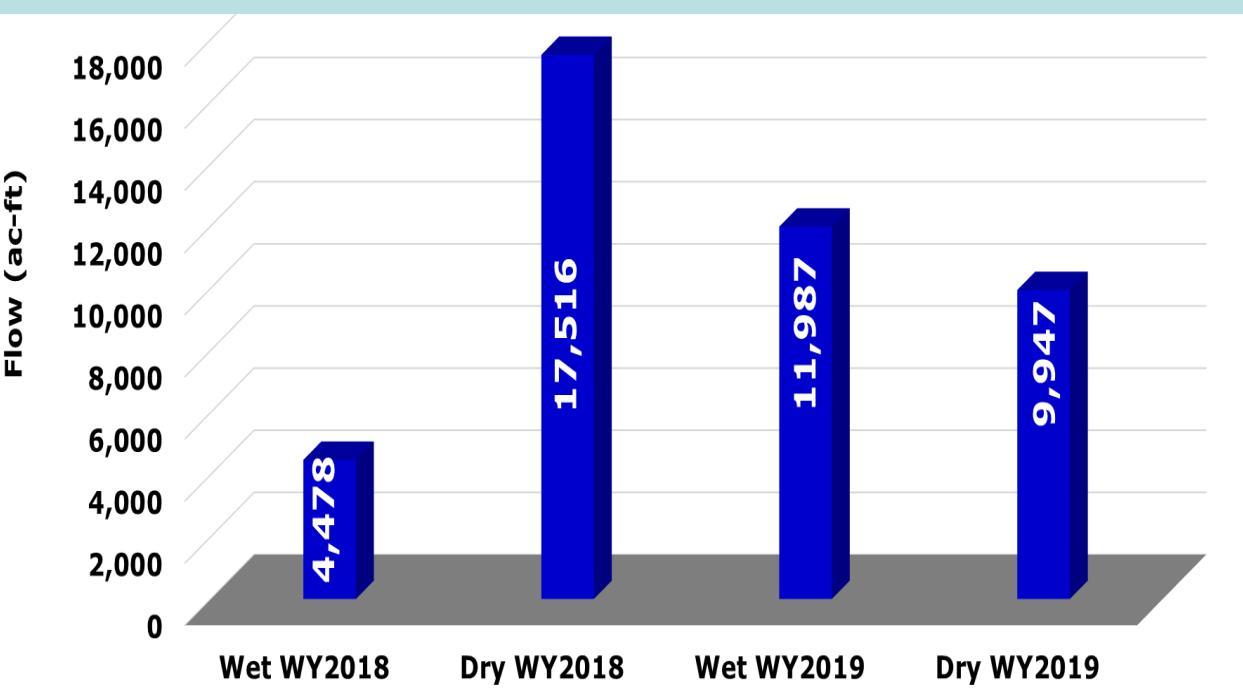
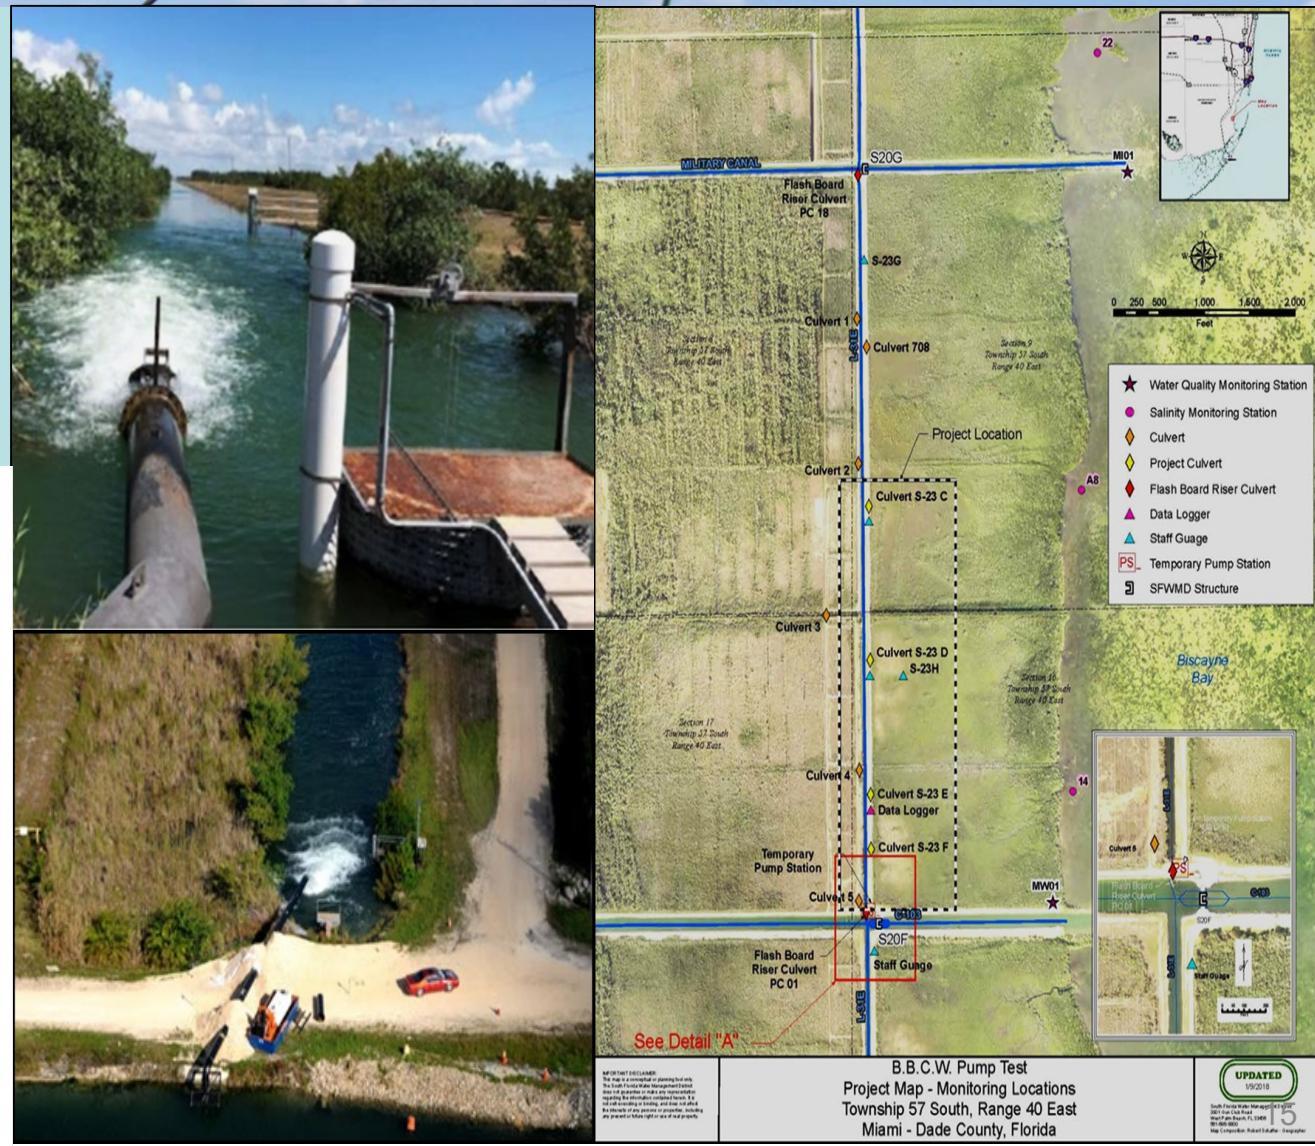
L-31E Flow way Interim electric pump project diverted approximately 44,000 ac-ft of freshwater to the coastal wetlands and Biscayne Bay since August 2017

- Interim electric pump dry season operations started August 2017
- Enhanced sheet flow to the costal wetlands and Biscayne Bay
- Pumping maintained L-31E canal stage at optimal level ~2.20 ft-NGVD29

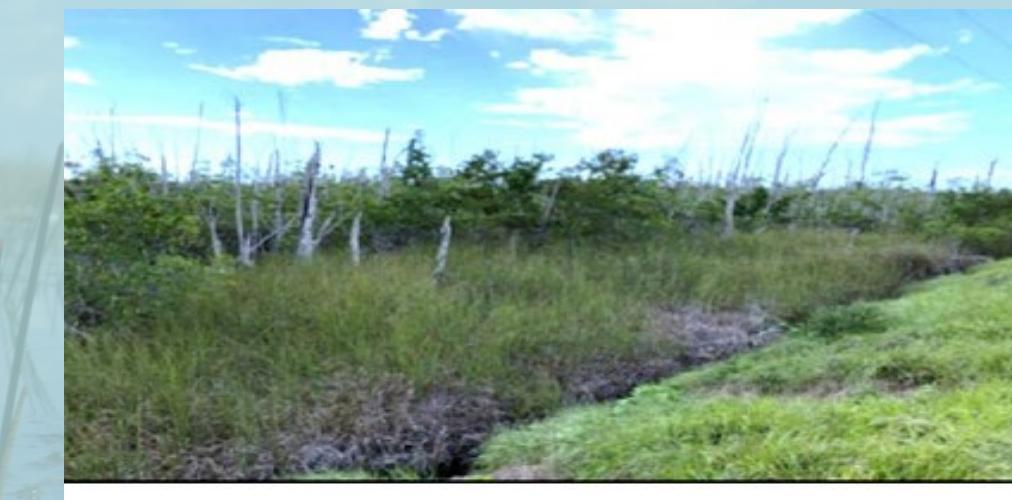
WY2018 sawgrass recruitment east of the L-31E levee

Sawgrass acreage increased more than 9 acres since 2013

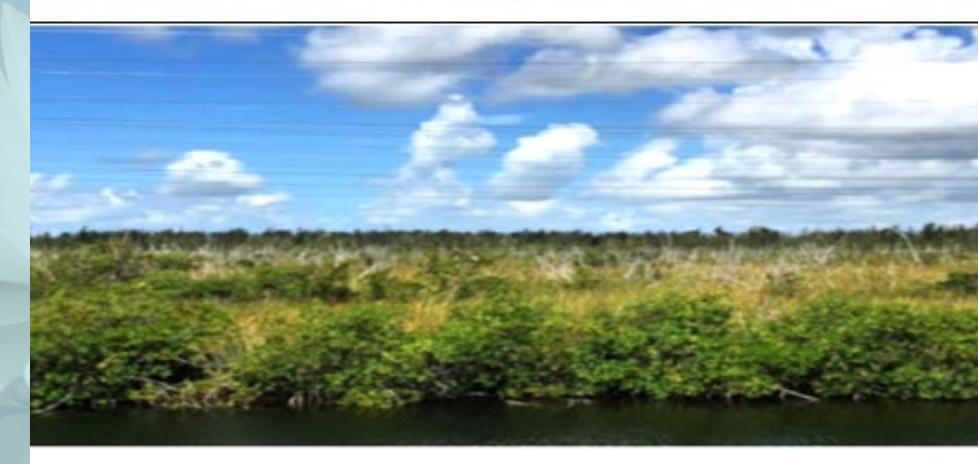
WY2018 sawgrass recruitment west of the L-31E levee 16

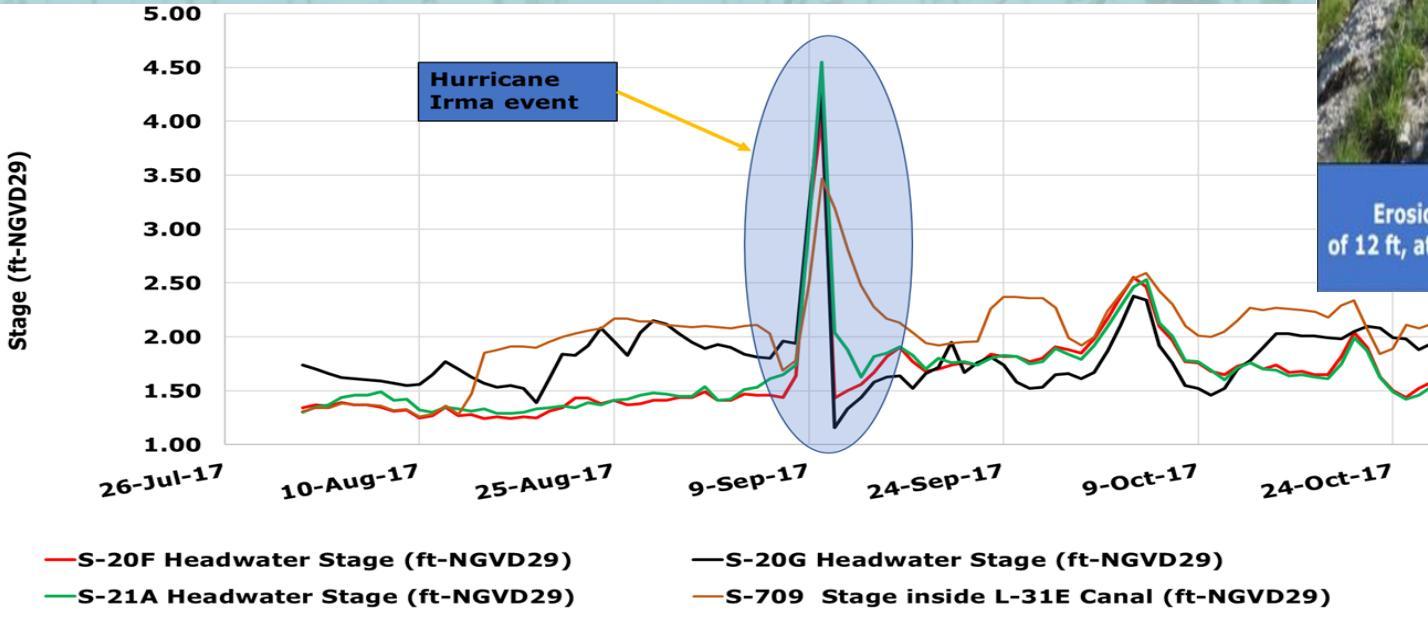
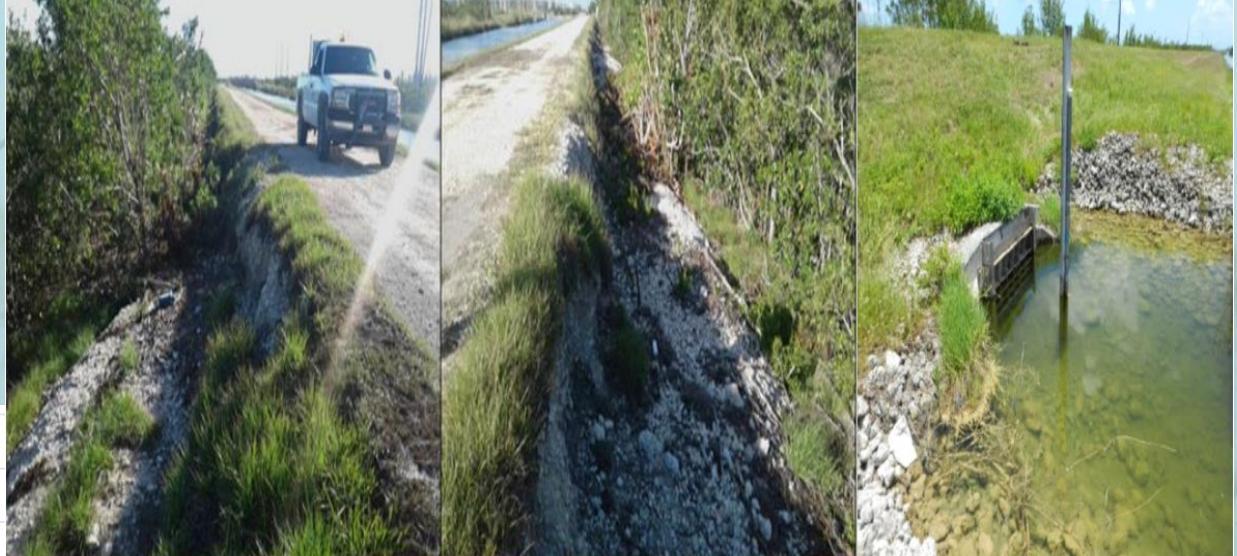
Erosion 4 ft deep and slope length of 12 ft, at culvert S-712A on L-31E levee Erosion entire length from south from S-20G to S-20F, 6,928 ft.

Comparison of stages at the L-31E Culverts in WY2018, highlighting water levels during Hurricane Irma.

SFWMD completed repair of L-31E levee in 2018

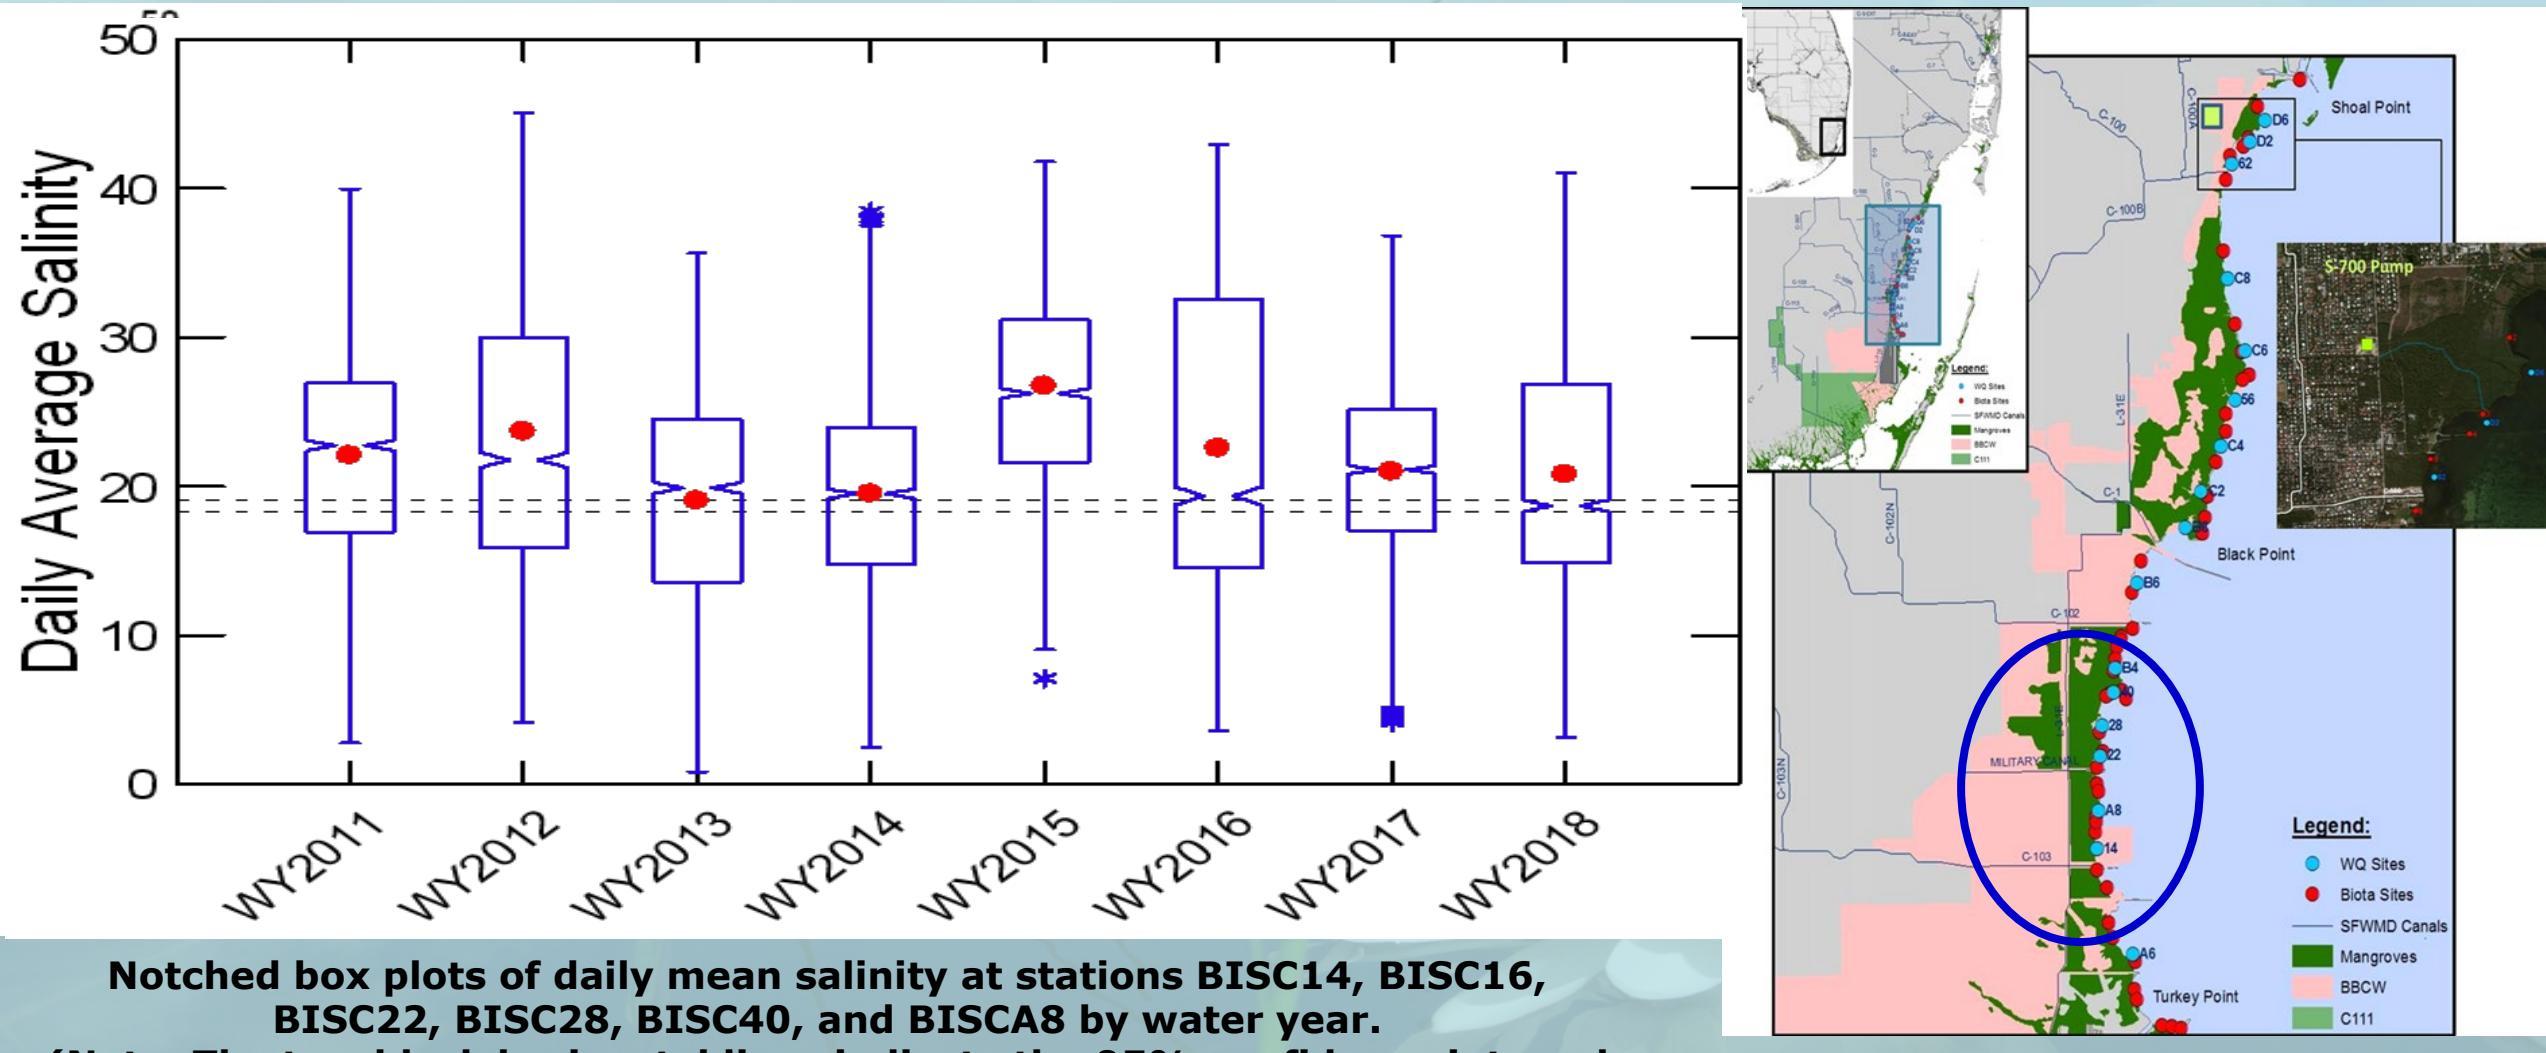
(Note: The two black horizontal lines indicate the 95% confidence interval around the median daily salinity for WY2018.)
