# **IMPROVING THE ROUGE RIVER GREAT LAKES AREA OF CONCERN (AOC) - FISH AND WILDLIFE** HABITAT IMPROVEMENT THROUGH DAM REMOVAL

## AUTHORS: JOHN O'MEARA, P.E., JAMES RIDGWAY, P.E., ENVIRONMENTAL CONSULTING & TECHNOLOGY, INC. KAREN MONDORA, P.E., CITY OF FARMINGTON HILLS AND KELLY CAVE, P.E., WAYNE COUNTY DPS

### DANVERS POND DAM REMOVAL AND **STREAM RESTORATION PROJECT**

### WAYNE ROAD DAM REMOVAL AND HABITAT IMPROVEMENT PROJECT

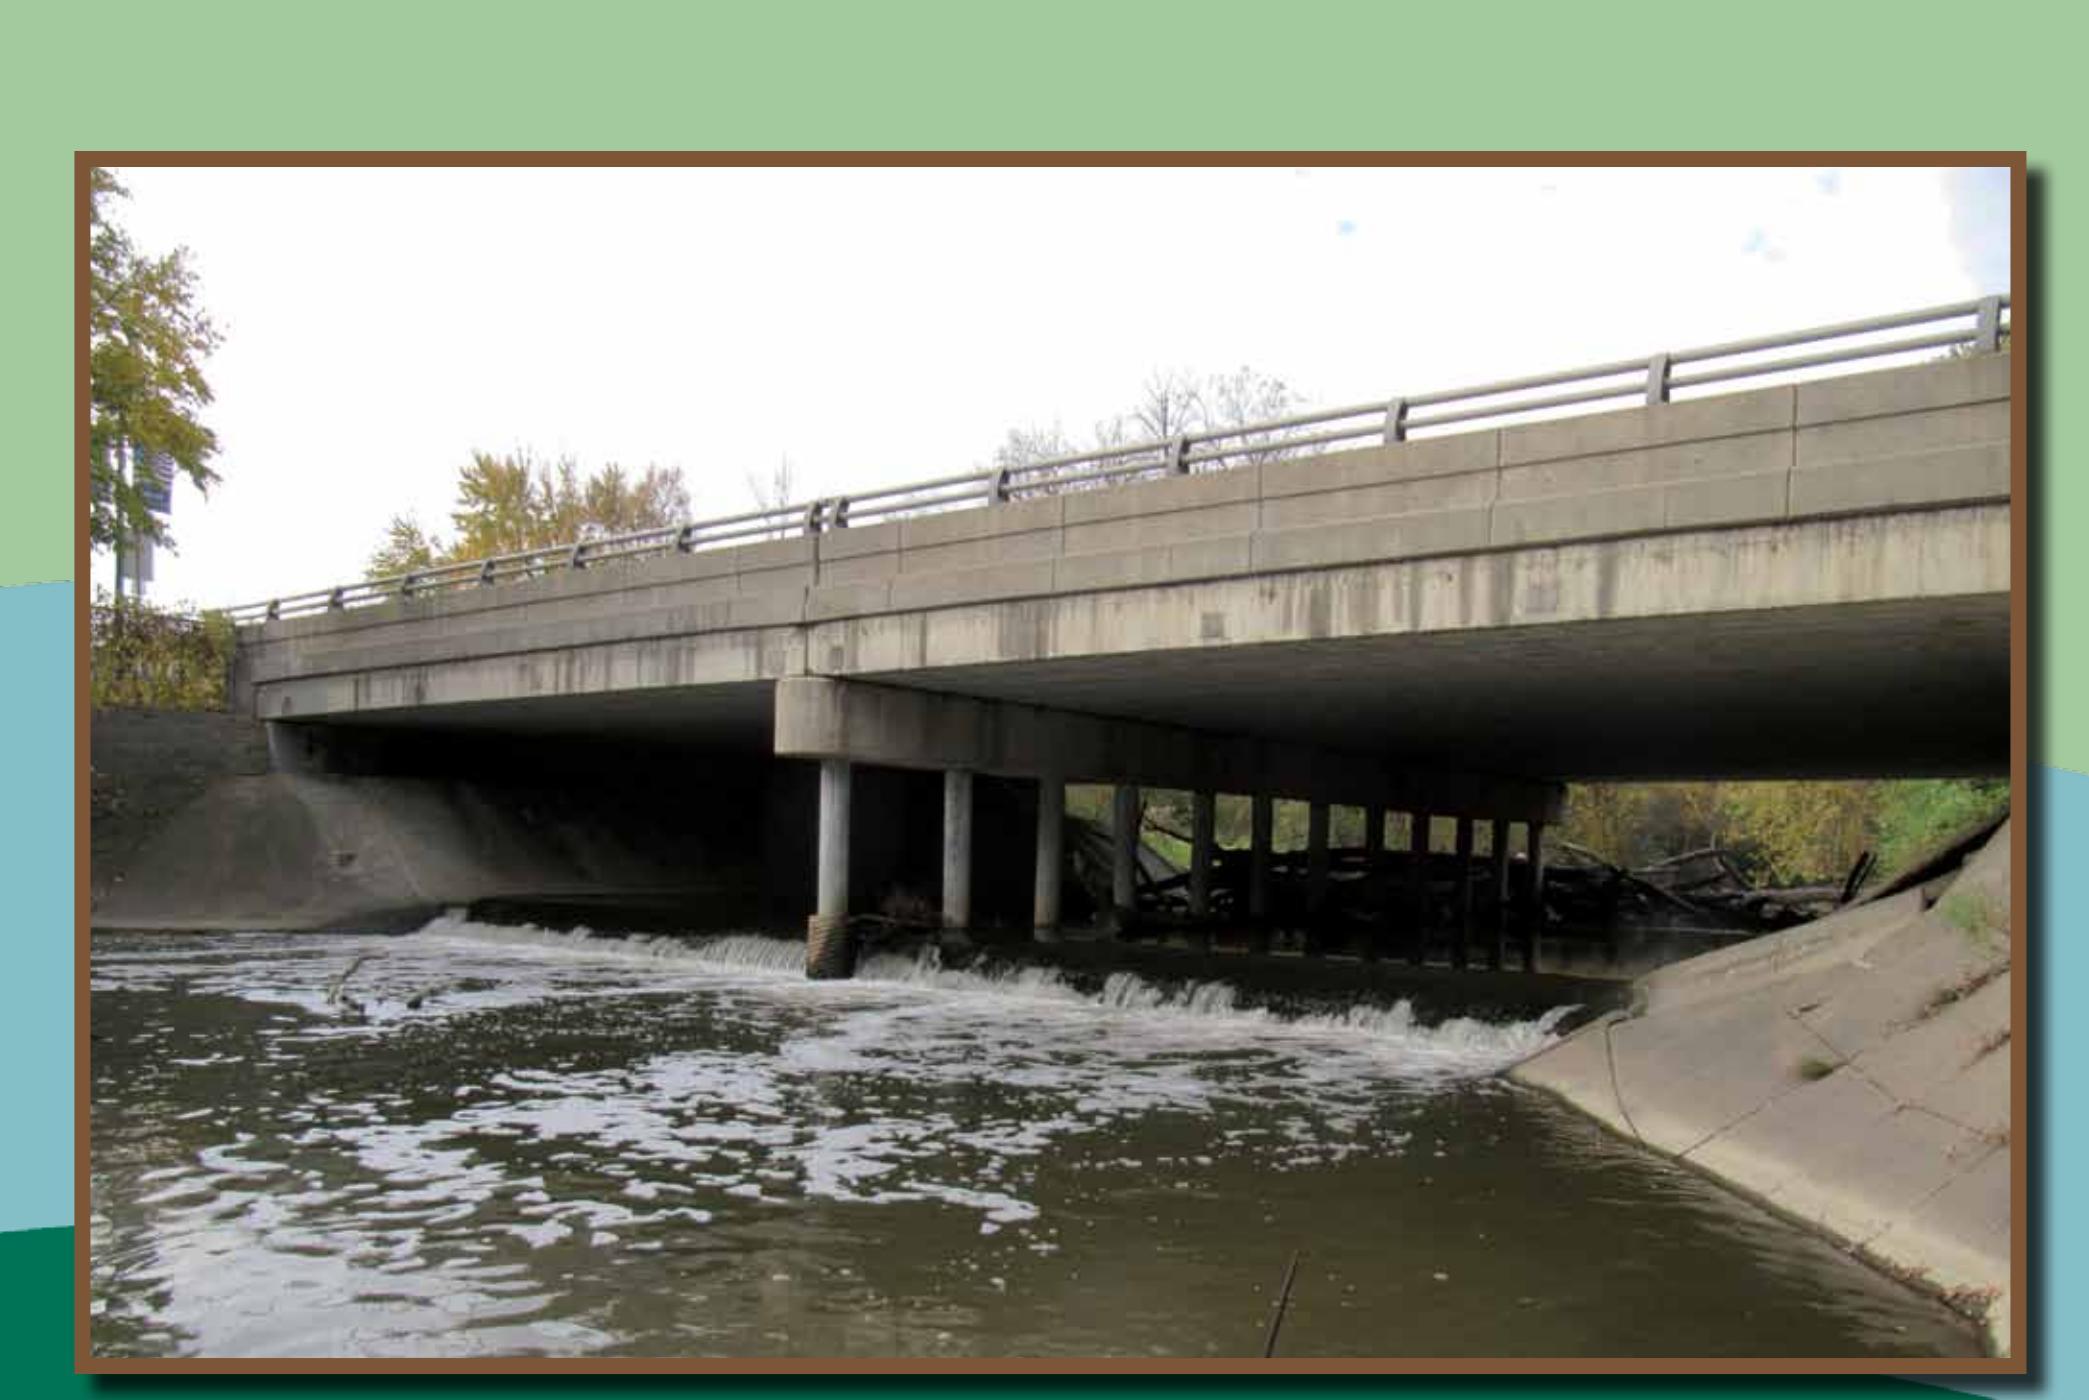
Wayne Road Dam before restoration

The Wayne Road Dam, built in 1914, was located in the City of Wayne, Michigan along the Lower Branch of the Rouge River. The dam no longer served a public purpose, and was an impediment to passage of the variety of fish found in the vicinity of the dam. An island

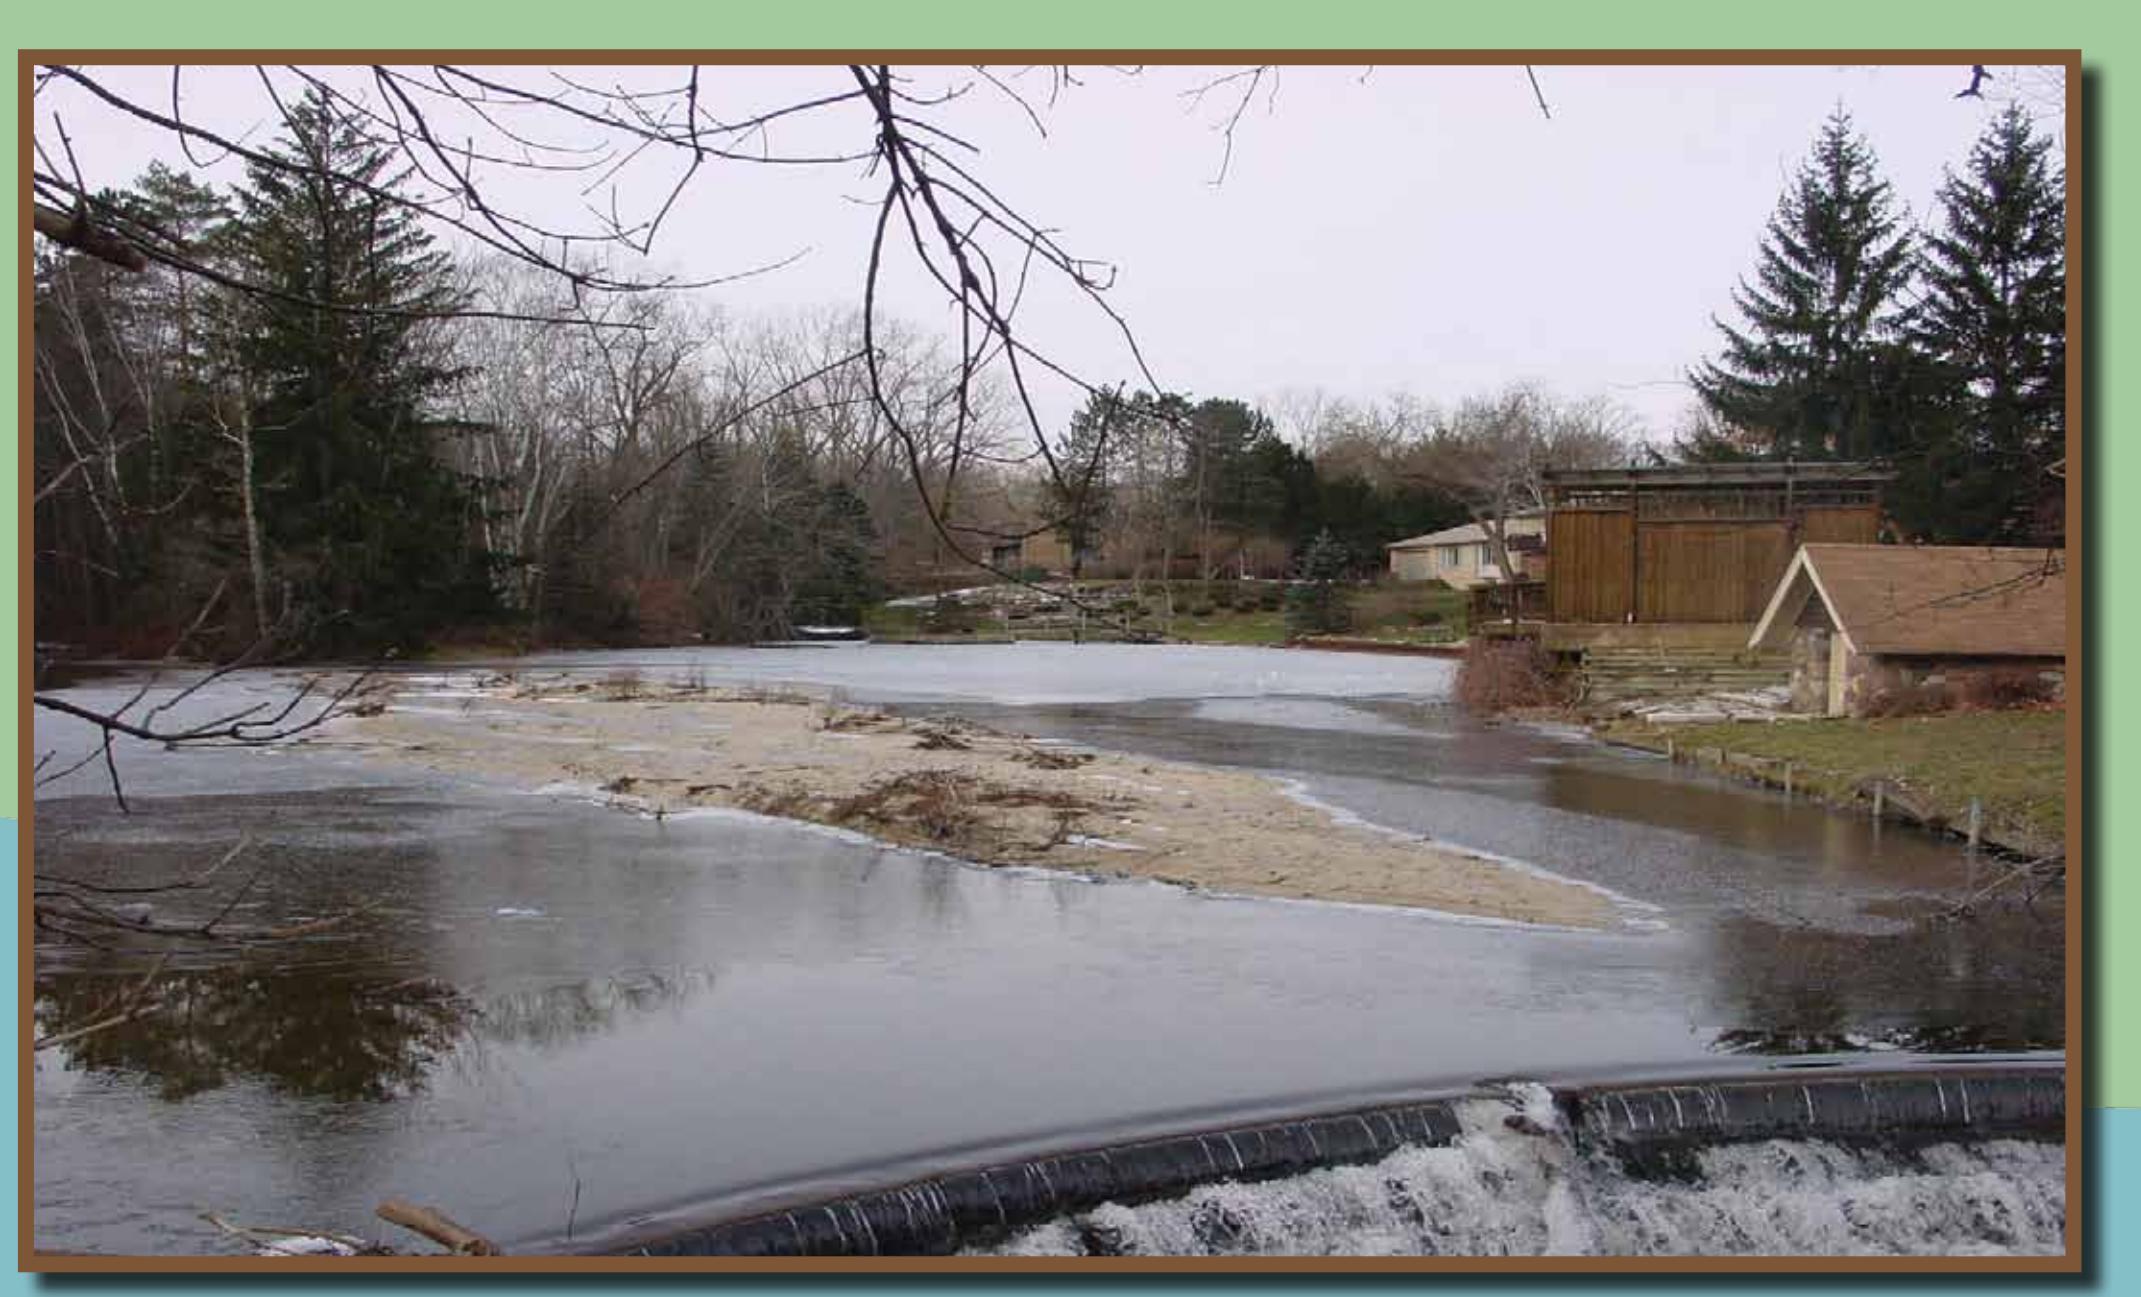
Danvers Pond Dam before restoration

The Danvers Pond, created when a dam was built in 1927, was located in the City of Farmington Hills, Michigan along the Main branch of the Rouge River. The dam acted as a barrier to fish passage as well as promoted the accumulation of sediment within the pond, which contributed to the degradation of the creek. Removal of the dam was a priority project for the Rouge Remedial Action Plan in order to implement delisting targets for Fish and Wildlife Habitat and Population BUIs. Removal and restoration reduced the impact on the environment. The project also fulfilled local and sub-watershed goals by improving the quality of the ecosystem and restoring approximately two acres of habitat for fish and terrestrial wildlife.

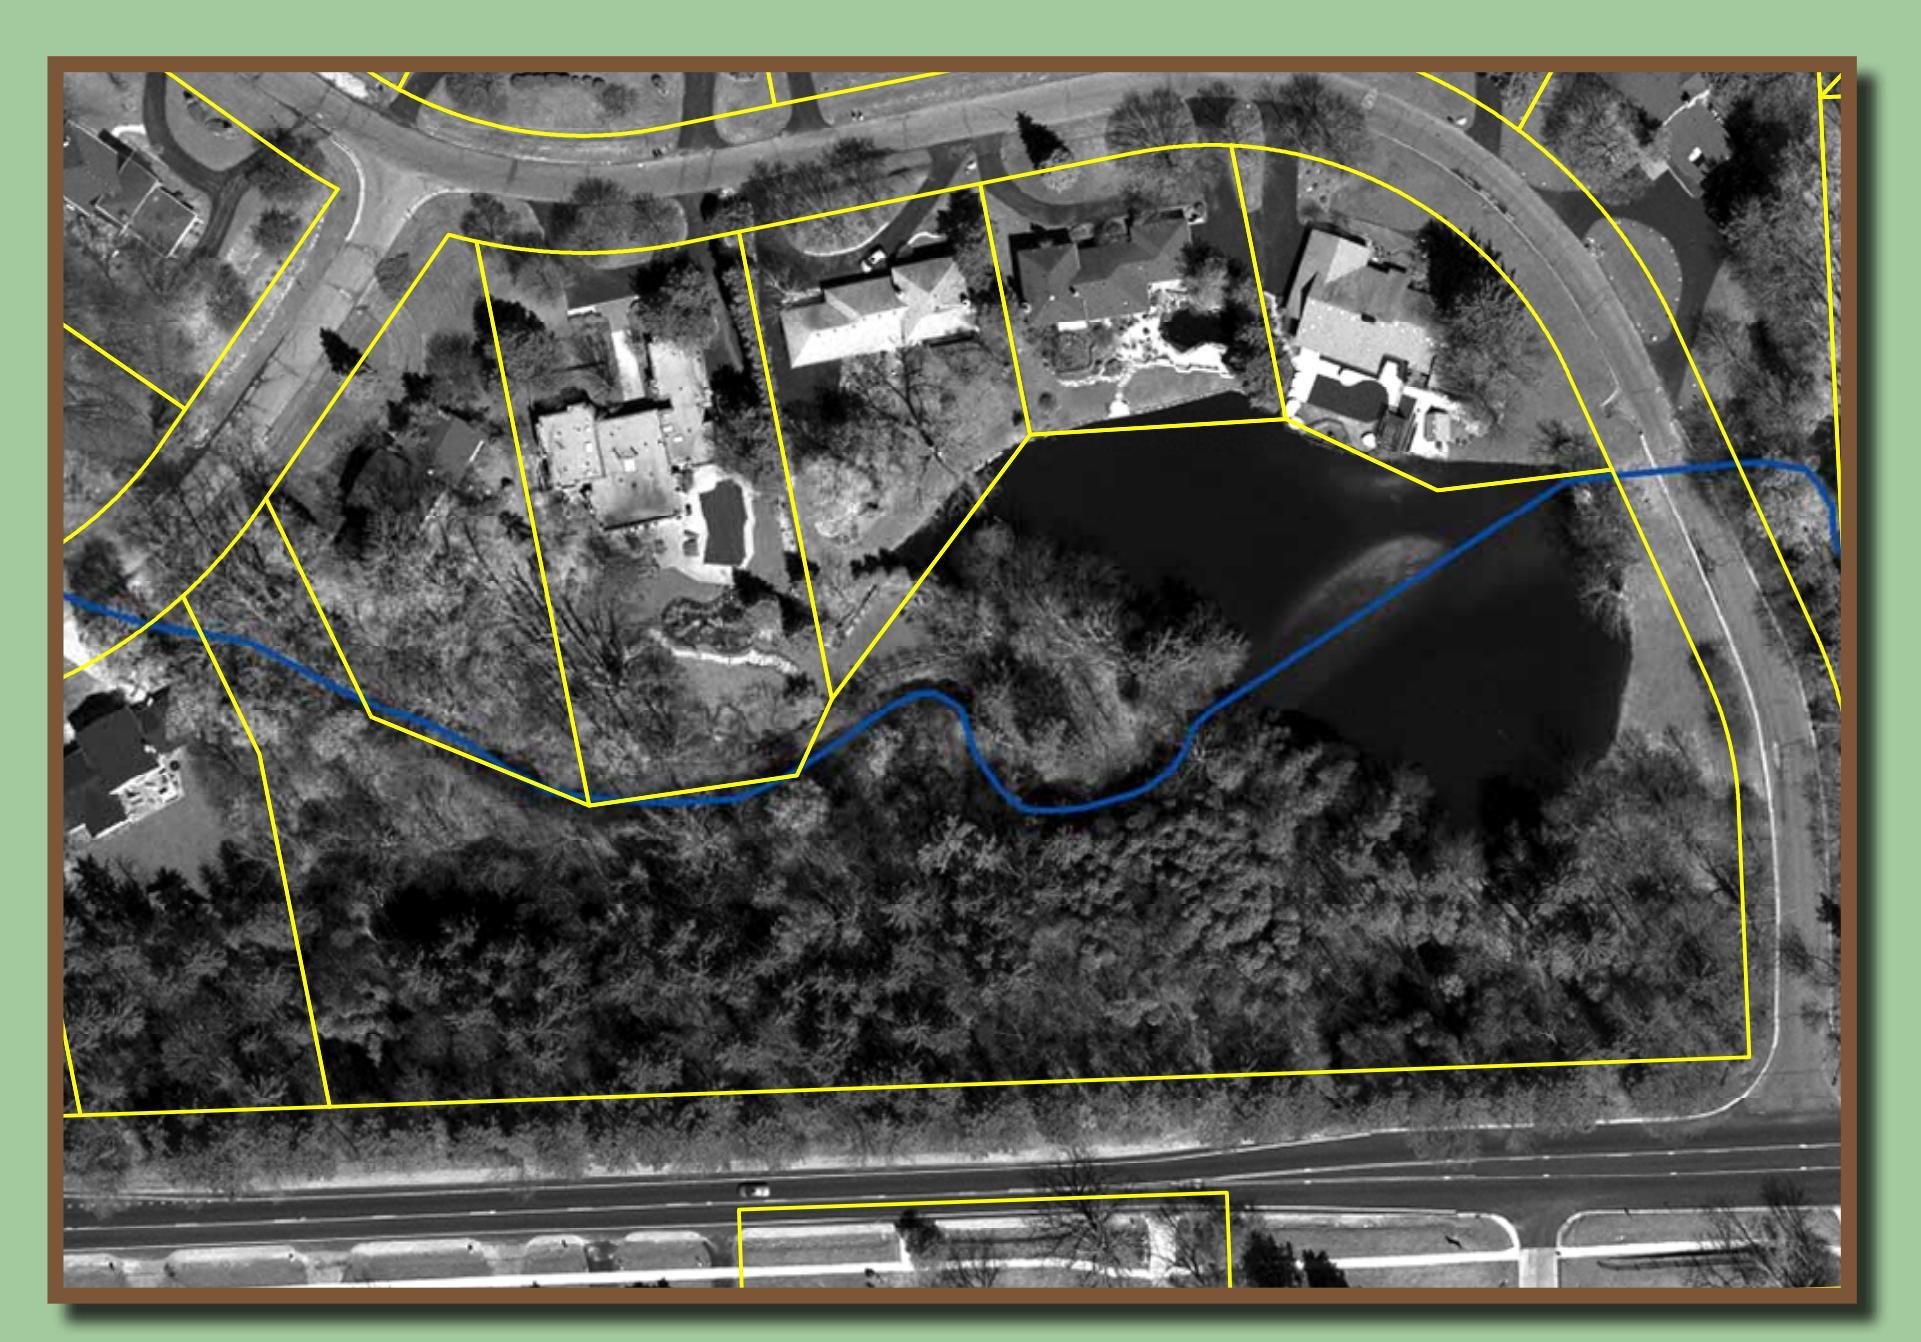
Aerial view of Danvers Pond Dam showing sediment accumulation - 2006

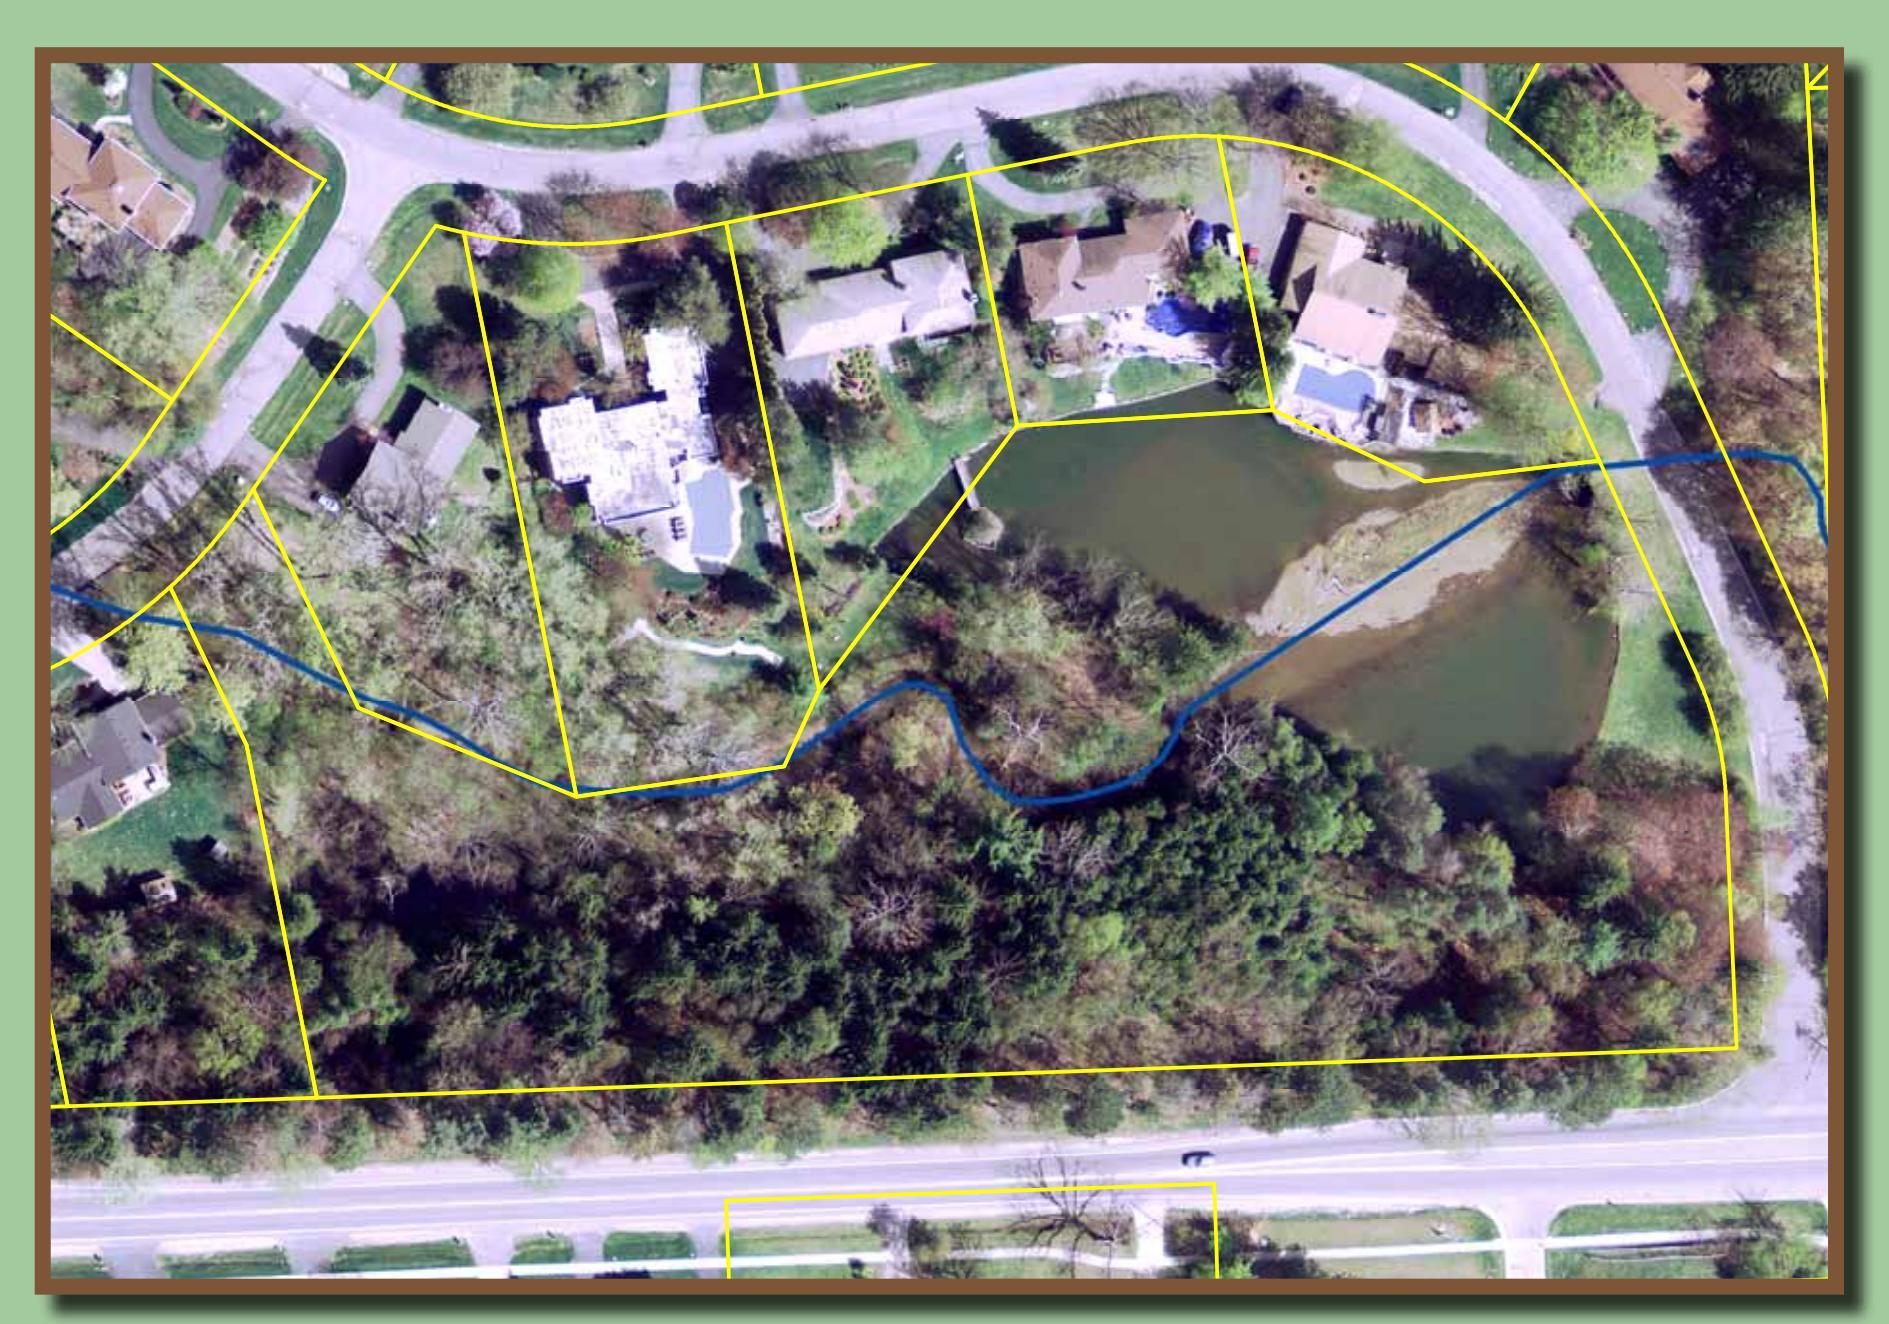
Aerial view of Danvers Pond Dam showing increase in sediment accumulation - 2010

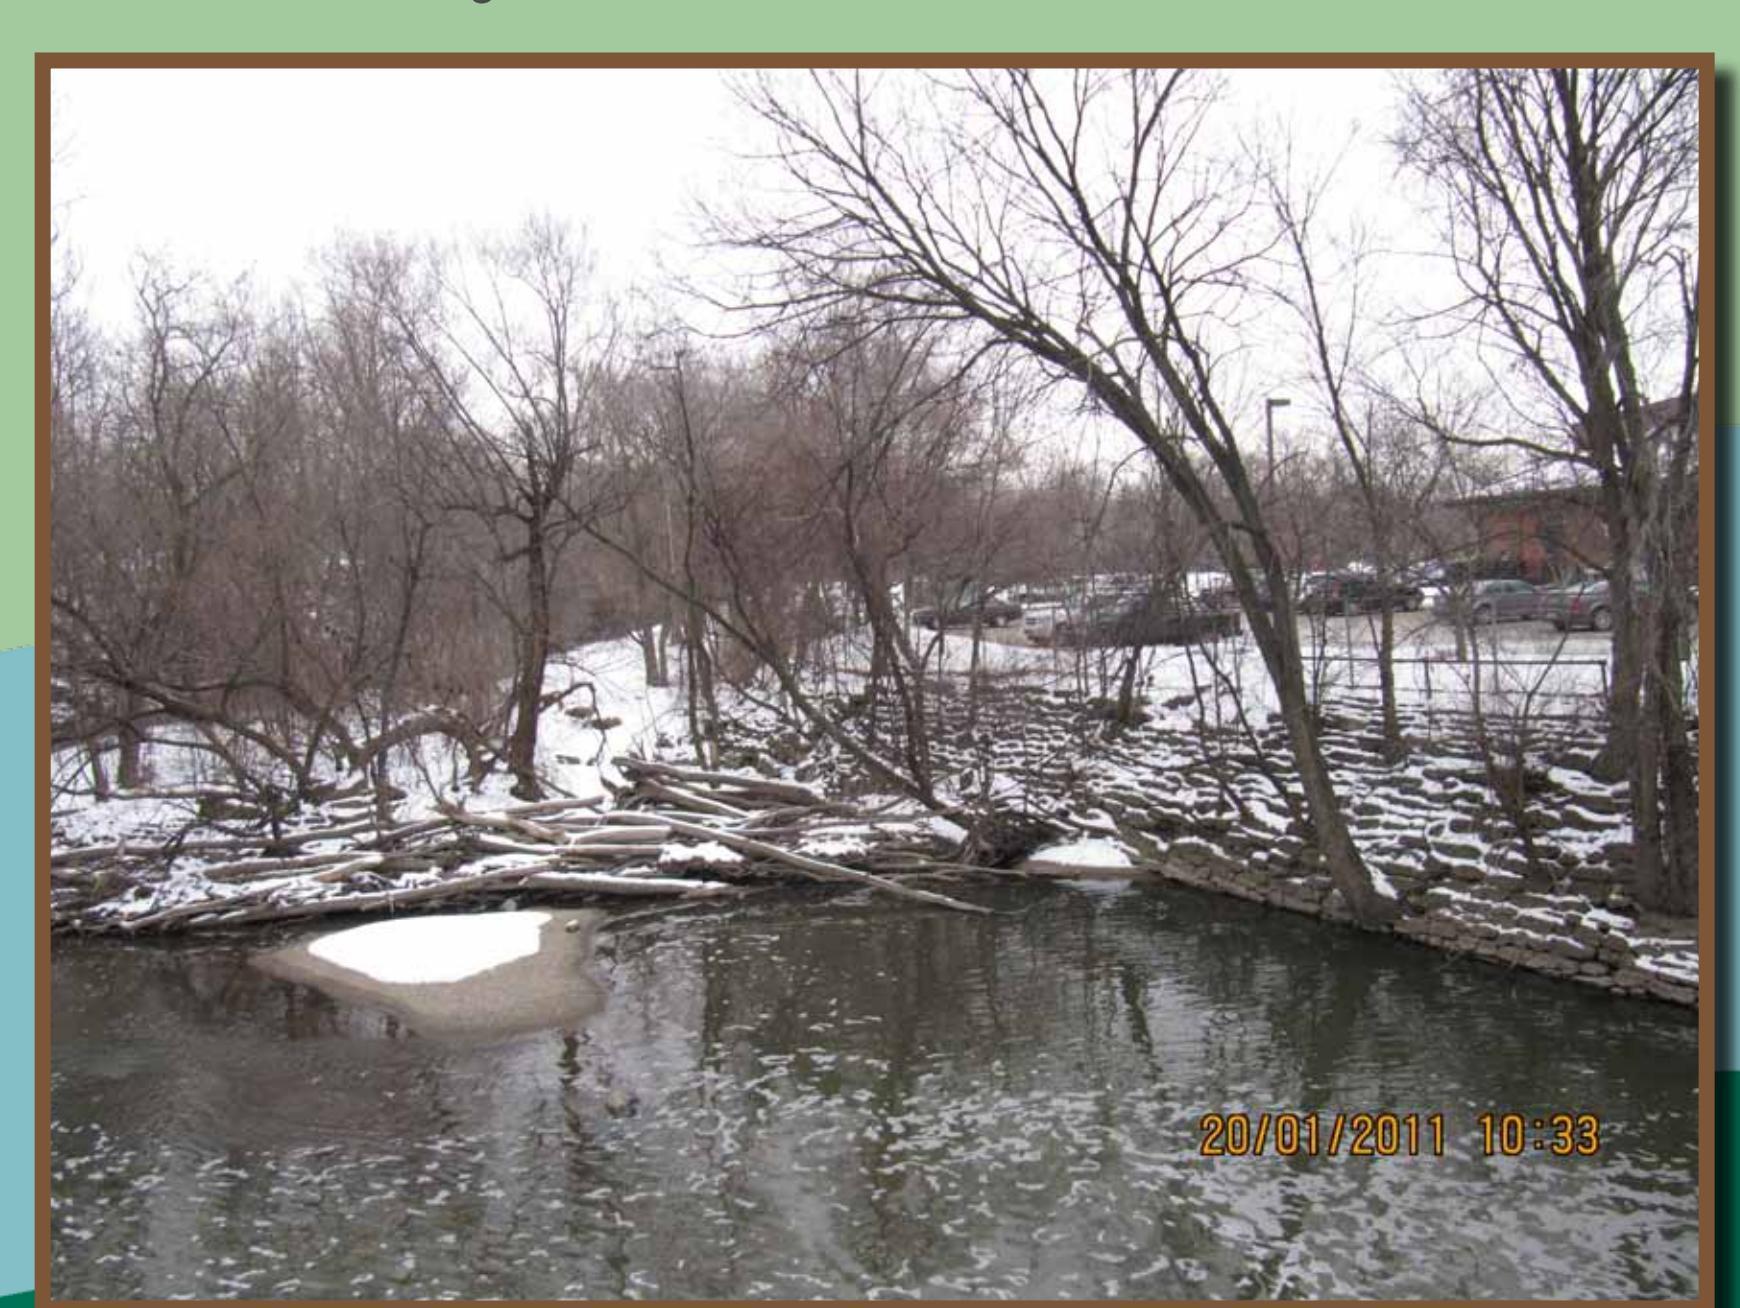
downstream of the dam was disrupting the natural sediment transport, causing flow impingement, and promoting erosion. The MDNR 1998 Fisheries Assessment identified the Wayne Road Dam as a major impediment to restoring fish and wildlife habitat in the Rouge River. Removal of the dam was also a priority project for the Rouge Remedial Action Plan in order to implement delisting targets for Fish and Wildlife Habitat and Population BUIs. Removing the Wayne Road Dam was considered one of the most important dam removal projects in the Rouge River Watershed because it reconnected the Rouge River to the Detroit River and the Lake Erie ecosystem.

Island downstream of the Wayne Road Dam

In order to create a sustainable flow channel with reduced shear stresses and velocities immediately downstream of the dam, approximately 320 feet of channel was modified. Improvements included removal of the in-stream island and re-grading to create a primary flow channel, with bankfull benches on both sides of the channel.

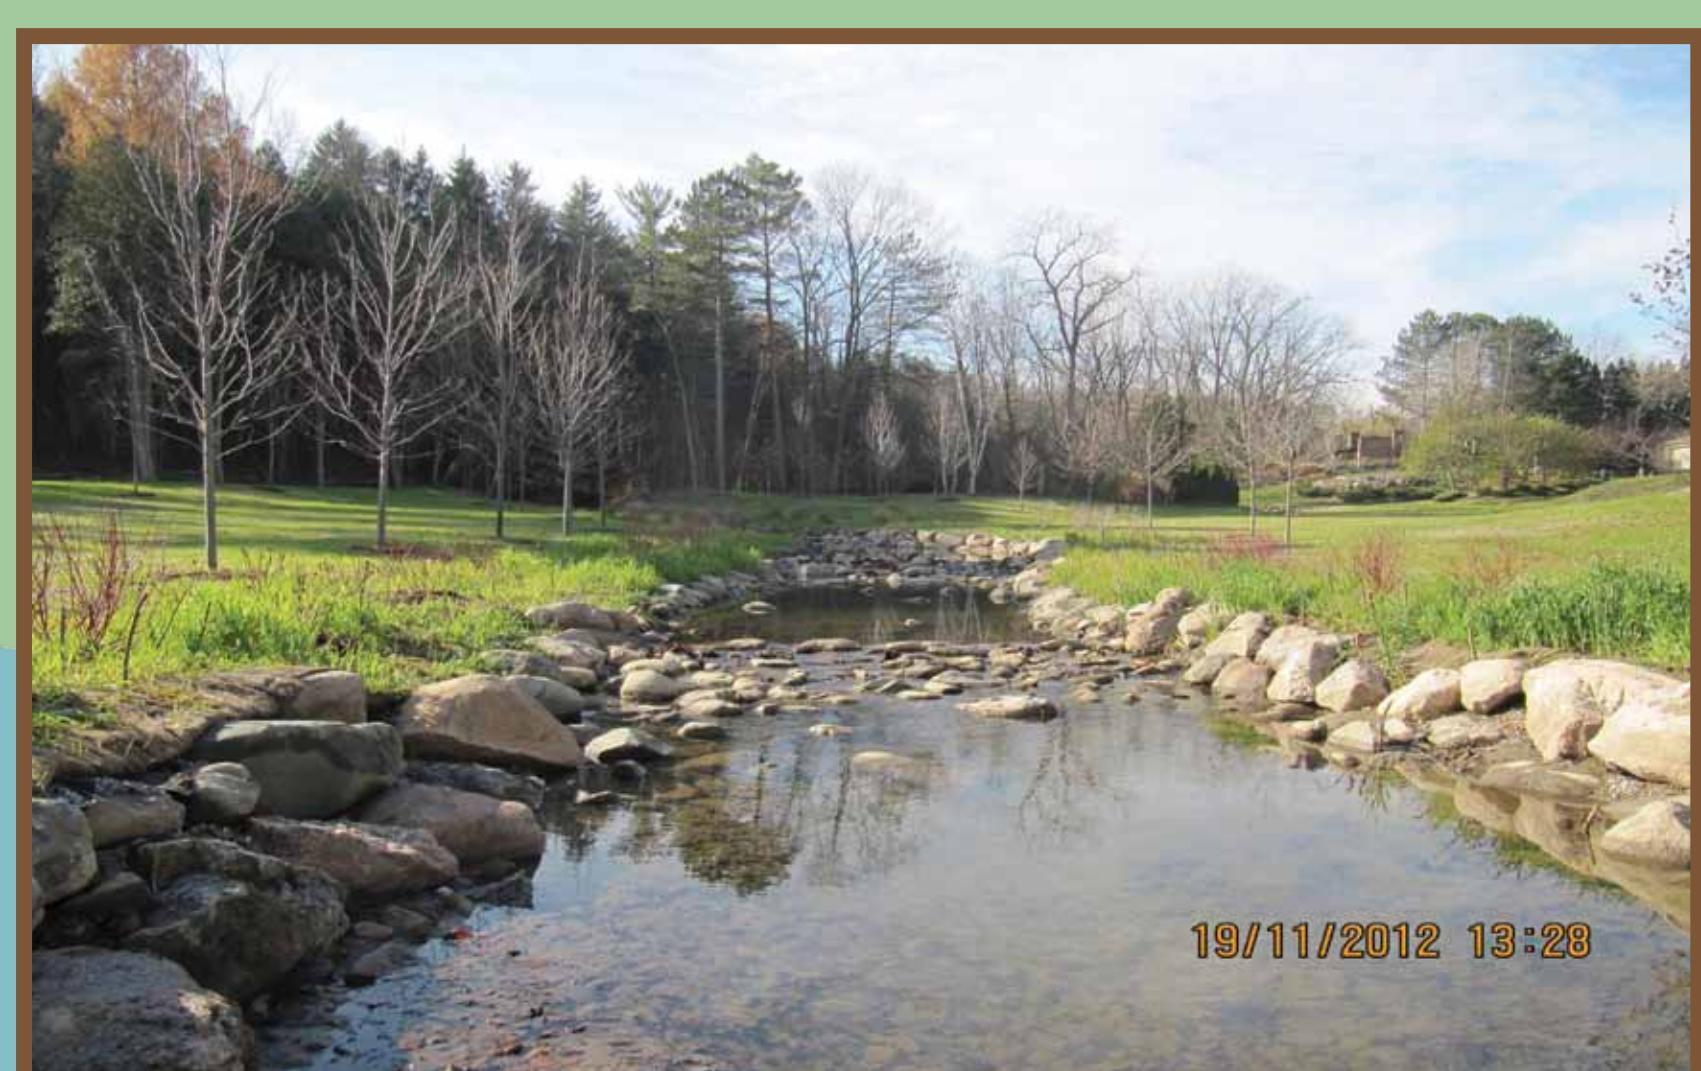
- Removal of the dam now allows for unencumbered fish passage for Pebble Creek.
- Sedimentation within the creek has been reduced.
- Two acres of woodland and wetland habitat were restored.
- Approximately 300 linear feet of naturalized stream channel was created which improved habitat conditions for fish and wildlife using the corridor.
- Created a natural buffer between developed private property and the stream corridor.
- Minimized the amount of soil erosion and sedimentation.
- Improve and maintain the river ecosystem for wildlife and restore/maintain aesthetically appealing conditions.
- Fulfilled a goal of the City of Farmington Hills Storm Water Pollution Prevention Initiative.
- Wildlife usage of the project site evident. Whitetail deer, great blue herons, small fish and crayfish have been observed.

After restoration

- Removal of the arch dam structure and wing walls and re-graded.
- The flow of Pebble Creek restored through the existing culvert.
- The existing culvert under the road serves as downstream grade control for stream channel.

- An artificial riffle was constructed to control the streambed elevation upstream of the impoundment. Constructed with natural boulders and cobbles and trenched into the streambed and banks to the expected depth of scour. If the streambed elevation was not controlled, bed erosion and incision would cause instability, leading to streambank erosion, infrastructure damage, private property damage, and excessive sediment transport downstream of the dam.

- Constructed riffles were used to dissipate energy and control the stream bed elevation in the restored channel. A benefit of the artificial riffles is that they have an appearance similar to natural riffles and provide habitat for macroinvertebrates and fish. Associated pools provide fish habitat and wading bird habitat.

- Restoration of the creek through the pond, including restoration of pattern, stream habitat, and a vegetated floodplain with expected terrestrial wildlife value.

- The bottom lands exposed were restored as a natural functioning floodplain.
- Restored floodplain is capable of conveying and storing water during floods with native vegetation similar to wet-meadow communities along streams.
- Floodplain restoration also creates a natural buffer and wildlife habitat along the corridor.

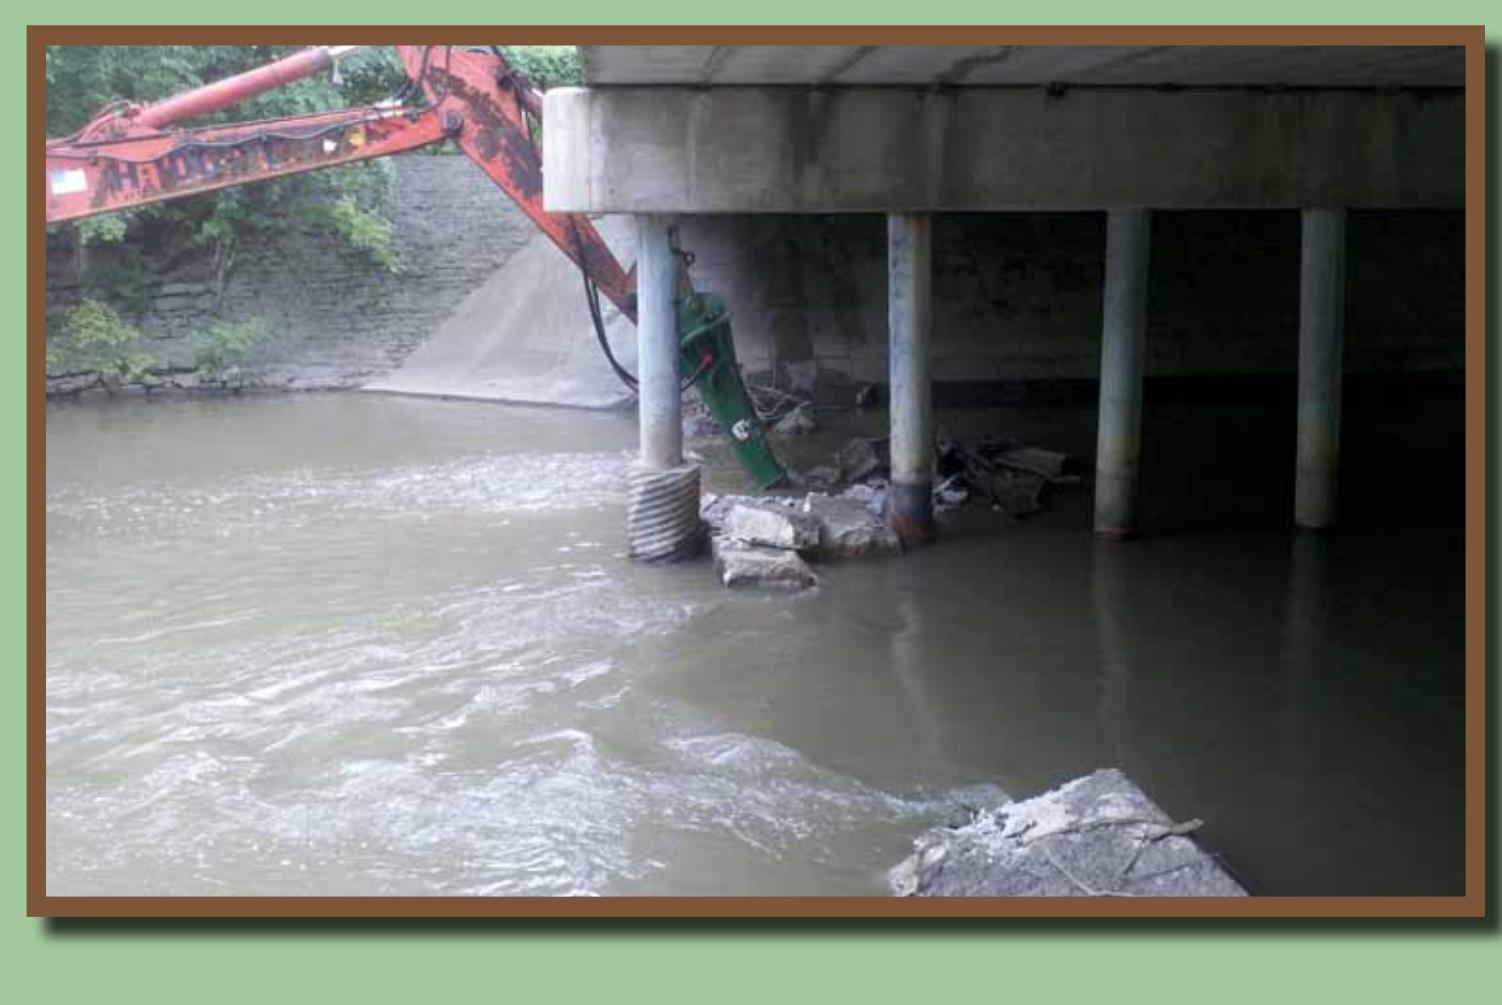
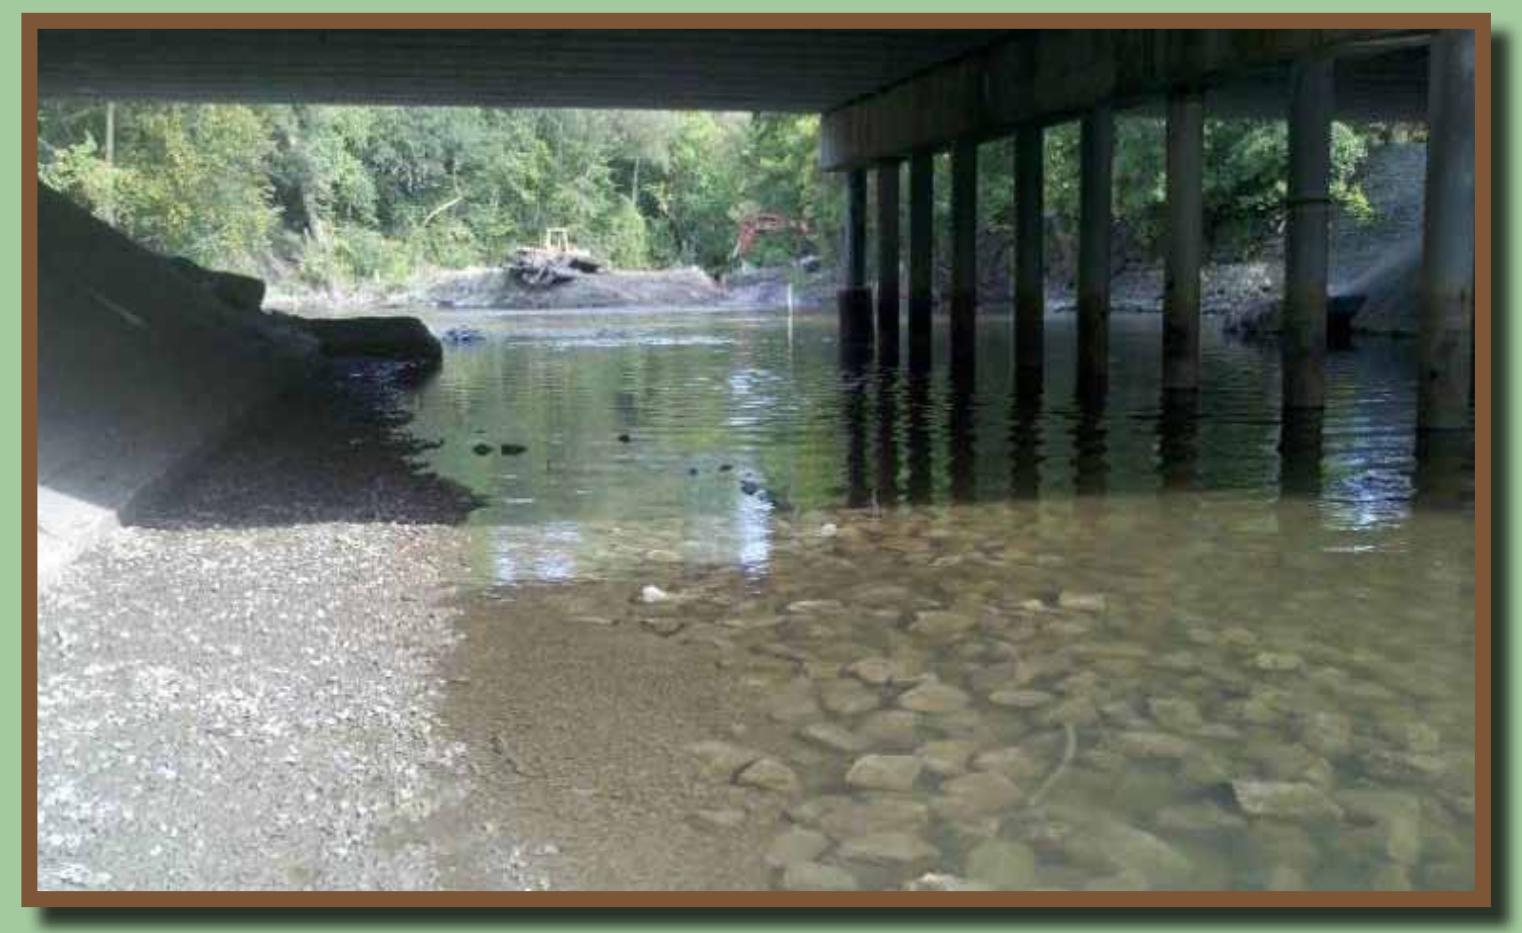
The riffle proposed for grade control is providing attachment sites for macroinvertebrates and feeding and spawning habitat for fish. The engineered riffle set the bed grade and prevents a head cut from developing and migrating upstream protecting the infrastructure (sanitary sewer lines, the Wayne Road bridge, and water main).

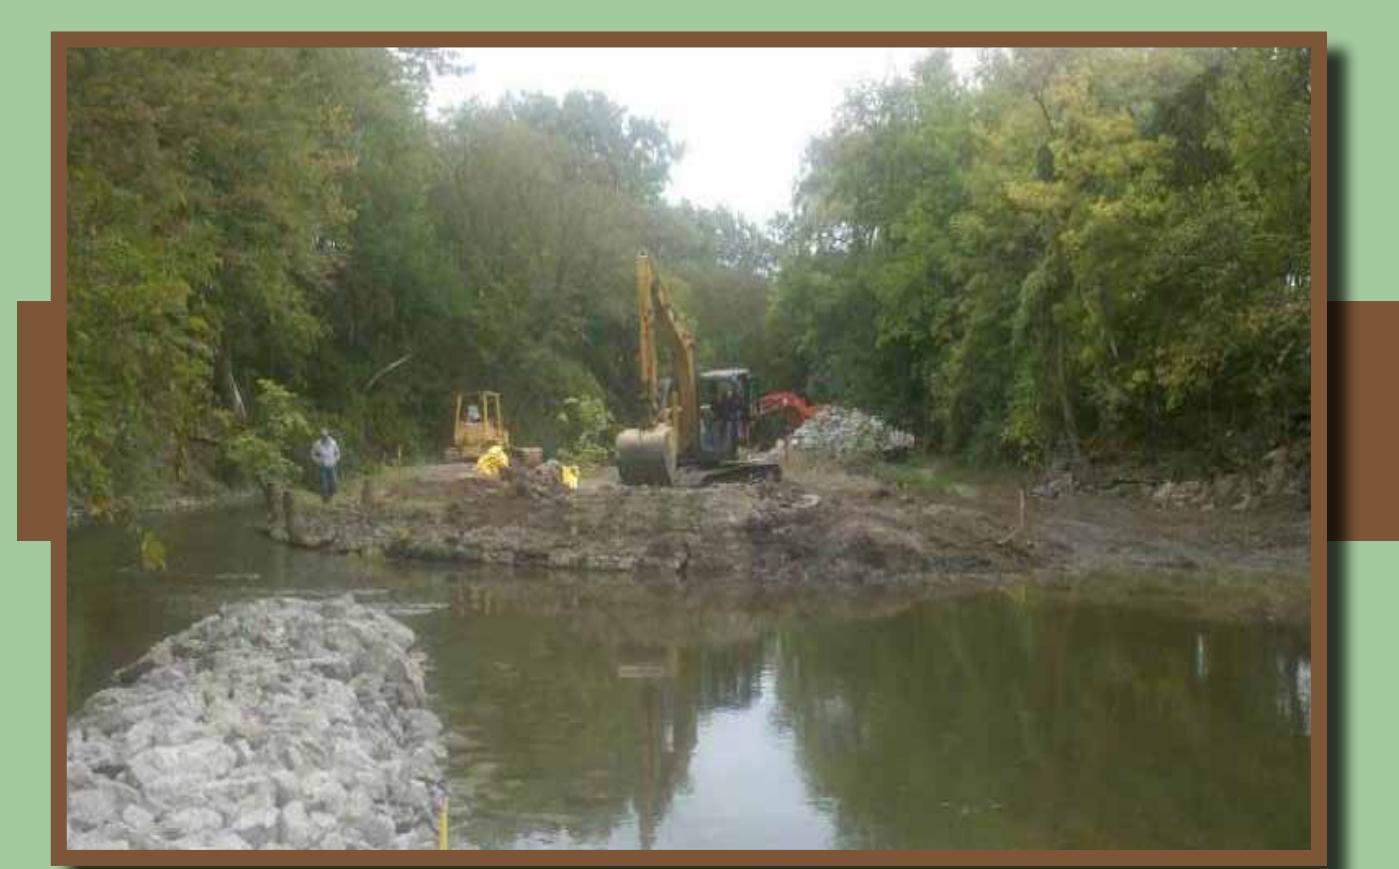
moval of in-stream island

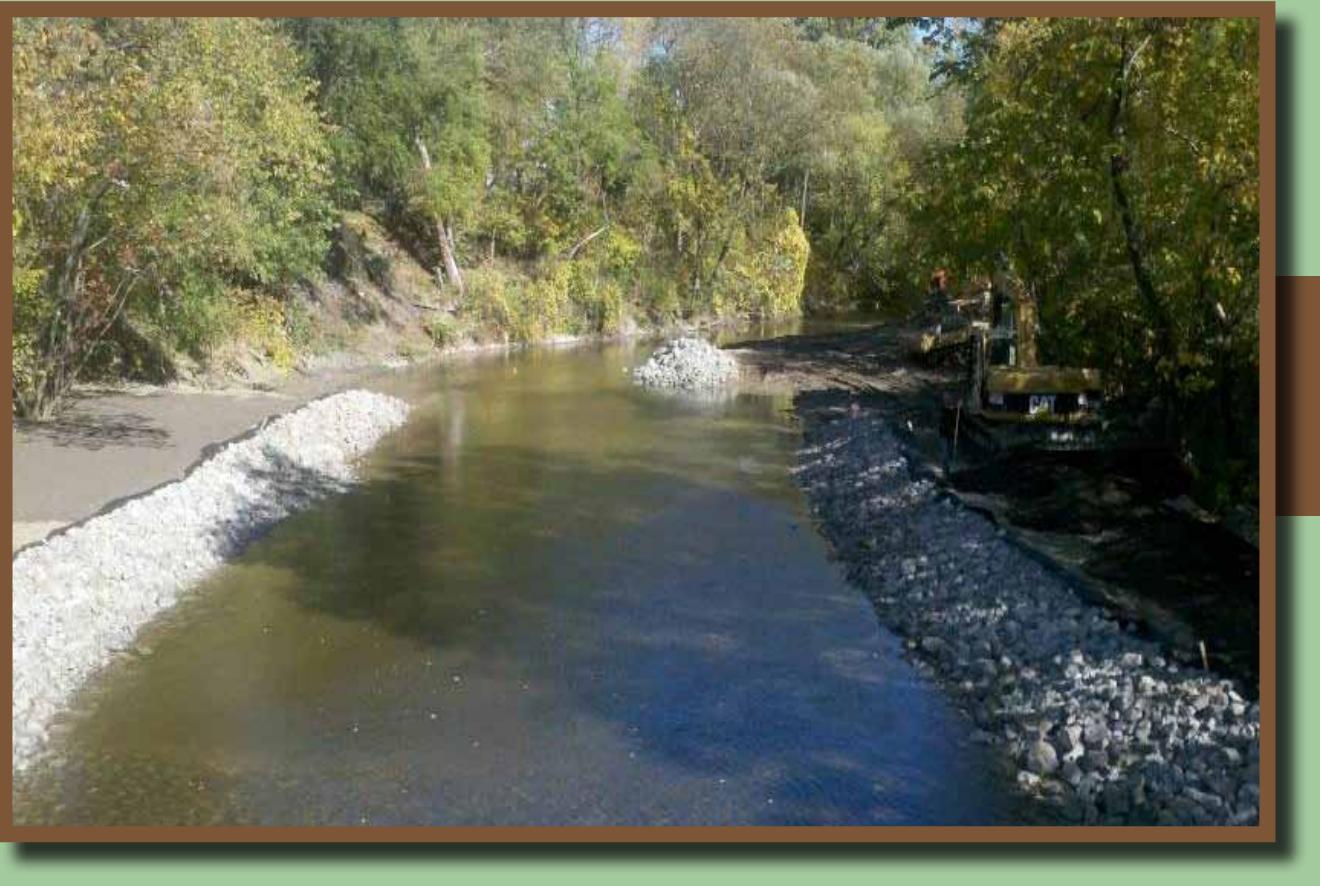
Bankfull benches

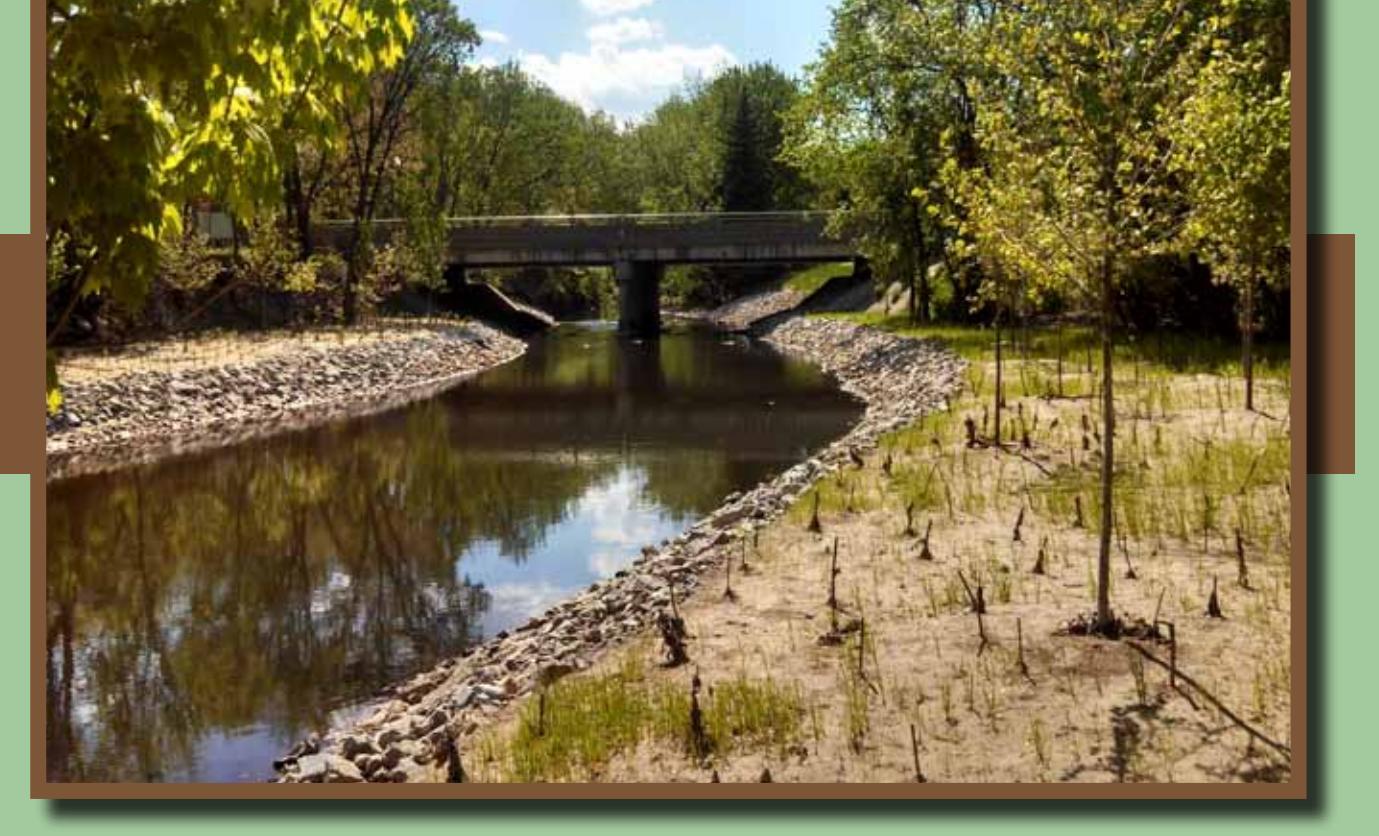
*Tree planting complete, seed placed and* erosion control blanket installed
